ODD FELLOWS' REST CEMETERY  
5055 Canal Street  
New Orleans, LA 70119

Final Practicum Report  
Teutonia Lodge Society Tomb HABS Report  
Existing Conditions Assessment

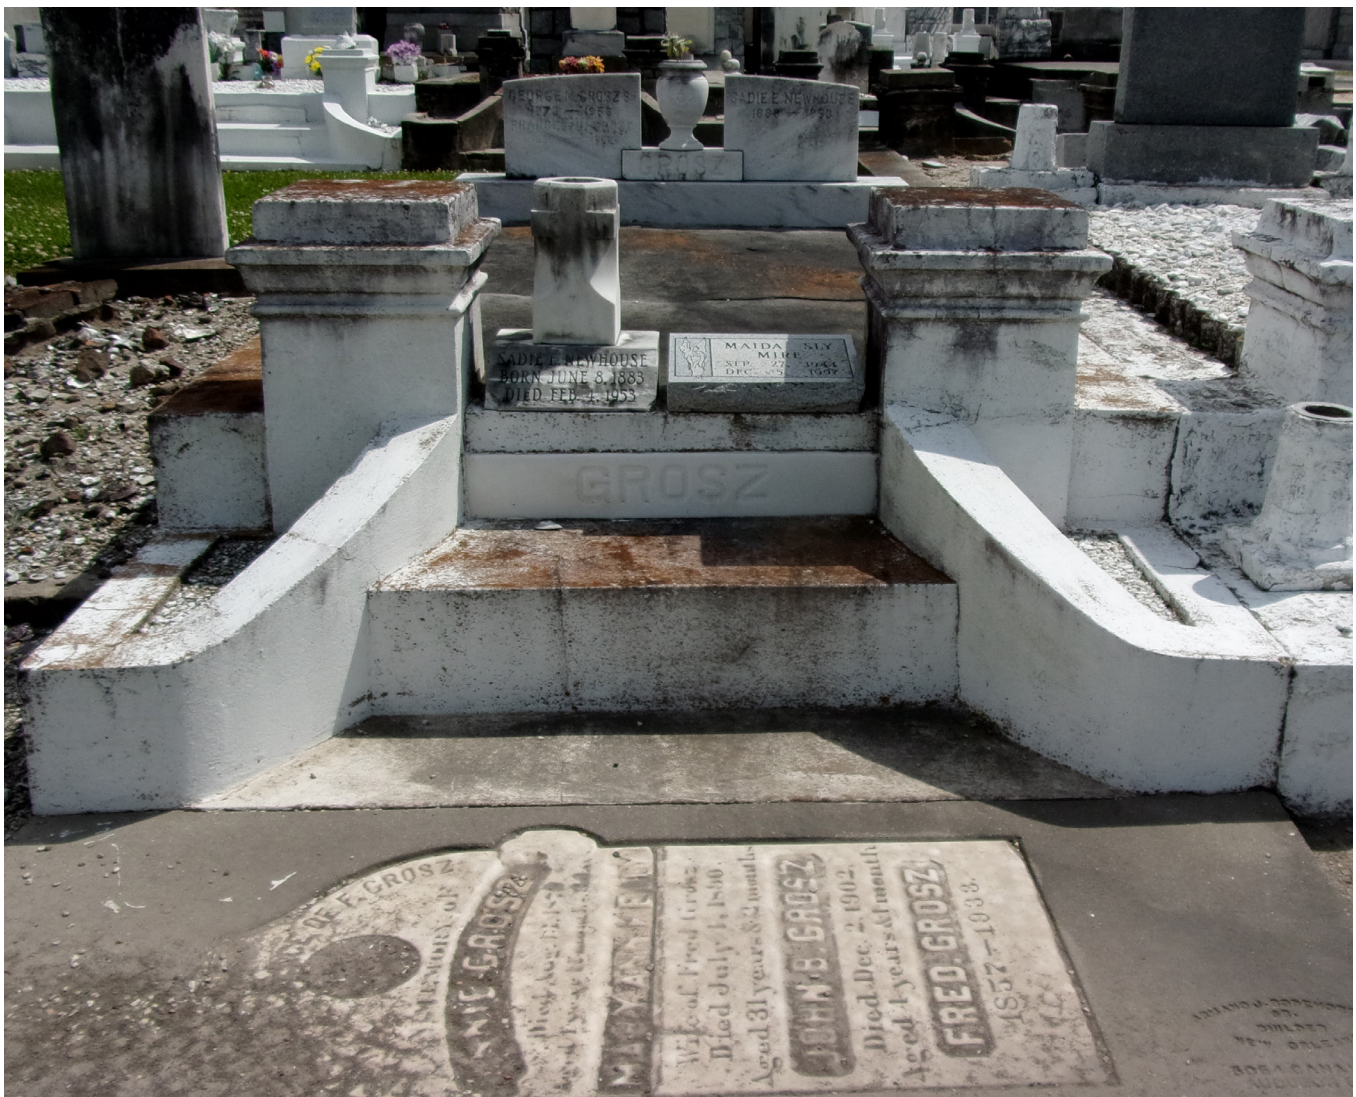
cement, rebar and granite in intervention methods on old tombs. He did construct some new tombs. An example of his work is shown below, the Grosz coping tomb (Figures 5 and 6). In this tomb, he most likely poured the concrete on the top of the coping tomb and re-sold the burial space to a new family. He also put the original owner's tablet in front of the coping tomb, and put a new table for the new owners above the tomb. Figure 6 shows his stamp of work, or signature, in the concrete in front of the tomb. Unfortunately, he died when he was at the height of his efforts, which stalled OFR as a whole.<sup>13</sup>

Figure 5. Grosz coping tomb, showing Rodehurst's intervention efforts. Taken by Emily Ford, 2012.

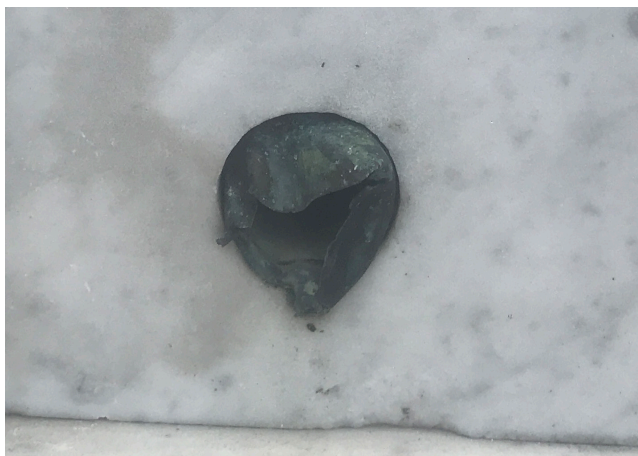
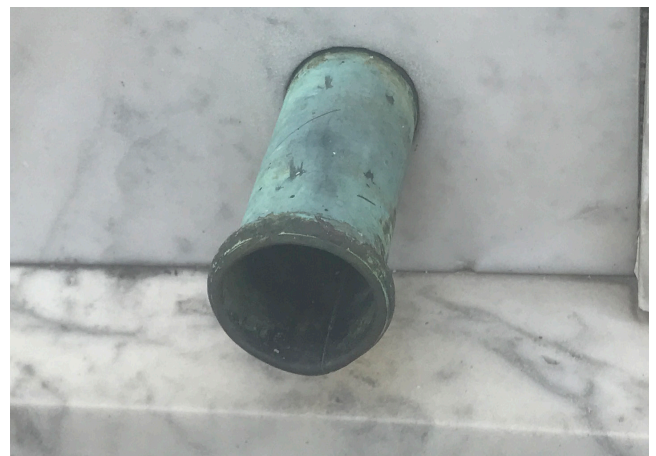
Figures 17 and 18. Copper pipes on the bottom corners of the northwest facade of Teutonia Lodge.

corners of the primary (northwest) façade (Figures 17 and 18).

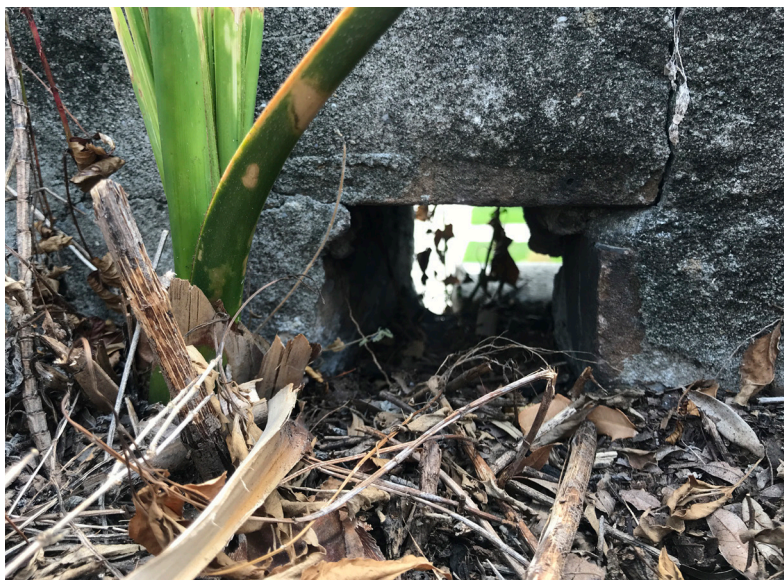
Figure 19. Photograph showing the brick that was removed on the southwest wall of the Teutonia Lodge in an attempt to create a draining system.

When the cement was added to the roof, a number of ties/hooks were installed in order to facilitate the stabilization of the structure. However, since the installment of these ties, many of them have failed due to the growth of various biological organisms, including plants, weeds, and trees, as well as various degrees of erosion. The presence of these ties, an attempt at stabilization, means that there was some sort of problem at the time of this addition, which was probably due to the failure of the building system within the walls. Interestingly, there seems to have been some sort of an effort to create a drainage system in the building: one brick on each corner of the rear upper façade was removed (Figure 19). This measly effort shows that at least there was some thought to the drainage system that was being covered up, although there is no way to determine who, how, or when these bricks were removed.

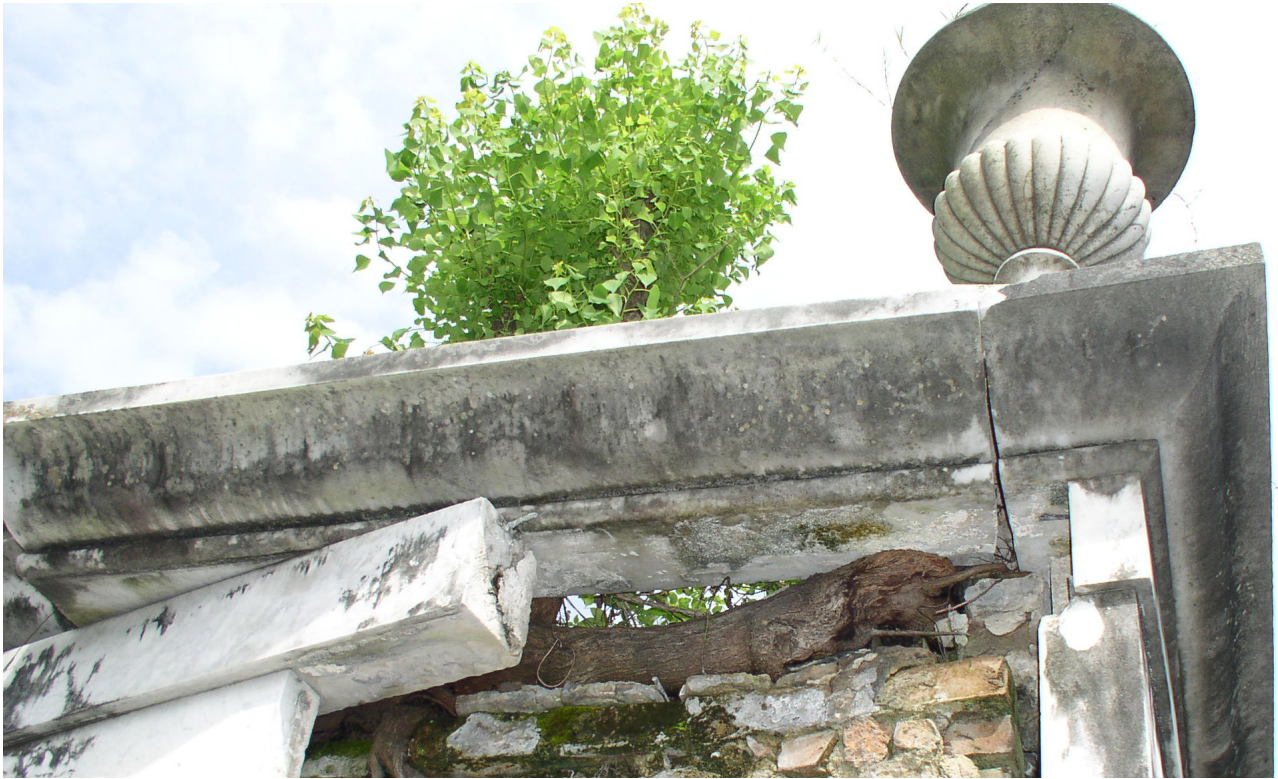
The most prominent source of the issues involved with this tomb is water. Water being trapped in a building system can lead to a number of other issues, many of which are occurring throughout Teutonia Lodge. This includes one of the most visible and jarring problems that the society tomb has seen in the past five years – the presence of a massive tree growing out of the southern of the tomb (Figures 21 and 22). There is also a tree growing in the southwestern wall of the building. The presence of these trees are another indication of the presence of water throughout the building. Fortunately, the tree has partially been removed from the tomb and the structure is stabilized (Figure 23). The tree seems to be recurring and requires consistent maintenance.

Figure 21. Photograph showing a tree and roots growing out of the northwestern wall/western corner of Teutonia Lodge, pre-stabilization efforts. Taken by Michael Duplantier, Sr., 2015.

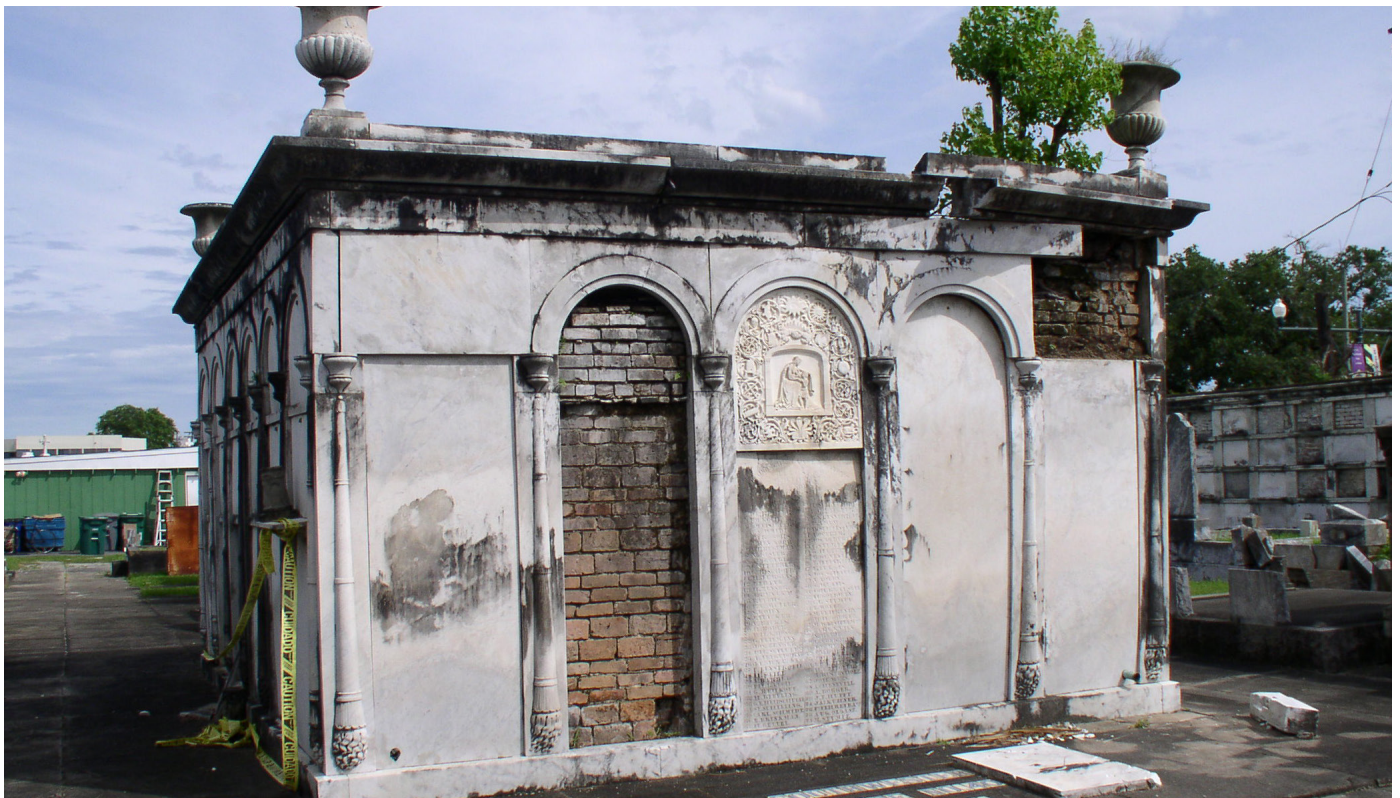
Figure 22. Northwestern facade pre-stabilization, showing the tree growing out of the southern corner of the wall. Taken by Michael Duplantier Sr., 2015.

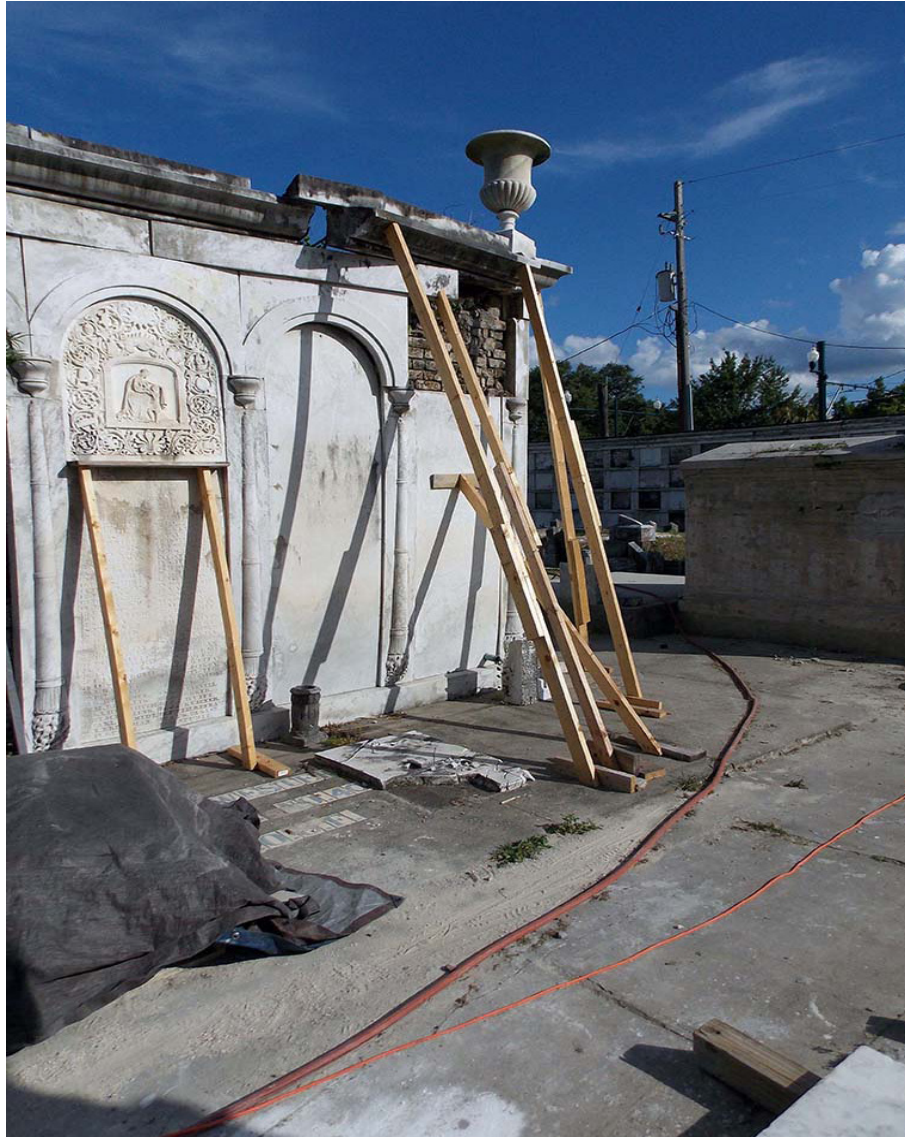
Figure 23. Southwestern facade after stabilization and partial removal of trees.  
Taken by Michael Duplantier, Sr., taken May 2018.

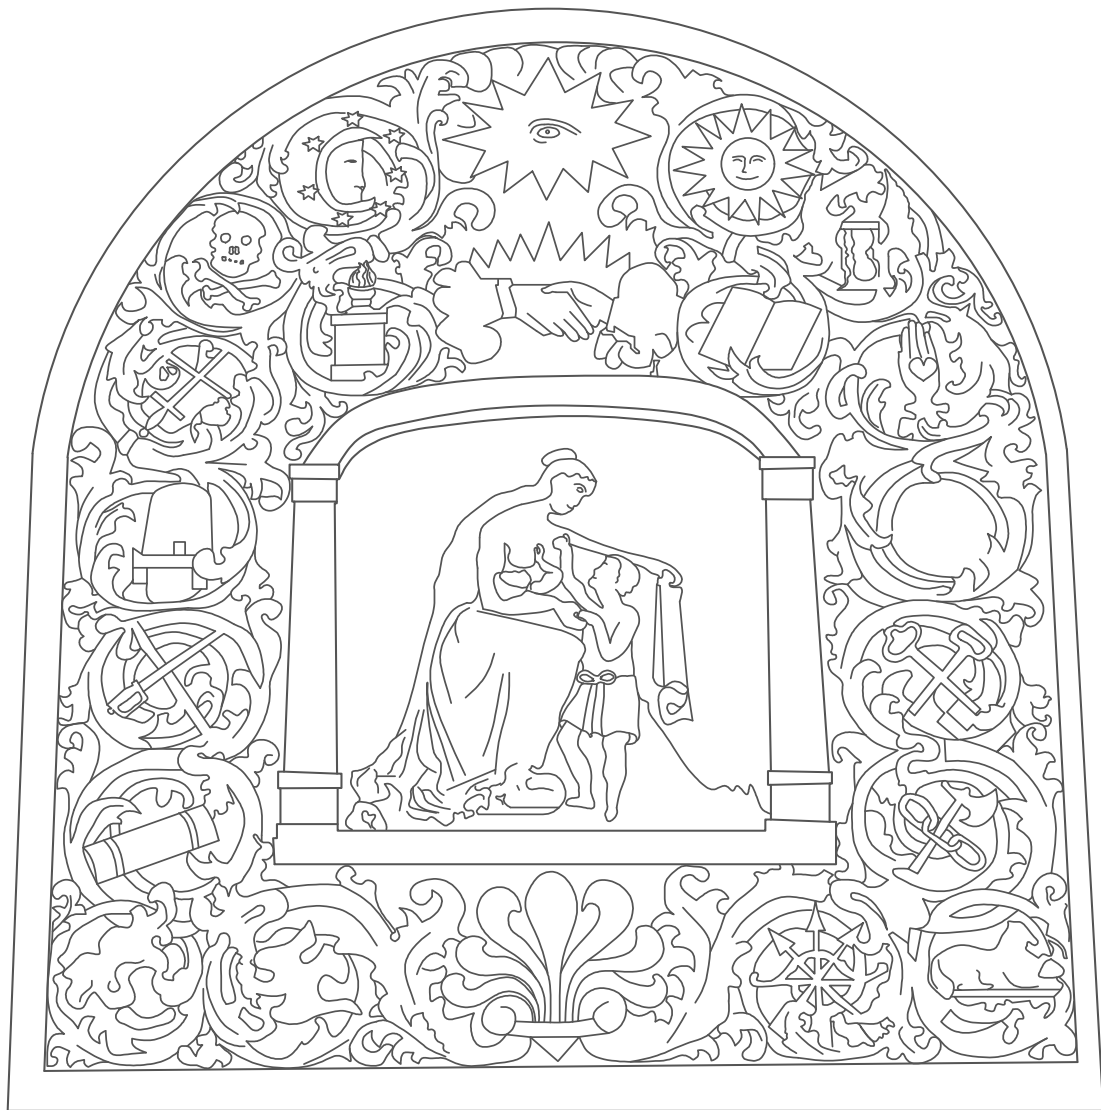
This marble panel is an excellent example of Anthony Barret's sculpting skills. He is a German born sculptor, so it is fitting that a German Lodge would want him to build their society tomb. While he has built many other tombs throughout the city's cemeteries, the Teutonia Lodge - especially this marble panel - is one of his most impressive structures. Barret's sons continued his legacy and started a marble sculpting company, the Barret Bros.

The panel itself shows all of the iconography of the Odd Fellows, with the widow and children being the most prominent. Other symbols include hands clasped, the all-seeing eye, and an axe with a three-linked chain.

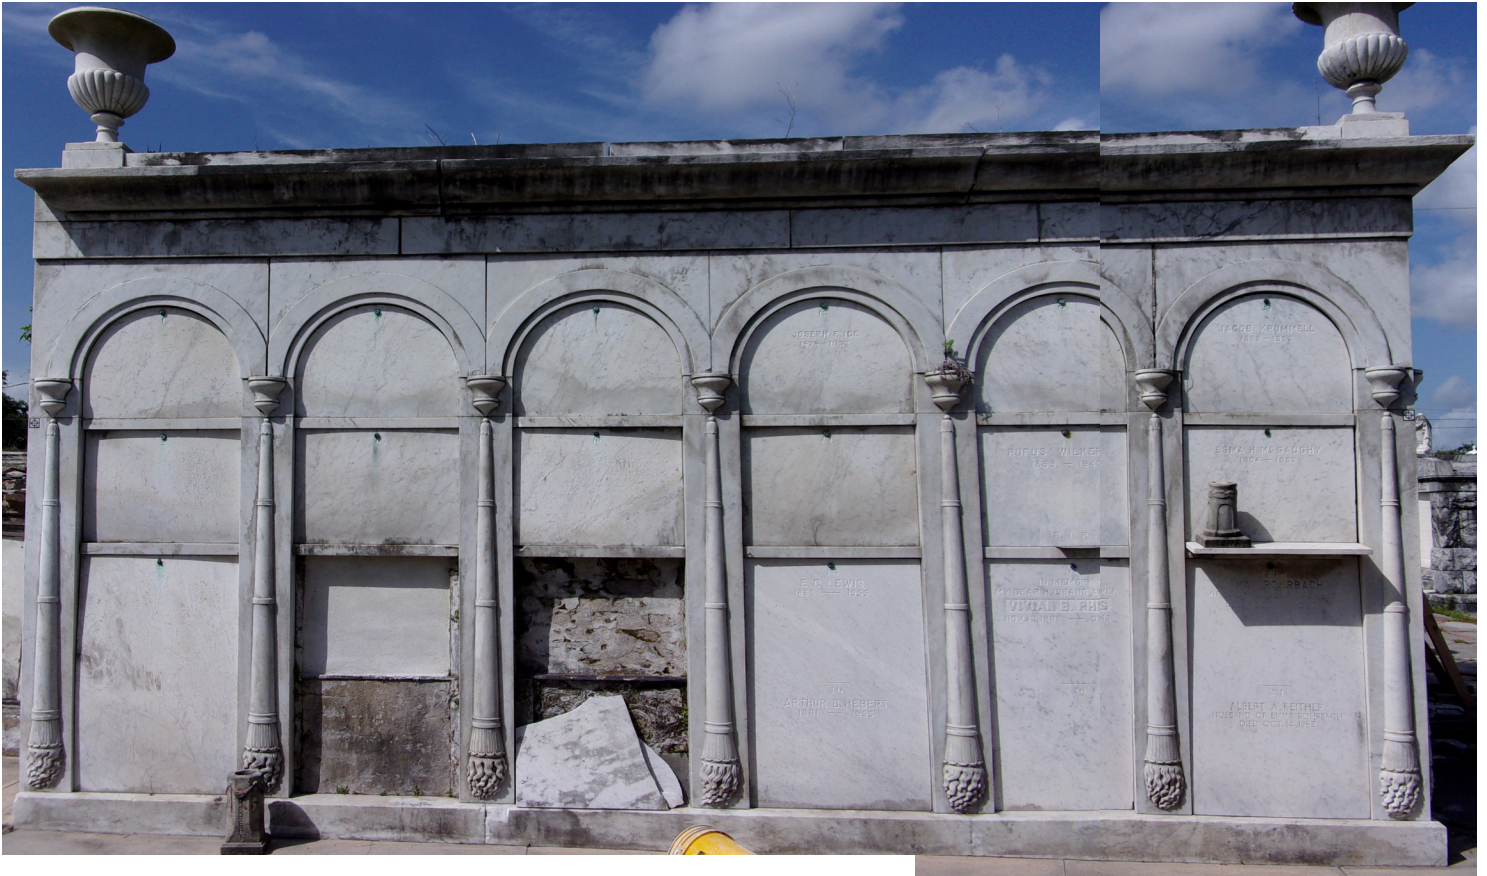
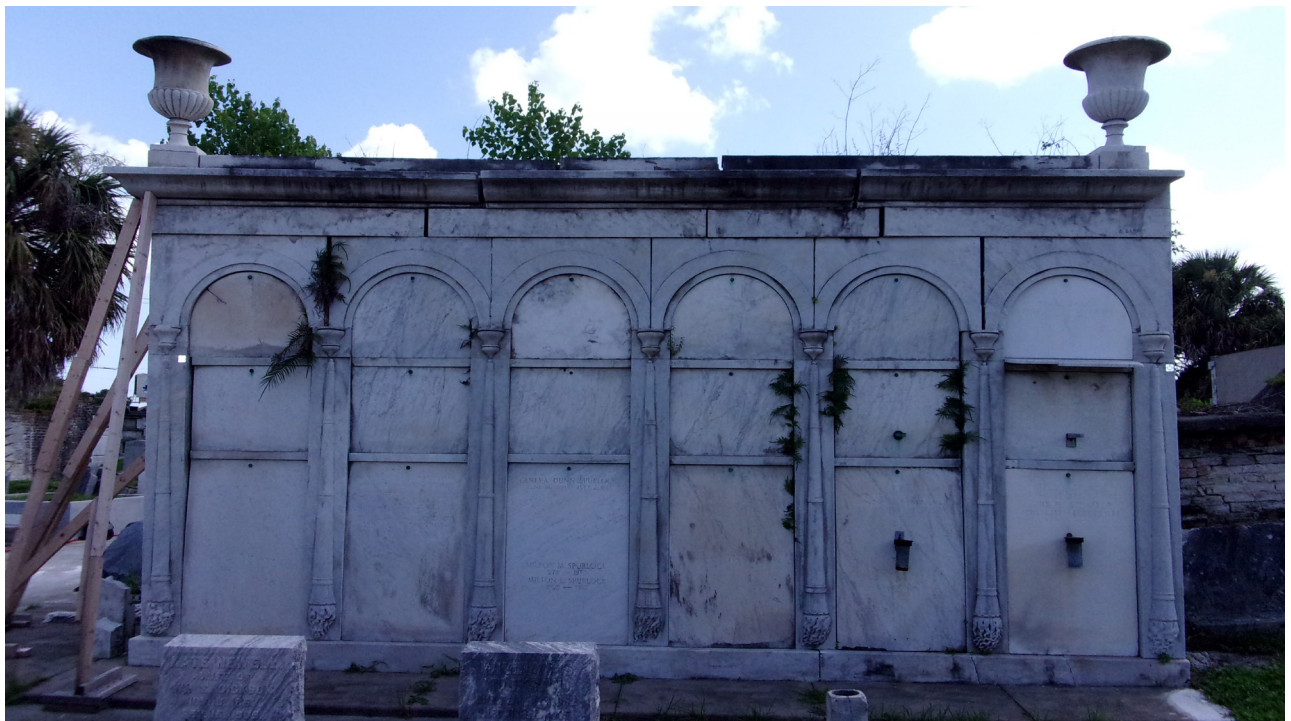
Figures 24 and 25. Teutonia Lodge. Top: Northeastern Facade. Bottom: Southwestern Facade. See Drawing A2, p. 22.

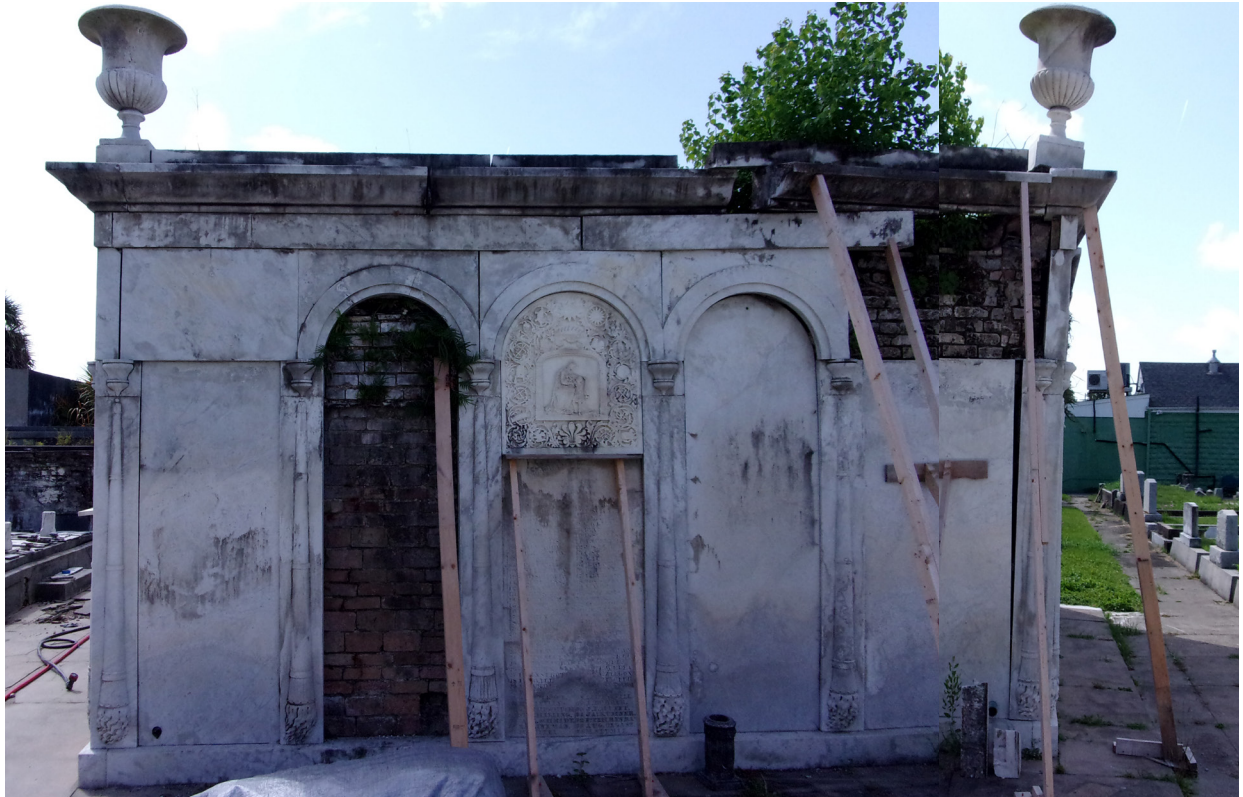
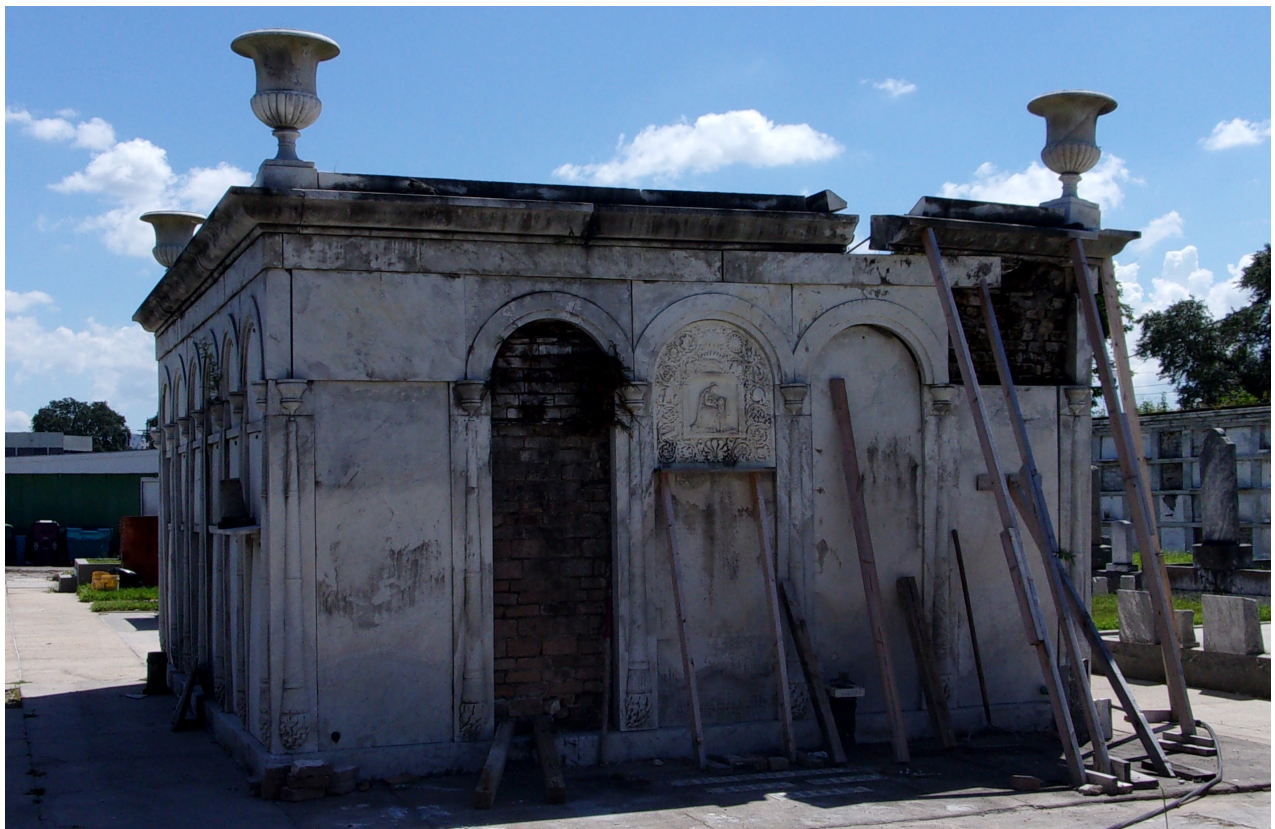
Figures 26 and 27. Teutonia Lodge. Northwestern Facade. See Drawing A1, p. 21.

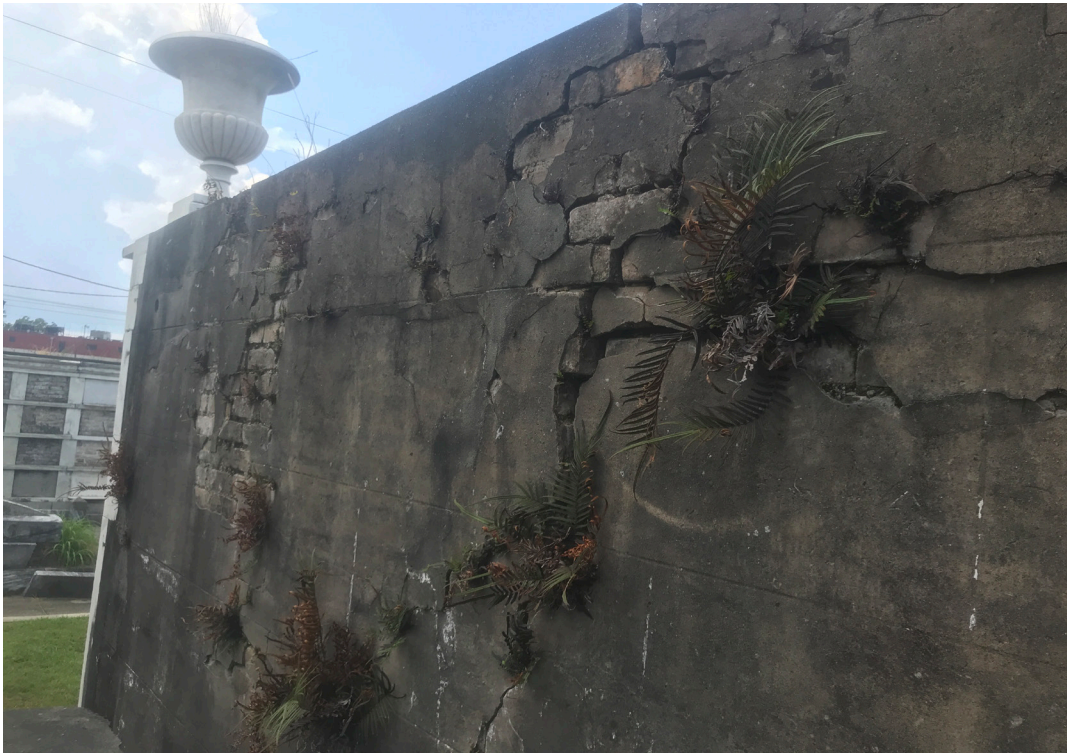
Figure 28. Teutonia Lodge. Southeastern Facade.

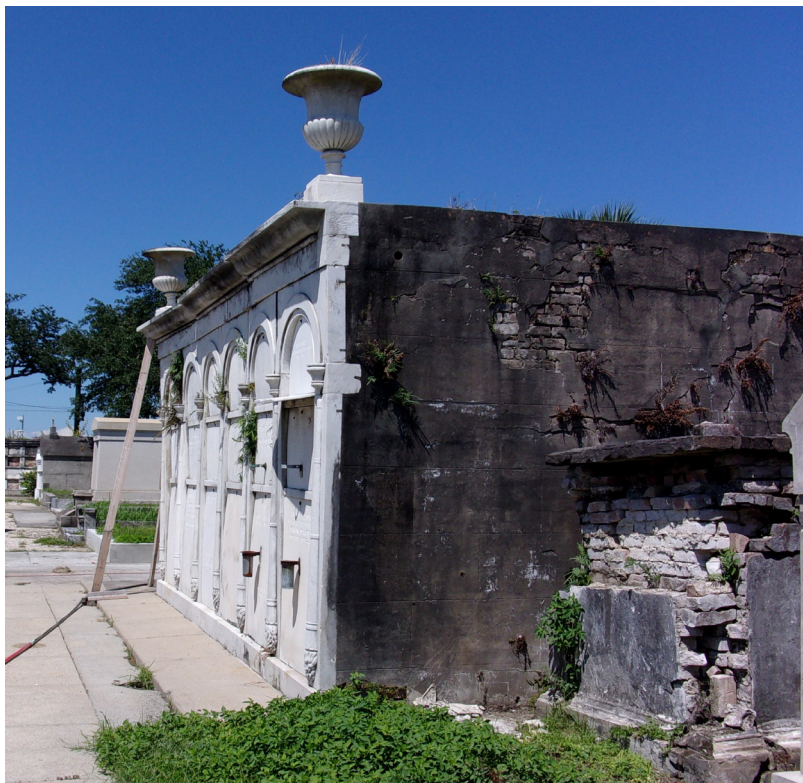
Figure 29. Teutonia Lodge. Rear corner, showing southwest and southeast facade. See Drawing A2, p. 22.

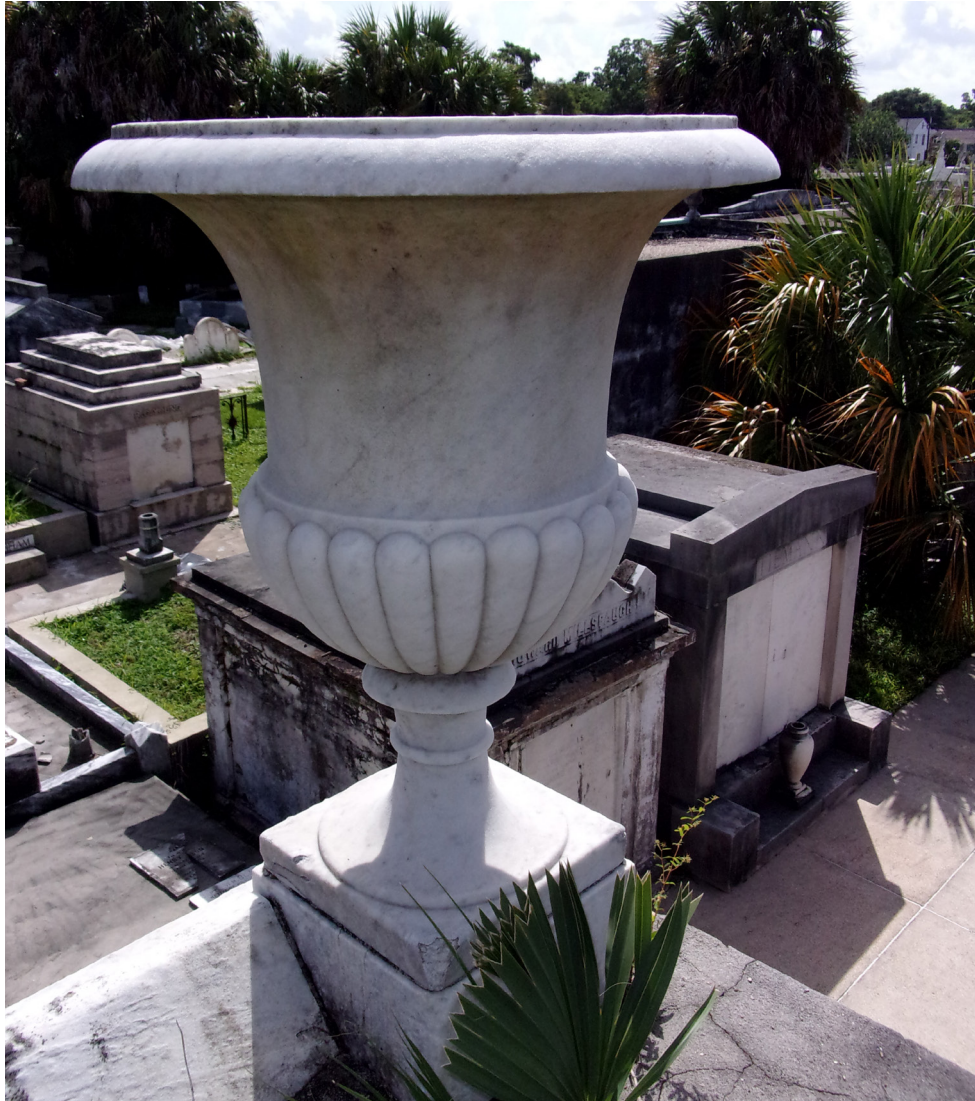
Figure 30. Teutonia Lodge. Urn. Located atop all four corners of the building. See Drawing B2, p. 24.

a wall as a decorative element. These blind arcades are framed by inverted torches, which are employed as an elemental motif. The inverted torch is a symbol of death or of life extinguished, a symbol originating in Greek mythology. The tomb also has marble urns on each corner of its roof, another symbol of death.<sup>10</sup>

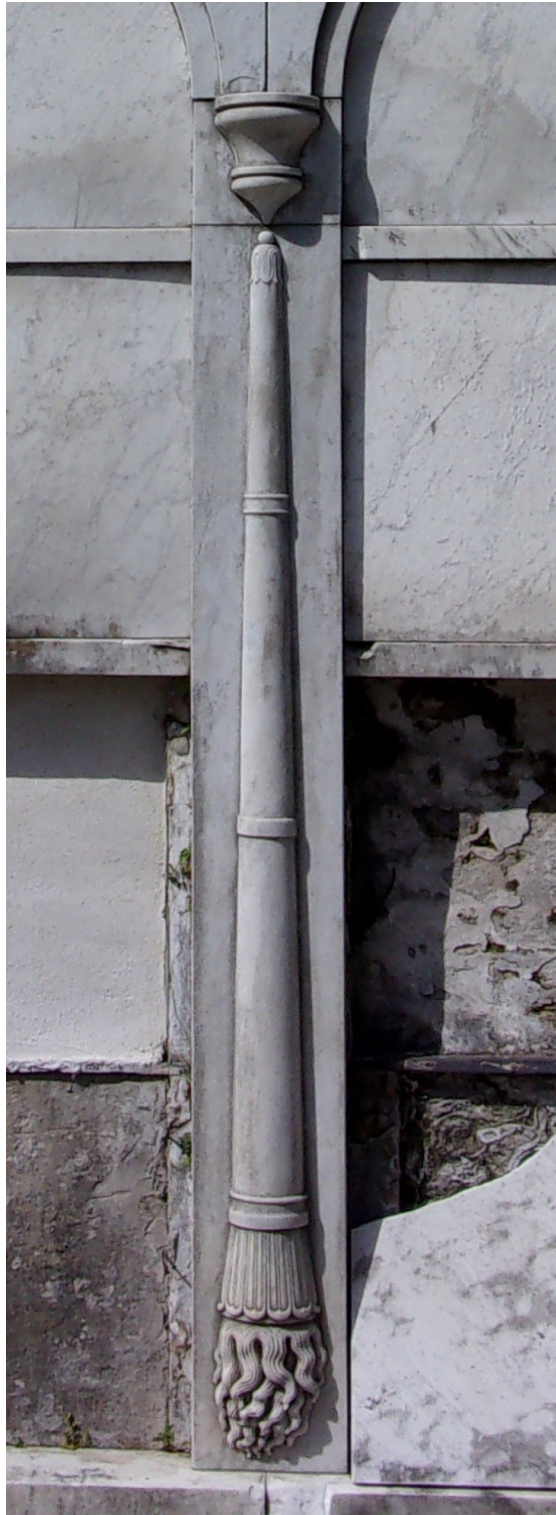
Figure 31. Teutonia Lodge. Inverted torch detail located on the three primary facades. See Drawing B2, p. 24.

The inverted torch is a common motif and symbol throughout cemeteries in New Orleans. It is a symbol of death, or of life extinguished. This symbol of a burning torch can be traced back to Pagan origins. During the Renaissance, the upright torch was an emblem of life and truth. Around this time is when the inverted torch became known as a symbol of death, a “memento mori.” On the Teutonia Lodge, inverted torches frame the blind arcades on the three primary facades of the tomb.<sup>13</sup>

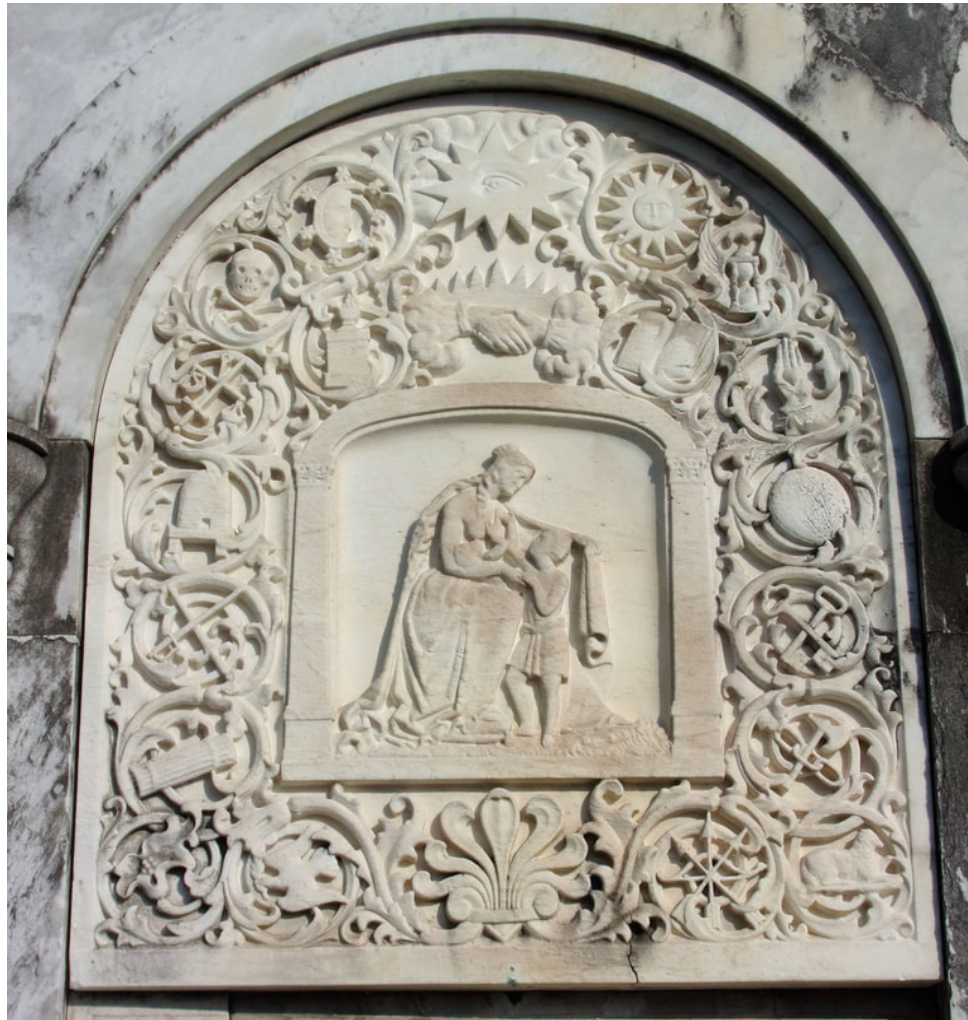
Figure 32. Teutonia Lodge. Marble Panel by Anthony Barret on northwest facade of Teutonia Lodge. See Drawing B1, p. 23.

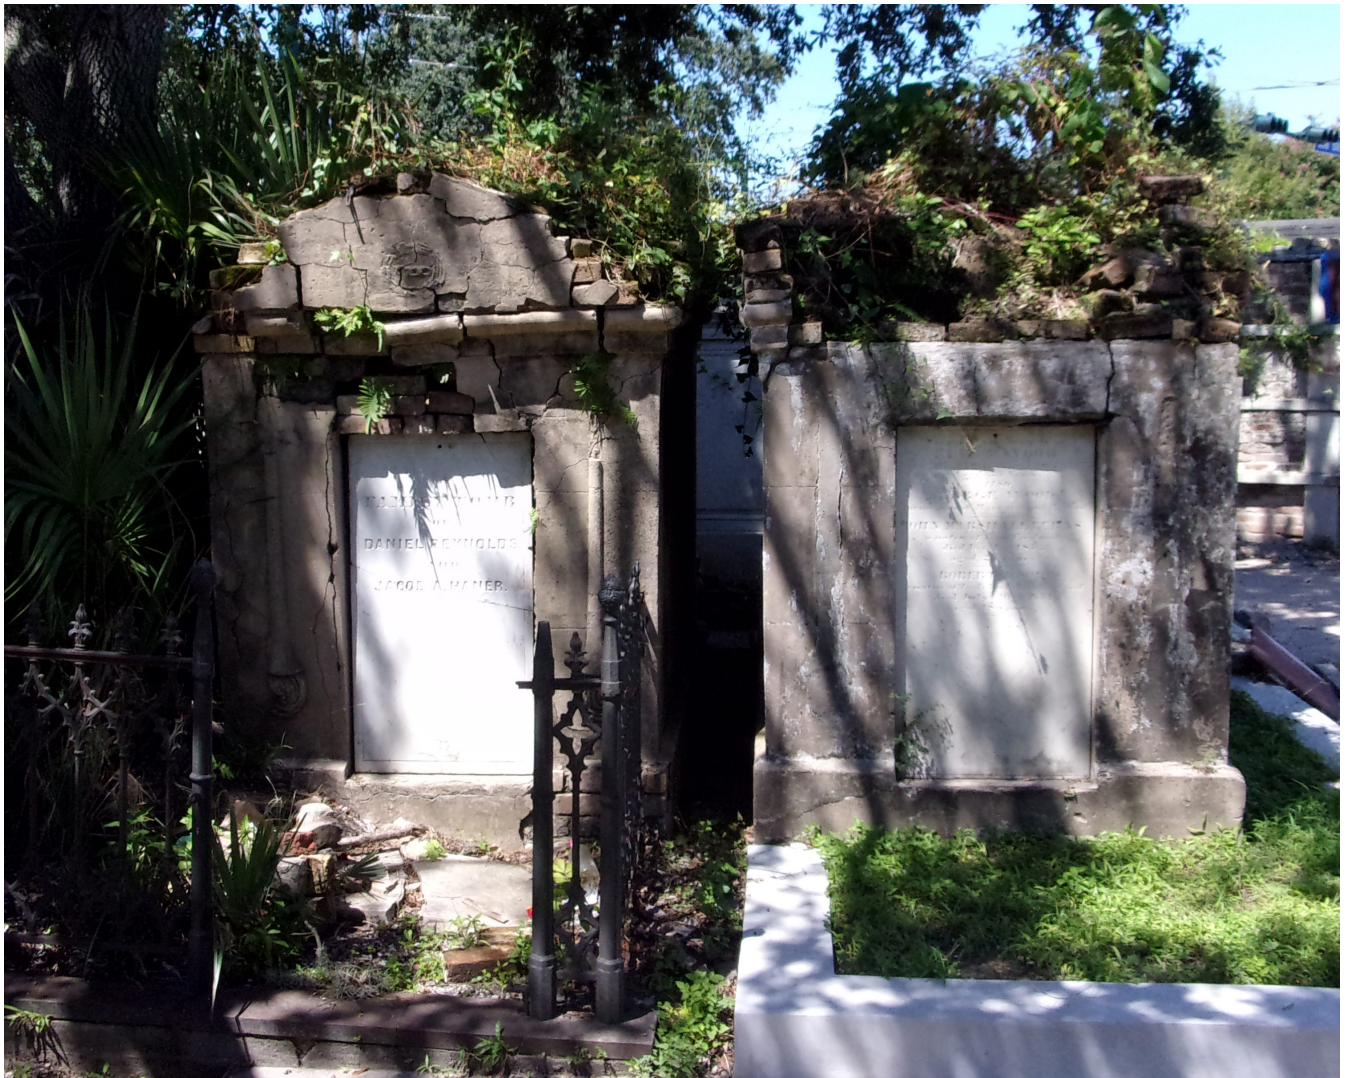
Figure 33. Two tombs in OFR, both in poor condition with crumbling brick walls and biological growth from the roofs.

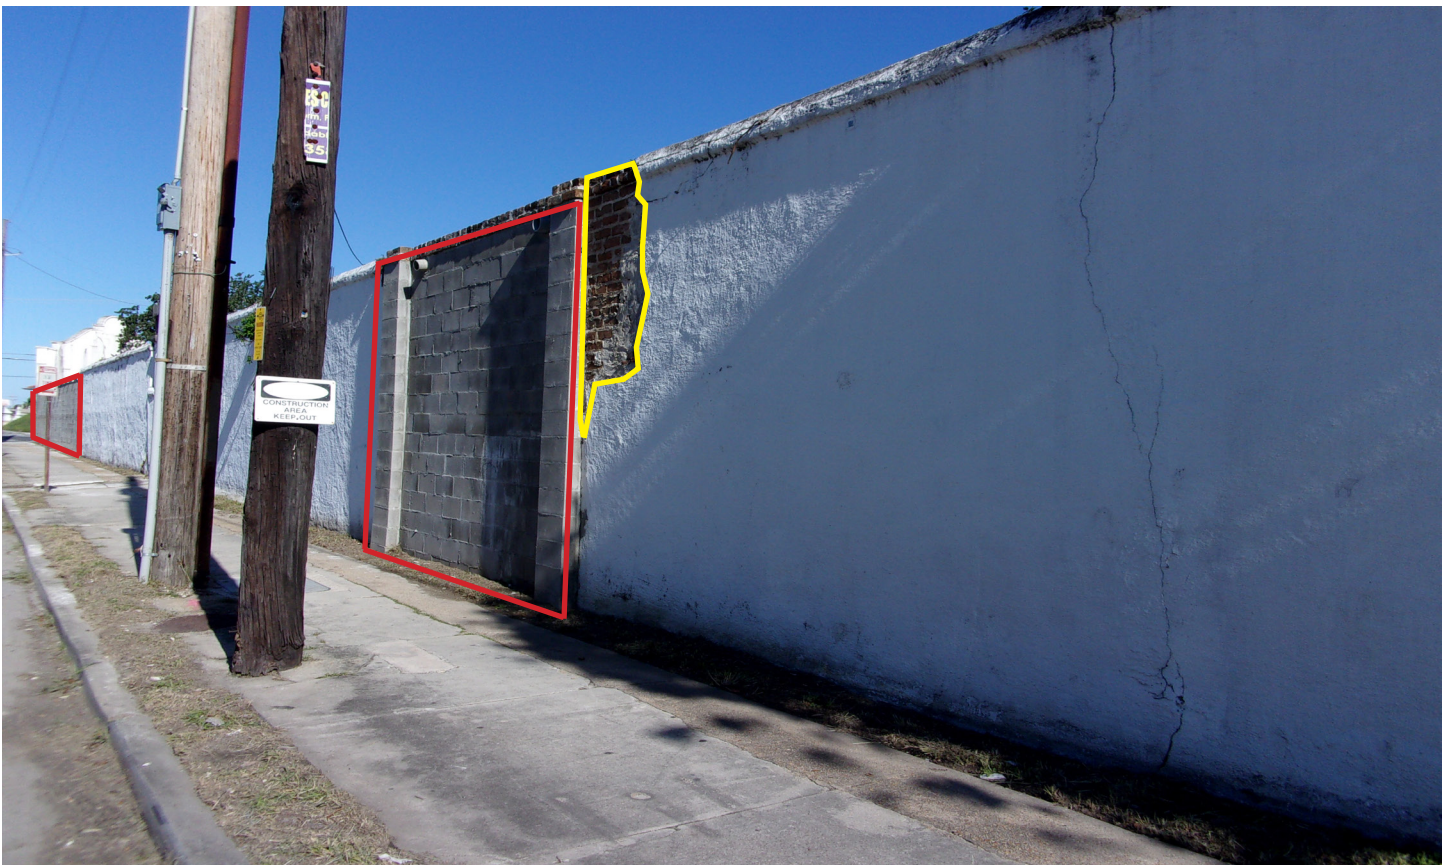
Figure 34. Photograph showing the repairs to the exterior Canal Street wall of OFR. Two cement sections are outlined in red, while the rest of the wall is constructed of brick covered in stucco, visible in the exposed patch outlined in yellow.

- Total reconstruction of the Southwestern wall (Canal Street) – more than 150 linear feet. Previously, the wall and wall vaults were in an unstable condition with crumbling material and an unsightly appearance, notifying the public of the status of the forgotten cemetery. The extent of this project included the total reconstruction of the majority of the roof and part of the wall – which is apparent and visible on the exterior of the wall (Figure 34) – and cosmetic repairs of some wall vaults, in addition to the reconstruction of the

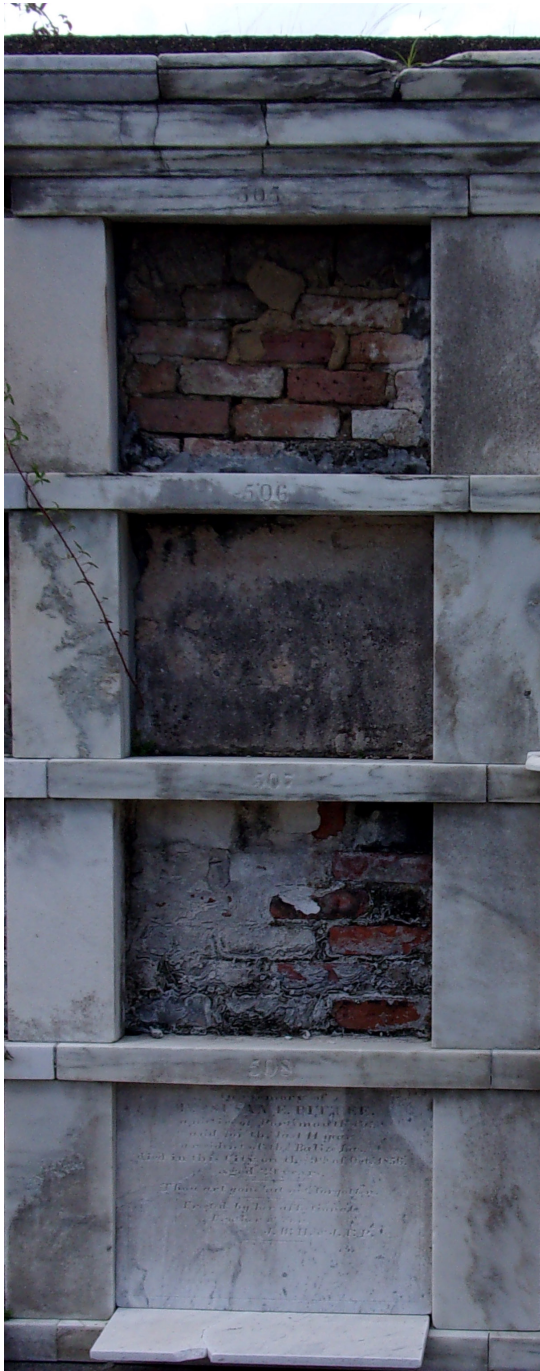
Figure 35. Wall vaults 505 – 508, Southwestern wall.

cornice. Some of the marble tablets on the wall vaults of both walls have fallen off, broken, or have been lost (Figure 35). With the help of local preservationists (some of whom occasionally do contracting work in the cemetery) a number of these tablets have been repaired and re-installed to the fronts of the vaults (Figure 36). All in all, these upgrades to the Canal Street wall have not only improved the appearance of the cemetery (hopefully creating a more positive view for the public to see), but have made the wall reliable. While the interior of the wall may still have some issues, the most pressing and dire repairs have been

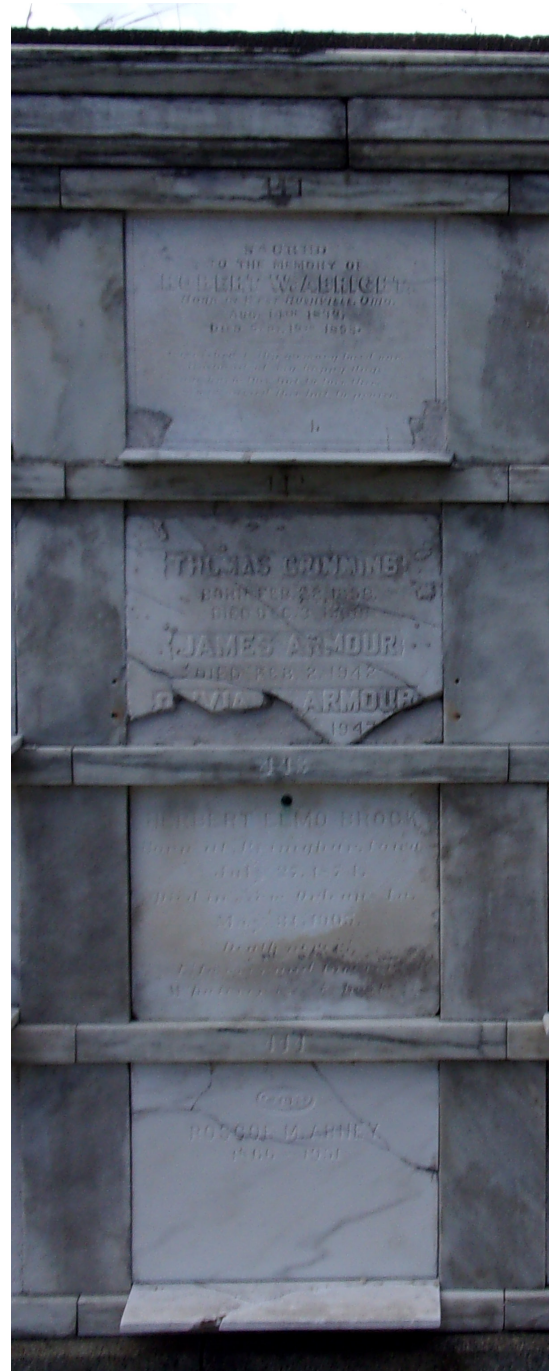
Figure 36. Repaired wall vaults 441 – 444, Southwestern wall.
