ODD FELLOWS' REST CEMETERY  
5055 Canal Street  
New Orleans, LA 70119

Final Practicum Report  
Teutonia Lodge Society Tomb HABS Report  
Existing Conditions Assessment

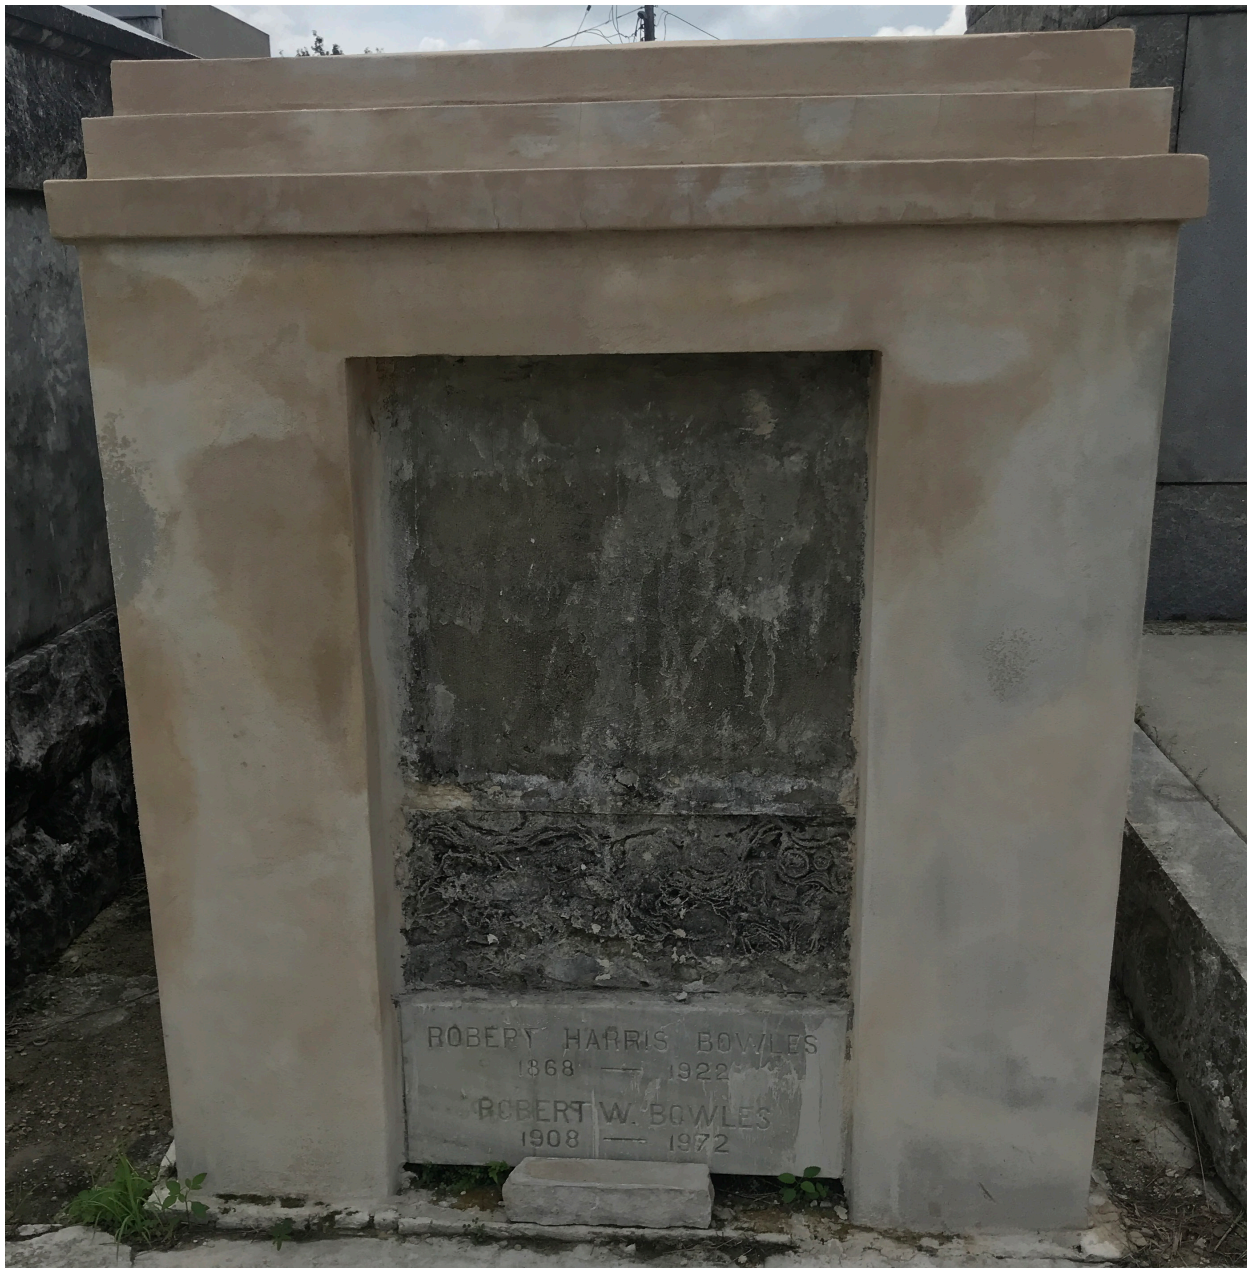
Figure 37. Repaired tomb with partially missing front tablet. Repaired in spring 2018.

- Various tombs have been repaired (Figure 37). These tombs were all reconstructed using similar materials, such as natural hydraulic lime, Portland cement, and
- Teutonia Lodge – stabilization efforts. While this tomb has major issues, as discussed in Part One of this report, there was some stabilization done due to necessity (Please see figures 21–23, pages 19 – 20). A more permanent rehabilitation plan has been created by Bayou Preservation, although no work has been completed thus far.

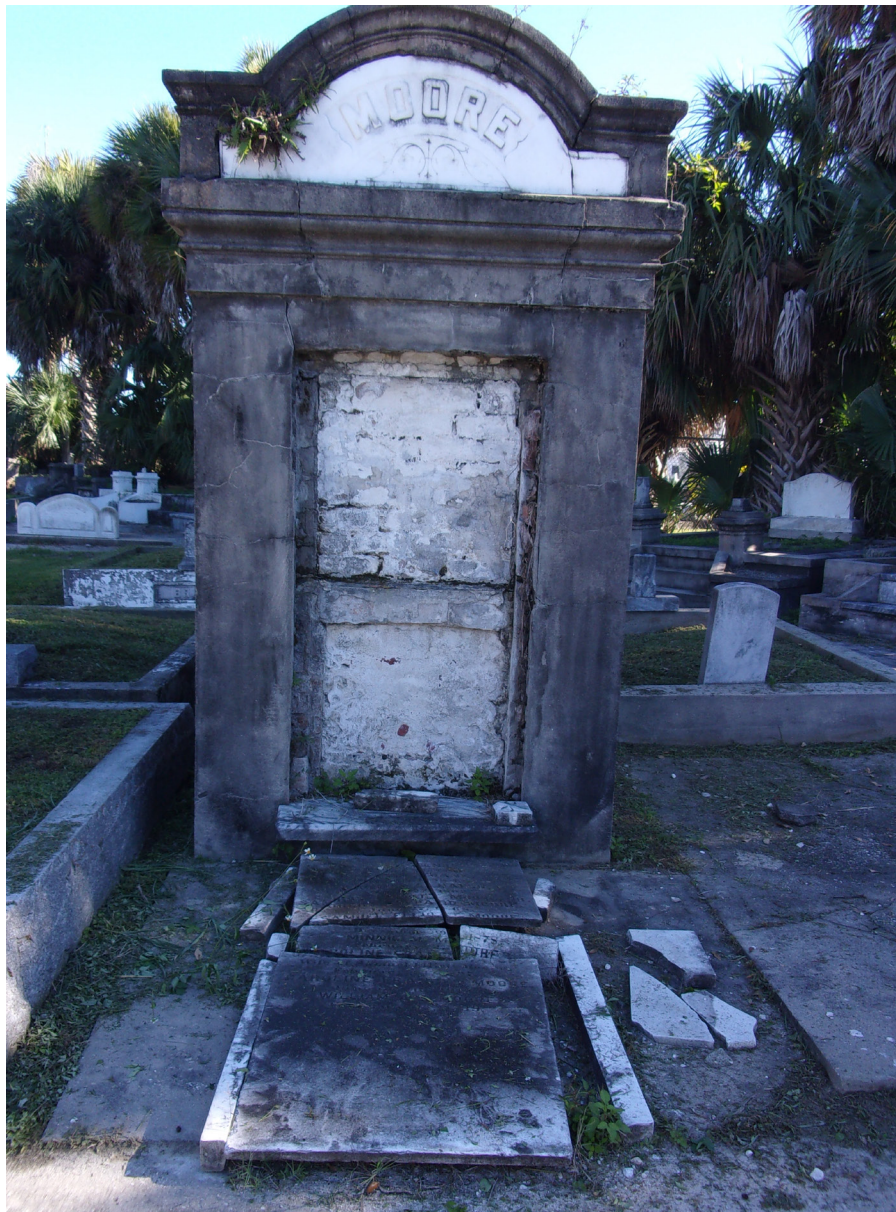
Figure 38. Tomb with fallen marble tablet, partially pieced together in front of the tomb.

- Marble tablets – finding, piecing together, replacing, re-installation. As previously mentioned, many marble tablets have fallen off wall vaults. This is the case for many other tombs as well (Figure 38). Unfortunately, some of the marble pieces have been lost – or at least not found yet in the cemetery. Many of the tablets are currently being treated as a puzzle (Figure 39), with the ultimate goal of getting the tablets reconstructed and back in their original place. One part of the problem is that the original tombs which these tablets were attached to are, for the most part, currently unknown. While occasionally this can be found out by research and the cross-checking of various cemetery logs, this can be a taxing and frustrating process. The

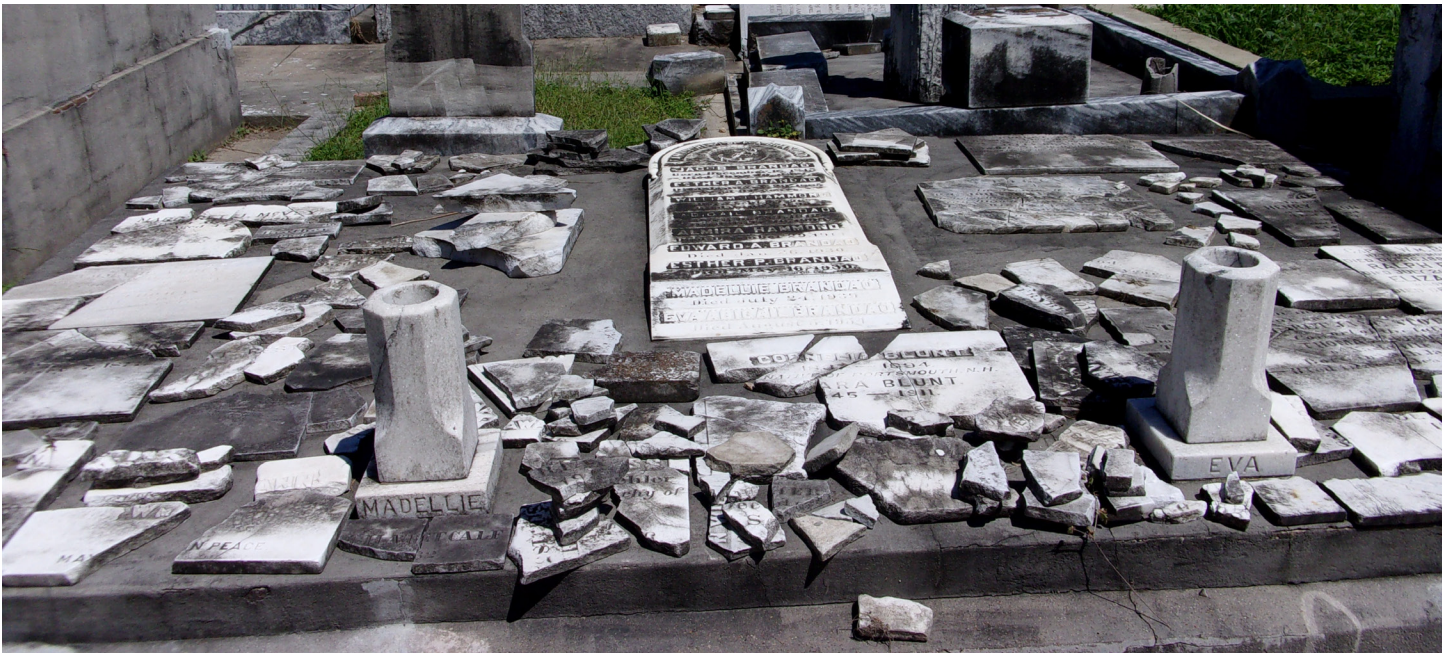
Figure 39. Pieces of marble tablets, partially laid out on top of a coping grave.

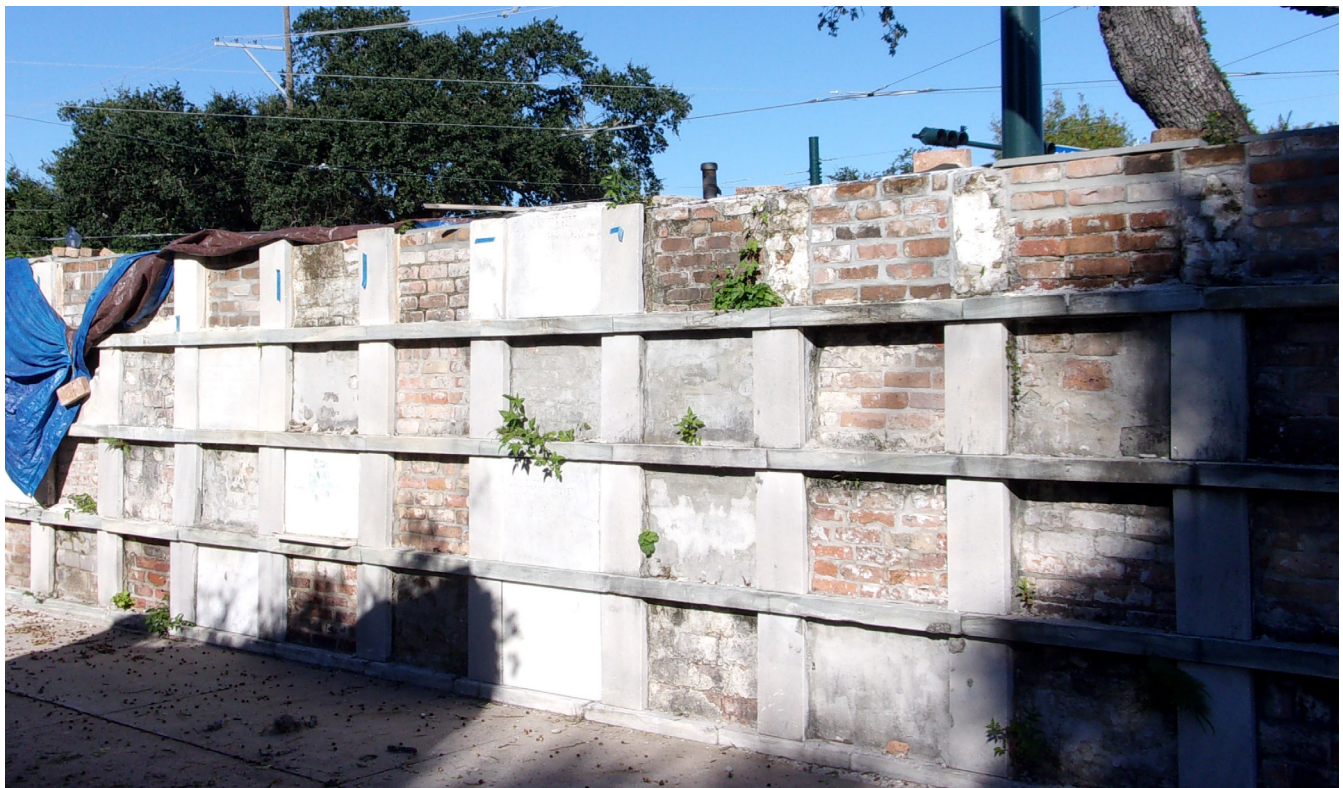
Figure 40. Photo showing the roof and cornice removed as work continues on the Northern (City Park Ave.) wall. The tarp (left-side of photo) is necessary in order to cover the open and vulnerable spaces of the roof.

- Reconstruction of the Northern wall (City Park Avenue). Similar to the already completed project of the Southwestern wall. Currently, the focus is on the outer wall and the roof – replacing the flagstone walls to

stabilize the inner wall and replace the cornice (Figure 40).

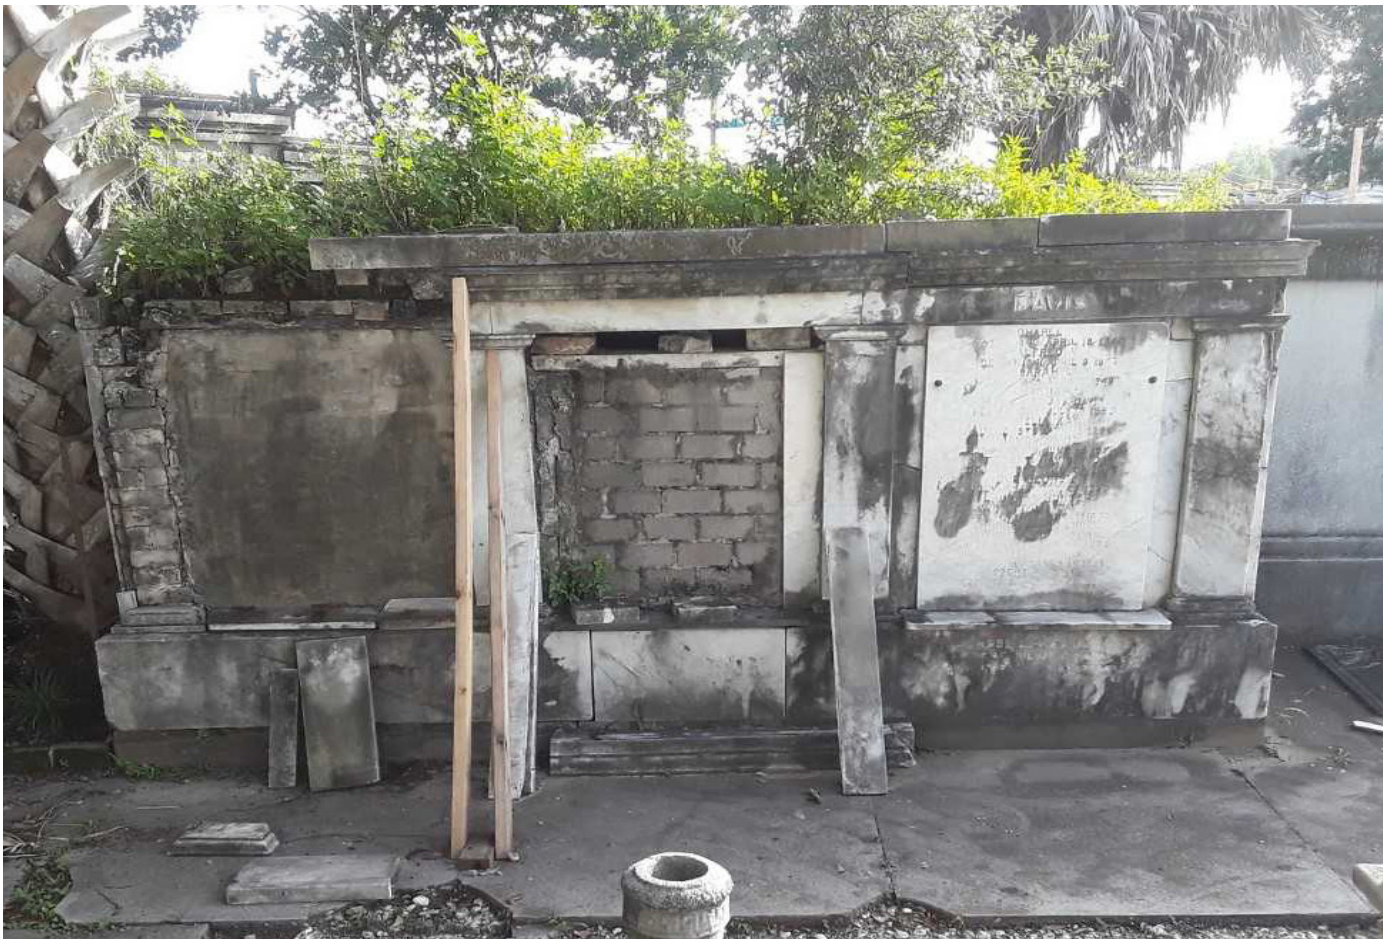
Figure 41. The Davis tomb before reconstruction efforts, taken by Michael Duplantier.

- Davis Tomb (near completion) – originally was three separate families crypts, even though they are all connected. Previously, the roof had collapsed, marble front was stained, trees and other biological growth, and the bricks were in poor condition (Figure 41). The bricks were removed from two of the walls – the rear and one of the sides – and replaced, using a natural hydraulic lime mortar. Roof, originally one large flagstone slab, was replaced with corrugated steel (Figure 42). Then poured over with three inches of concrete, a layer of brick, and a second layer of concrete (which has yet to be poured as of October of 2018). Bricks were reused when possible. The stained marble was cleaned with D2. Three marble panels will be installed on the front of the tomb. The tomb is almost completed, and should be done by the time this report is finalized (Figure 43).

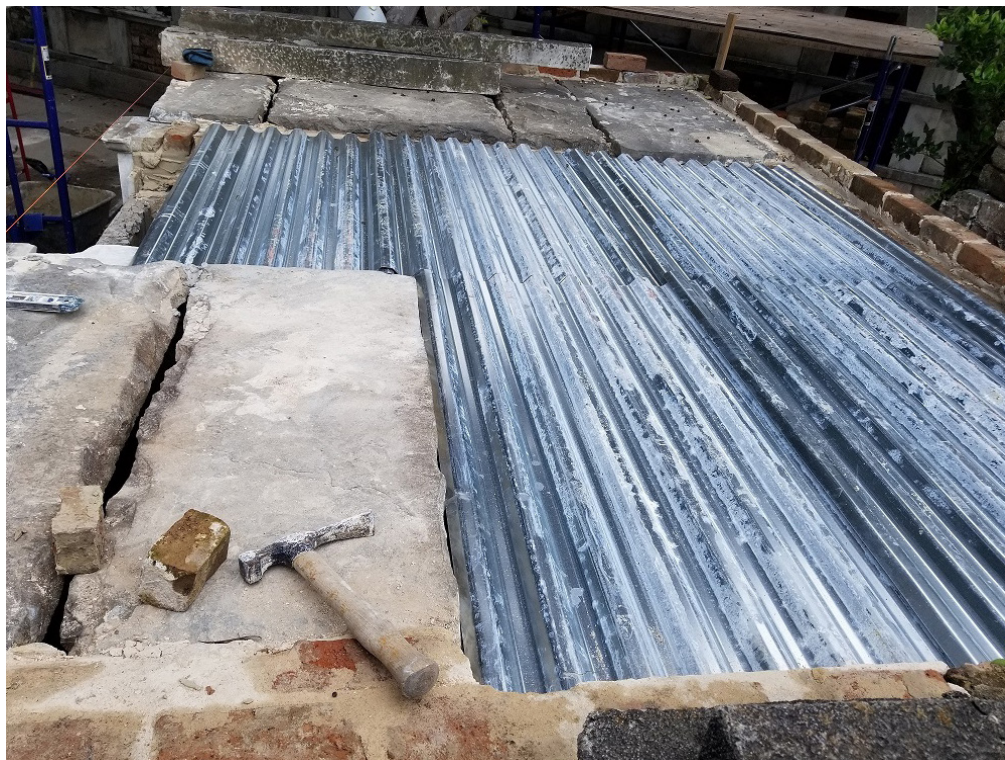
Figure 42. New corrugated steel roof, as a part of the Davis tomb reconstruction, taken by Michael Duplantier.

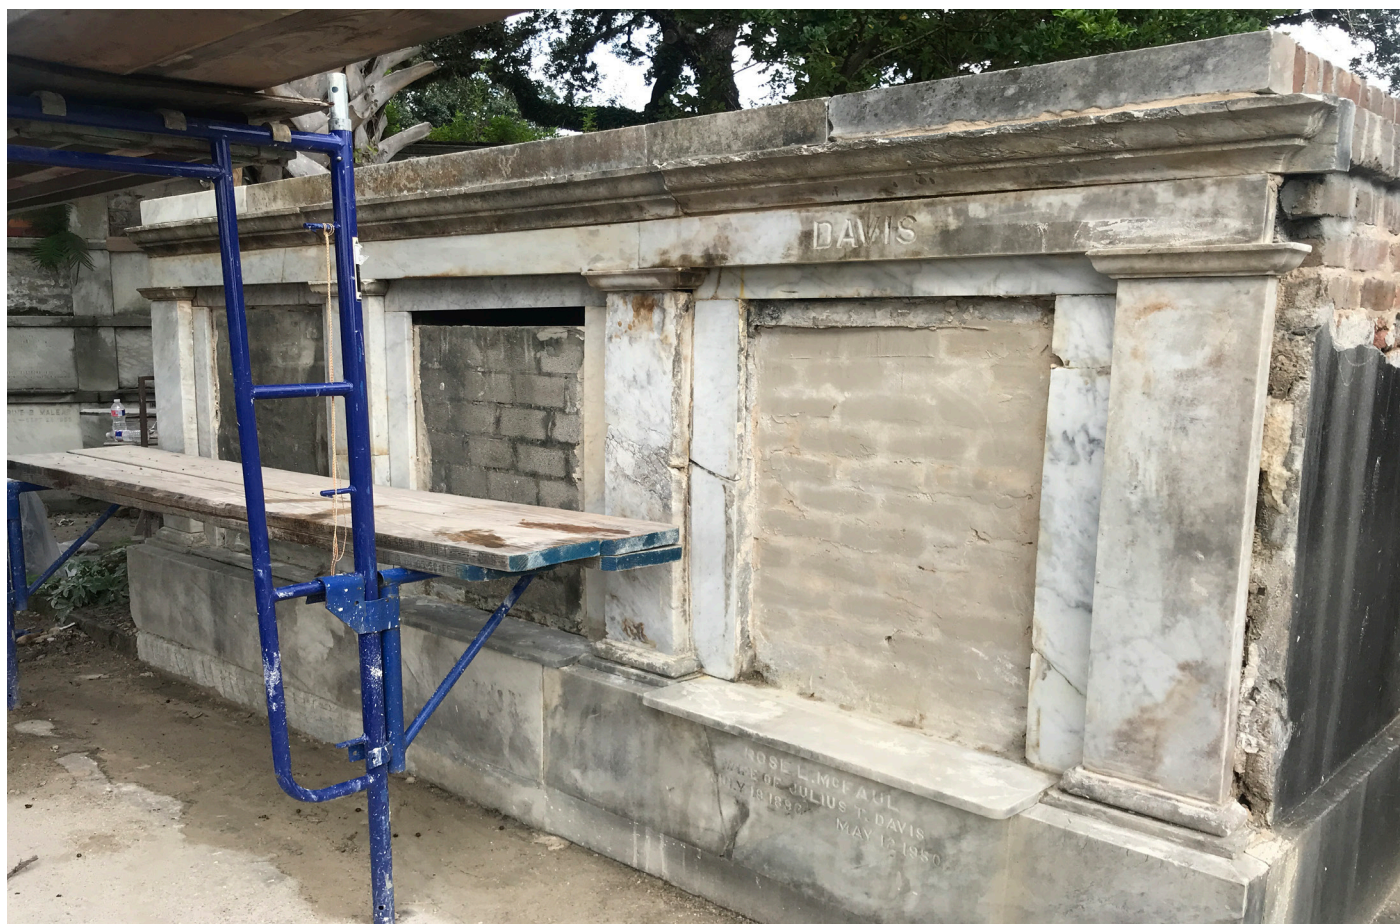
Figure 43. Newly reconstructed Davis tomb, still awaiting the installation of three front marble tablets, taken September 2018.

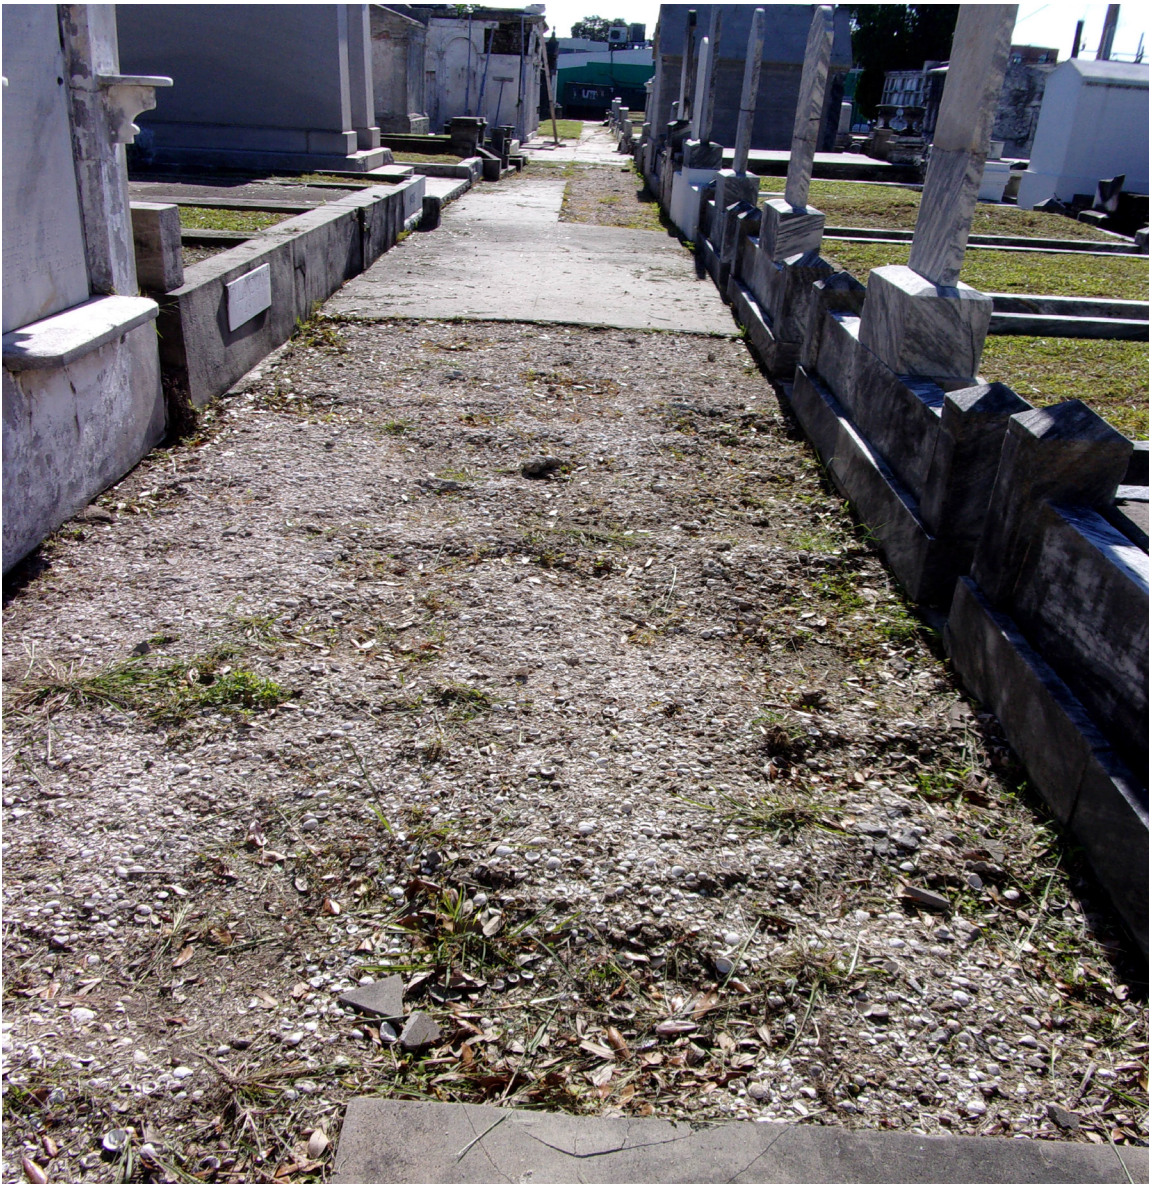
Figure 44. Partial removal of cement sidewalk. Eventually, all sidewalks will be removed and grass will be planted.

- Sidewalk/Landscaping – removal of cement sidewalks in order to install grass walkways throughout OFR

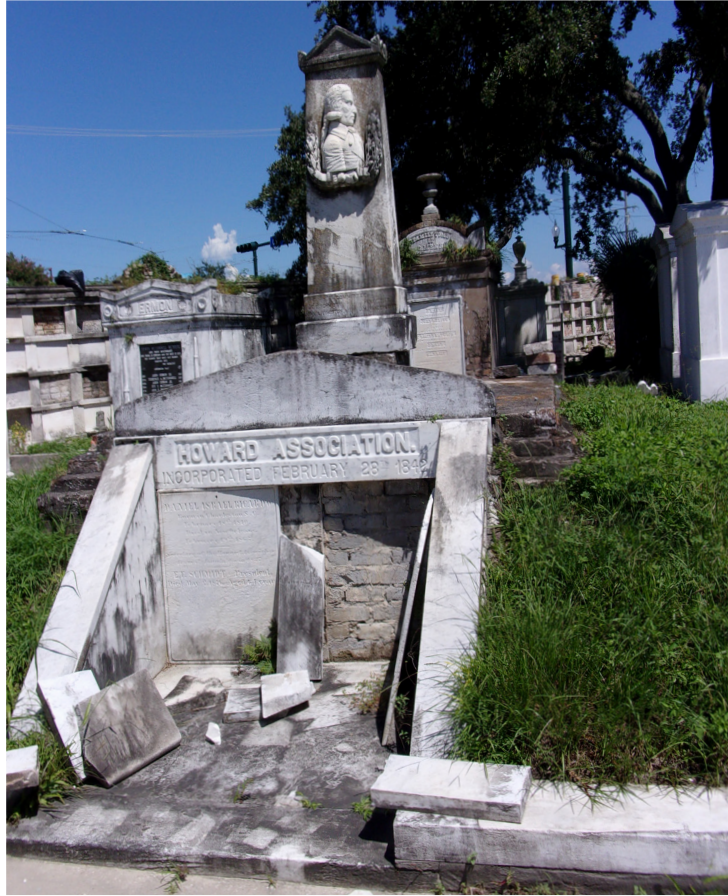
Figure 45. Howard Association tomb and monument, before being cleaned. Photo taken September 16, 2018.

- Howard Monument (Figures 45 and 46). The Howard Monument, an important memorial sitting atop the tumulus of the Howard Association Tomb, was cleaned in October of 2018. While this might seem insignificant, the Howard Association is historically significant as its members provided assistance and risked their lives during the numerous yellow fever epidemics that plagued New Orleans until the early twentieth century. On this Monument, there is a sculpture relief of the organizations founder, John Howard.
- Coping grave reconstruction – the complete reconstruction of a coping grave, using mainly cement and NHL

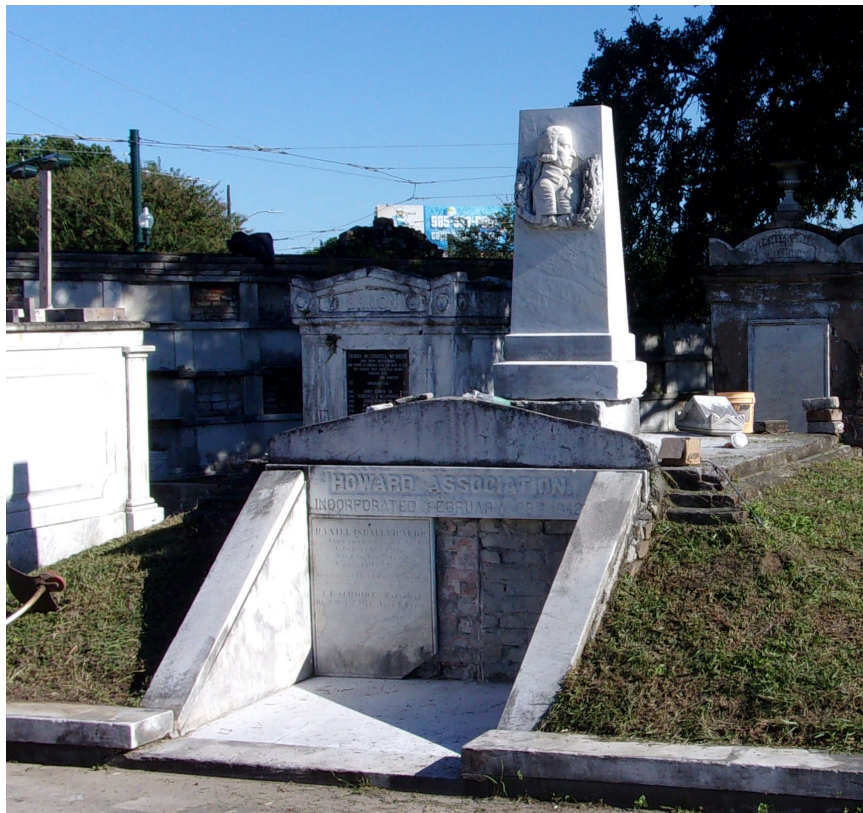
Figure 46. Howard Association tomb and monument, after being cleaned. Photo taken October 27, 2018.

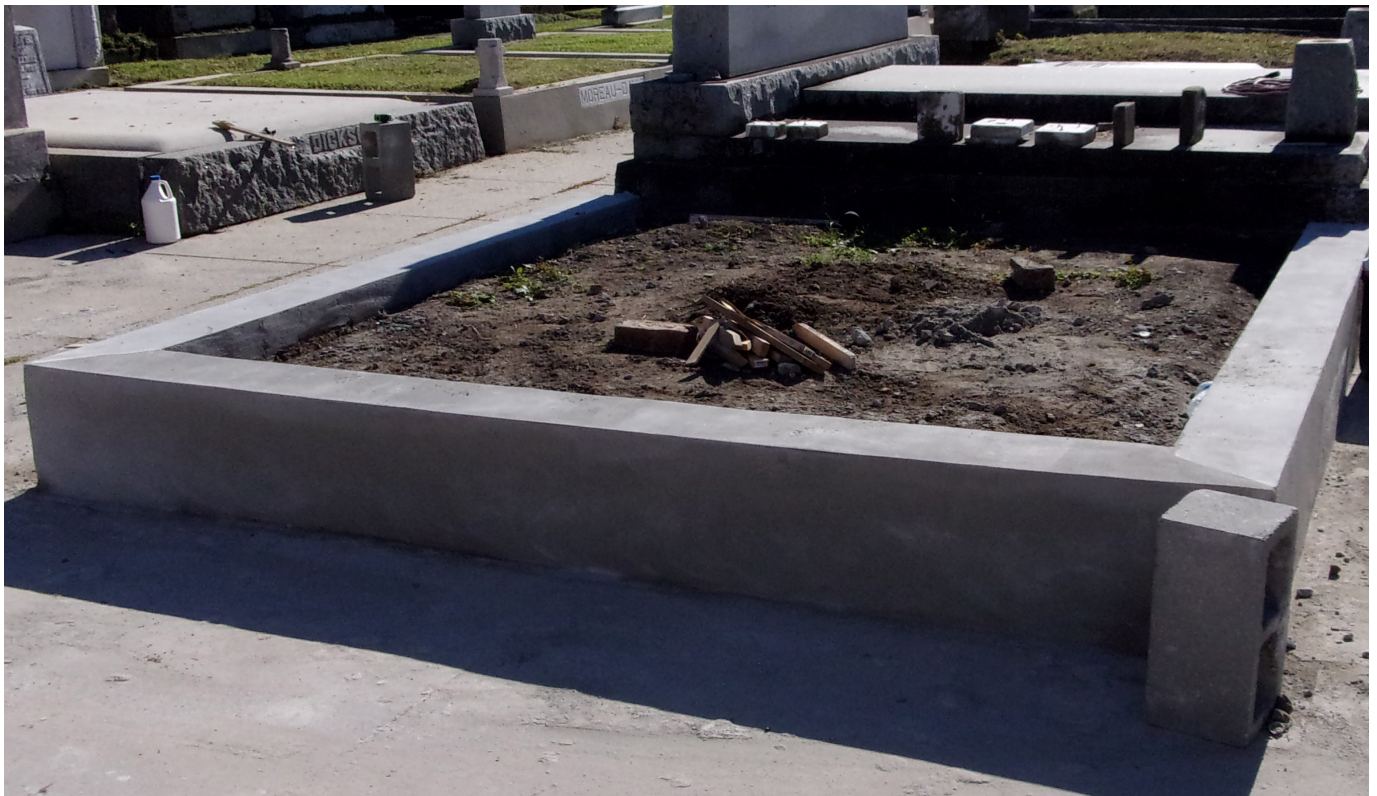
Figure 47. Reconstructed coping grave.

mixture (Figure 47). Finished October 2018.

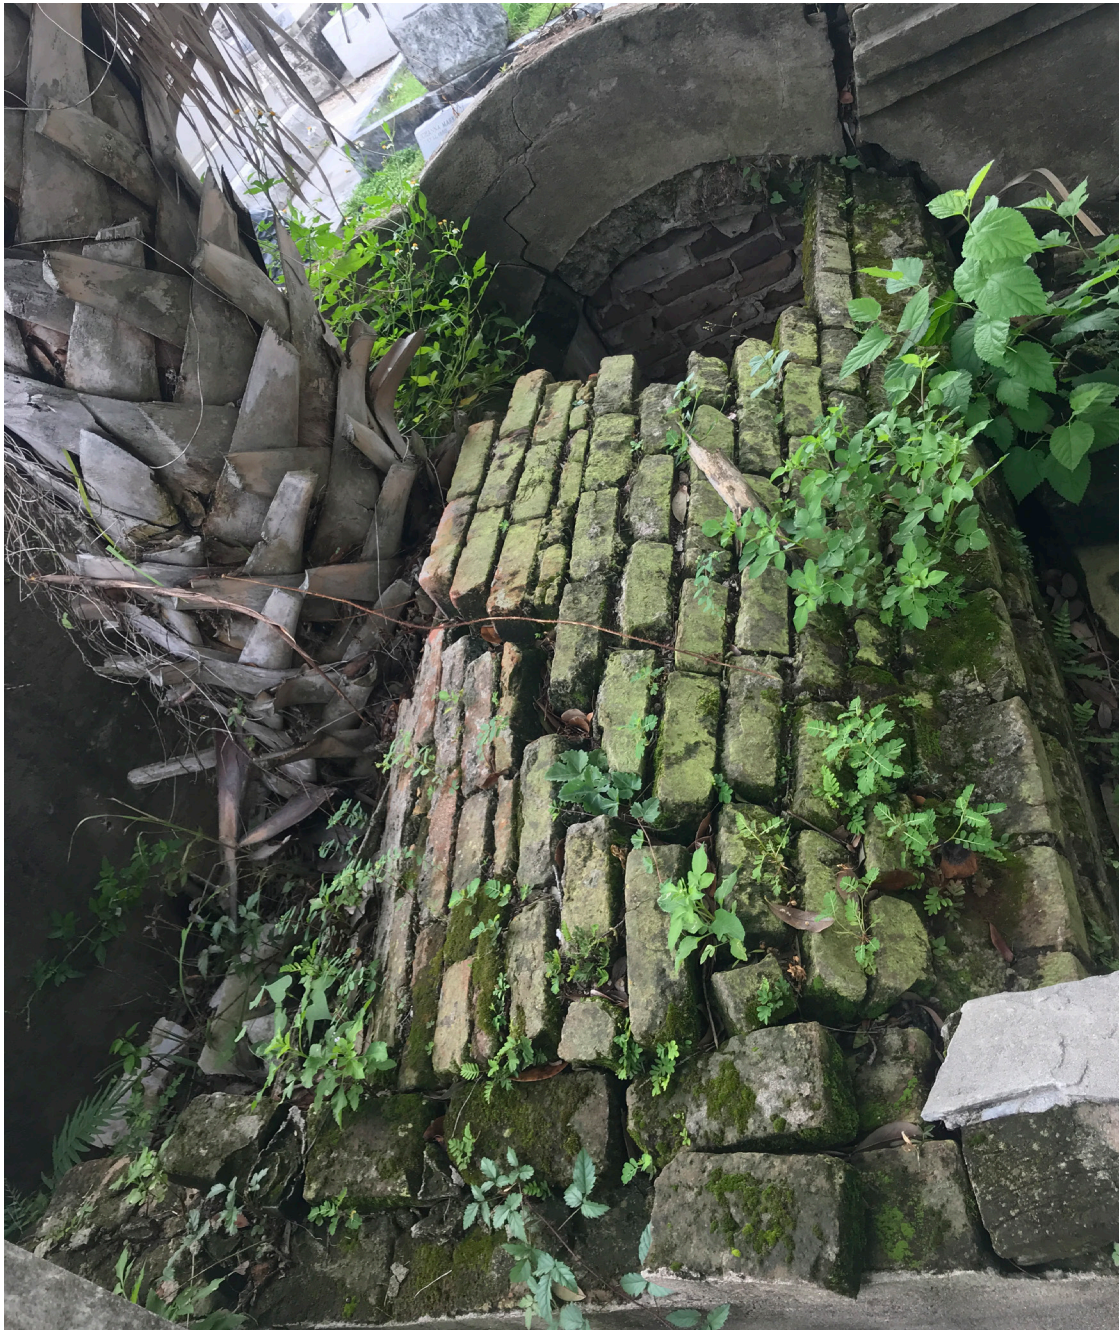
Figure 48. View from rear of barrel vaulted tomb, showing palm tree growth and conditions of the vault.

- Barrel Vault reconstruction. The only barrel vaulted tomb in the Cemetery was in poor condition, as it previously had a massive palm tree growing out of it, as well as other biological growths (Figure 48). The tomb is currently being reconstructed, with the removal of the palm tree being the first endeavor. It is important to try as best as possible to not damage the remaining integrity of the tomb while removing the tree. The removal of the tree is the current stage of this project. In the future, the tomb will be reconstructed using similar methods and materials as its original construction.

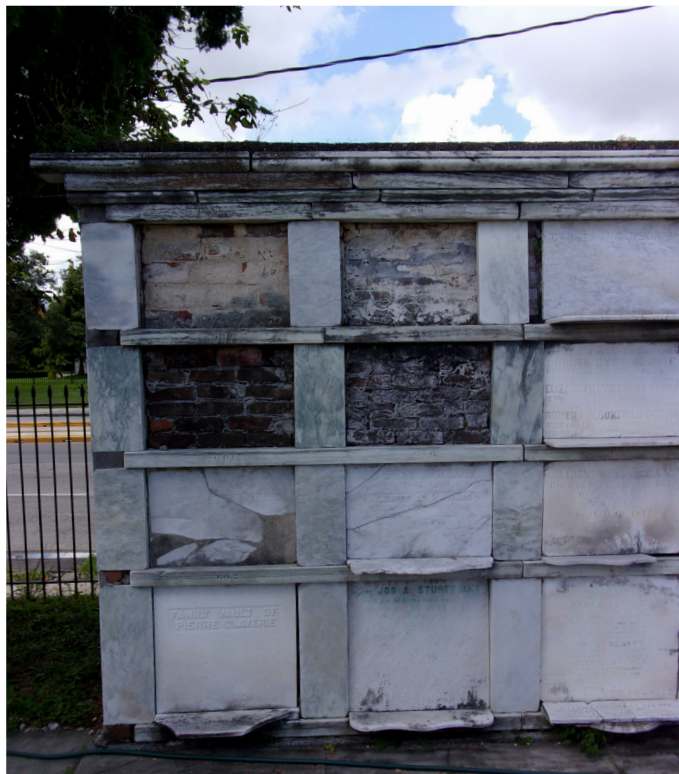
Figure 51. Wall Vault tomb numbers 685-692 in OFR.

A wall vault tomb is, as the name suggests, a wall comprised of individual burial chambers. These chambers, most normally made of brick and separated by stone slabs (flagstone, in the case of OFR), is an "oblong cube that contains an individual coffin" (p. 195). These tomb types were used in New Orleans frequently through the Civil War until the mid -1900s. At OFR, these wall vaults create barriers for the cemetery, similar to the wall vaults at the St. Louis Cemeteries, going along both Canal Street and City Park Avenue. There are over 600 vaults at OFR. Marble tablets were originally placed in front of each vault – some of fallen, some have been repaired, and some are still in their original location.

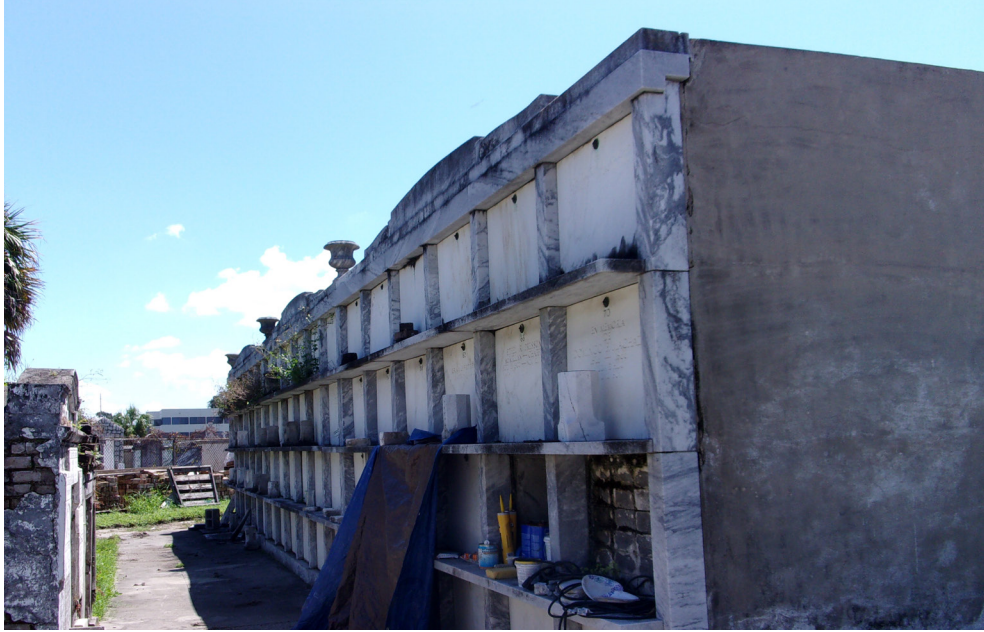
Figure 52. Block Wall Vault tomb.

This tomb type is quite similar to a wall vault tomb but does not surround the cemetery as a wall would. These structures are large, rectangular and consist of chambers separated by flagstone slabs and brick walls. These tomb types sometimes functioned as society tombs or other various group tombs and both instances of this are found in OFR. These types were built in New Orleans for about a century starting in the mid-1800s.

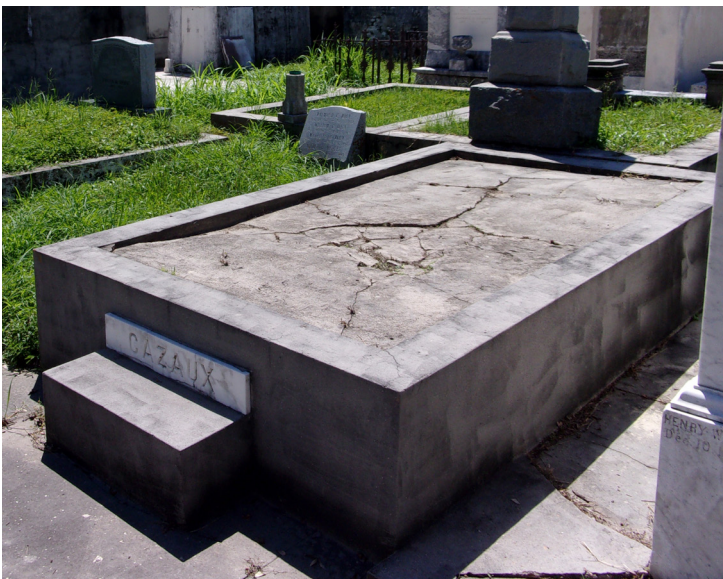
Figure 53. Coping grave in OFR that has been covered in cement due to rising remains.

Coping graves are an interesting tomb type in New Orleans as they are, in a sense, below-ground tombs. The coffin is buried within four short walls, made of either stone or brick, raised three feet aboveground. The main purpose of these tombs is to allow an in-ground burial above the historically high New Orleans water table. After the Civil War, these tomb types became more and more prominent throughout New Orleans cemeteries. These types started showing up in the 1820s and are still used today. Many coping graves have been cemented over (see left) because remains were beginning to rise up through the ground.

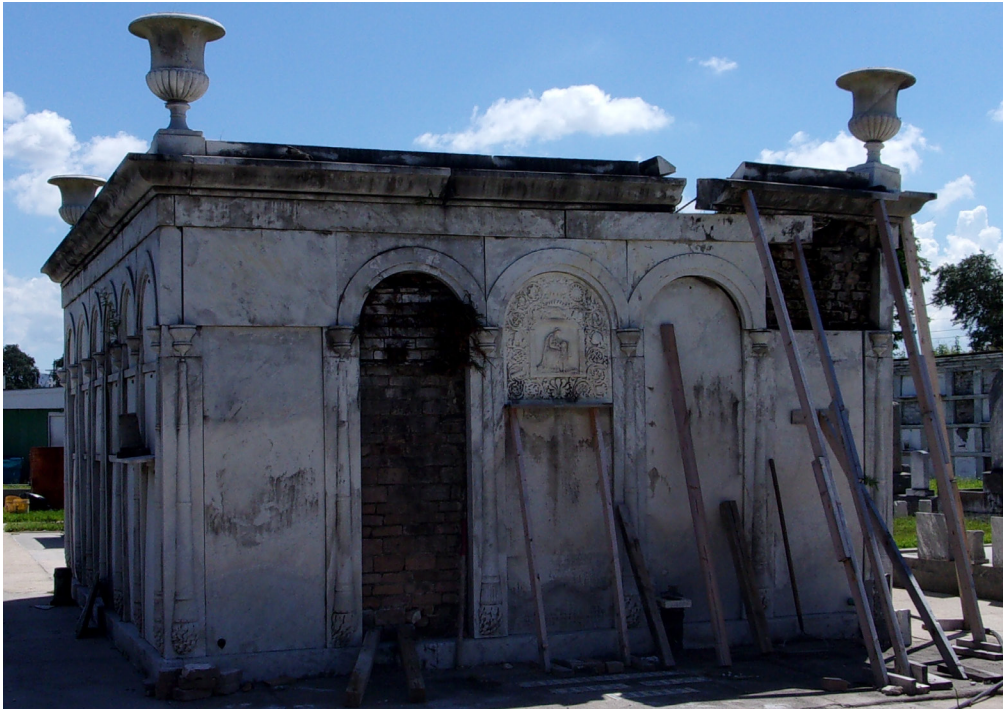
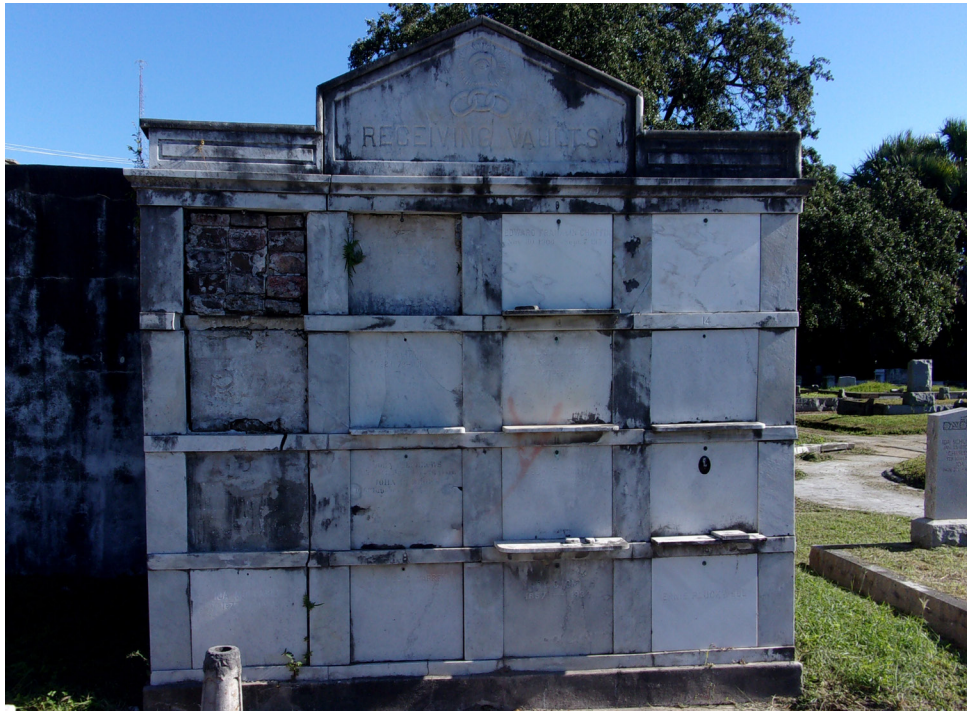
Figures 54 and 55. Two society tombs in OFR.

These tombs are quite large – normally holding anywhere from ten to fifty chambers – and are more elaborate than other tombs. These structures were built by benevolent societies whose members paid monthly dues, which ensured them and their families a respectable burial in the tomb. The structure of the tomb itself is similar to a block vault tomb, in that the chambers are separated by flagstone slabs and brick walls. These chambers are reusable and create a grid-like façade in some cases. Many society tombs are faced with stone and in OFR's case, the society tombs are all marble. These tombs were built in New Orleans from 1840 to 1940.

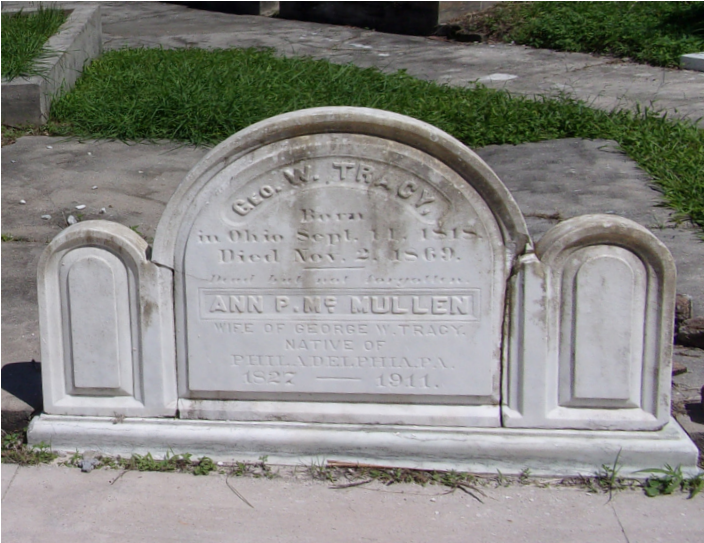
Figure 56. Marble headstone in OFR with cemented layer behind to prevent the rising of remains, similar to a coping grave.

Headstones are perhaps the most recognizable and archetypal grave marker in our society today. They mark an underground burial, which are rare in New Orleans, and are engraved with the names, dates, and sometimes an epitaph of those interred in the grave. Headstones are typically one solid piece of stone of varying size and ornament. While these types are found more regularly in the cemeteries of other cities, they have been present in New Orleans since the early nineteenth century. While there are quite a few in OFR, the example to the left shows a typical treatment of underground burials, similar to that of a coping grave, with a layer of cement to stop remains from rising.

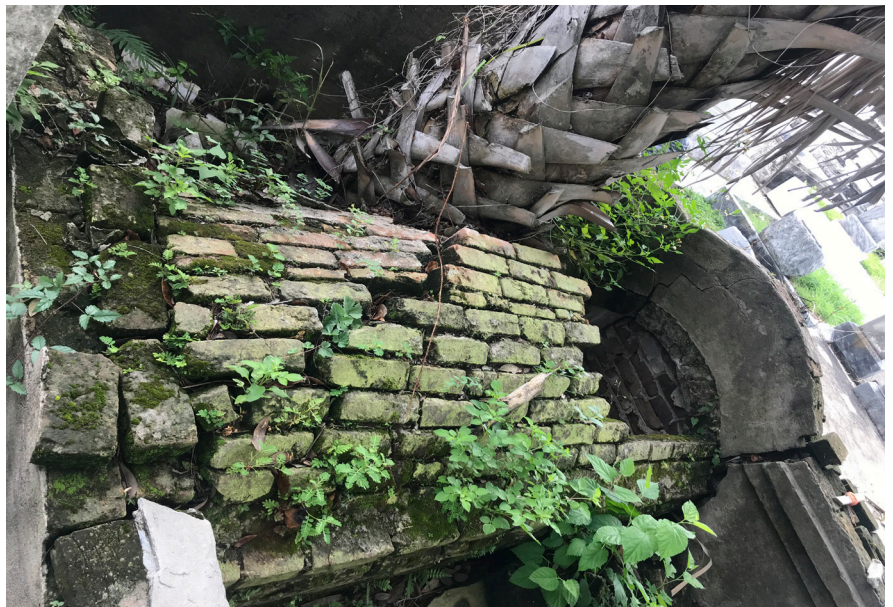
These tombs are similar to pediment tombs except that they have a round roof. These roofs are constructed of brick and normally covered in stucco. The only barrel vaulted tomb in OFR is, unfortunately, in horrendous condition as there is a palm tree growing out of it. It is currently under a reconstruction project, please see page 45. There is only one in OFR and it is a single chamber tomb. Barrel vaults require a special skill of a mason to construct, so reconstructing them can be somewhat difficult.

Figure 57. View from the rear corner of the barrel vault in OFR. Rounded roof and palm tree growing out of it are visible.

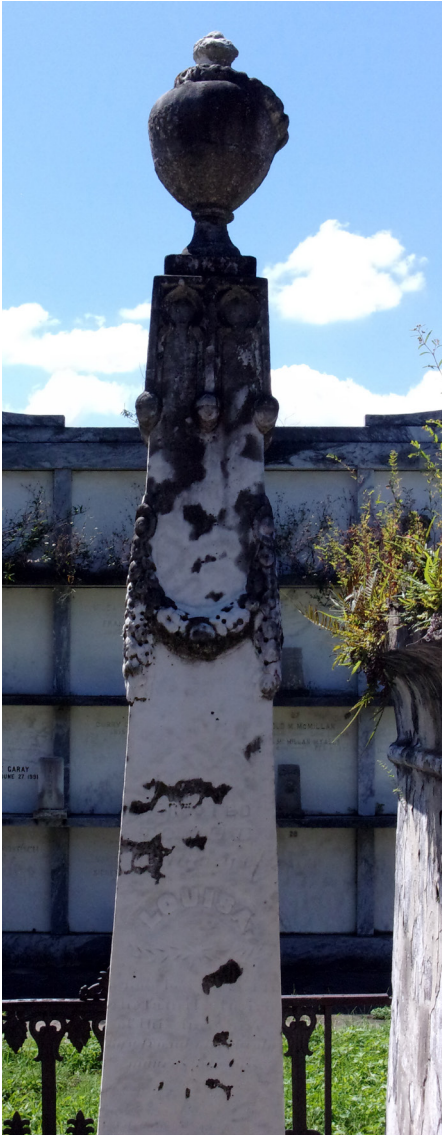
Monument tombs are one element of other tombs, normally set upon a base of varying tomb types. These tombs can be in the form of an obelisk, urn, statuary, etc. These monuments were most normally made of stone and constructed in New Orleans in the latter part of the nineteenth century. While there may not be too many of these tomb types in OFR, there are quite a few through out the rest of the historic cemeteries in New Orleans.

Figure 58 (left). Monument tomb in OFR. This specific monument is not on top of the tomb, as it is in other cases, but next to the tomb it is acting as a monument for. It was originally a part of the family tomb that's next to it and is engraved with family member's names.

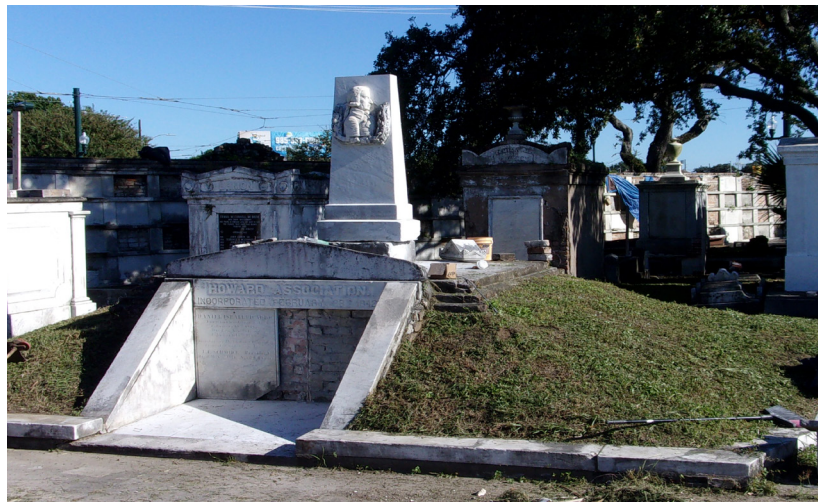
Figure 59. Howard Association tumulus tomb.

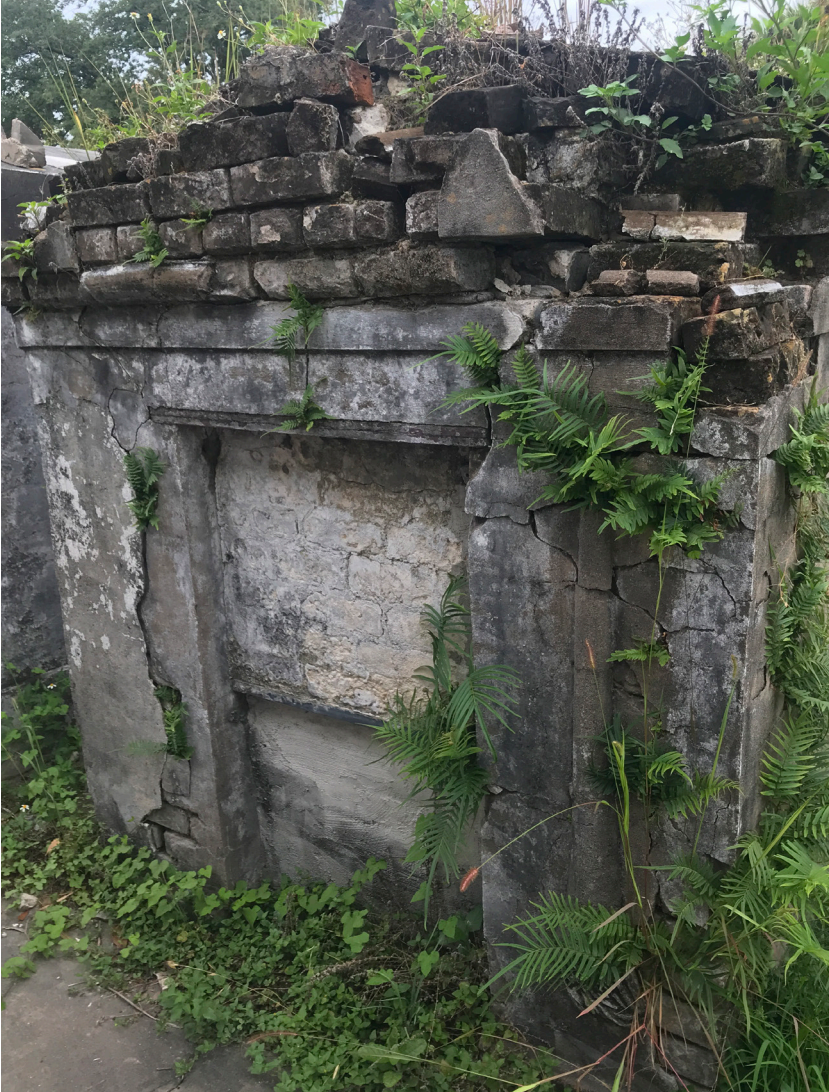
Pediment tombs contain two or more stacked vaults and are normally family tombs. Shaped like miniature temples, the plan of these tombs are rectangular and a low-pitched gable roof. These tombs are tall and the façade has a pediment (most of the time), sometimes surrounded by decorated cornice. Built of brick covered in stucco, these tombs were built in the 1800s. These tombs are one of most common type found in OFR, with a variety of styles and even materials.

Figure 60 (left). One of the older and dilapidated pediment tombs in OFR.

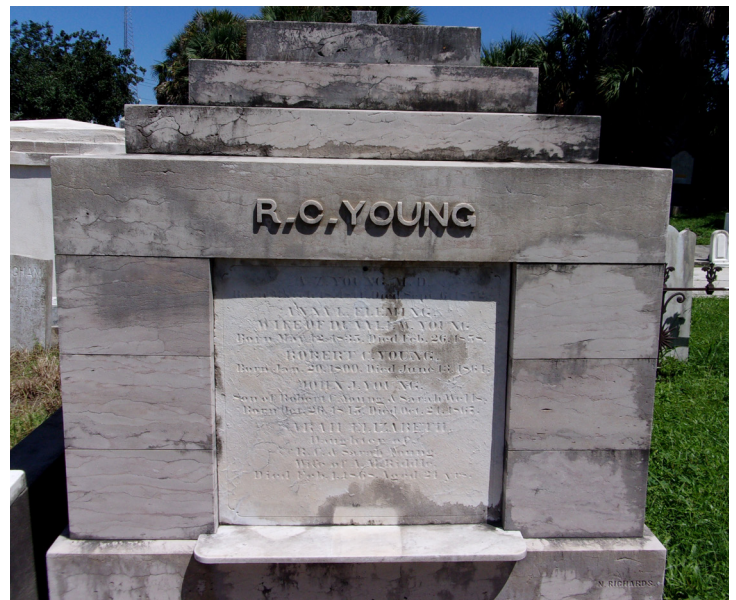
Step tombs are common tomb types in the various cemeteries in New Orleans, and OFR is no exception. These tombs contain one burial, are oblong cubes in shape, are quite squat in form and have a stepped roofline. These tombs were most commonly used in New Orleans from 1800-1870.

Figure 61 (right). Step tomb in OFR.
