ODD FELLOWS' REST CEMETERY  
5055 Canal Street  
New Orleans, LA 70119

Final Practicum Report  
Teutonia Lodge Society Tomb HABS Report  
Existing Conditions Assessment

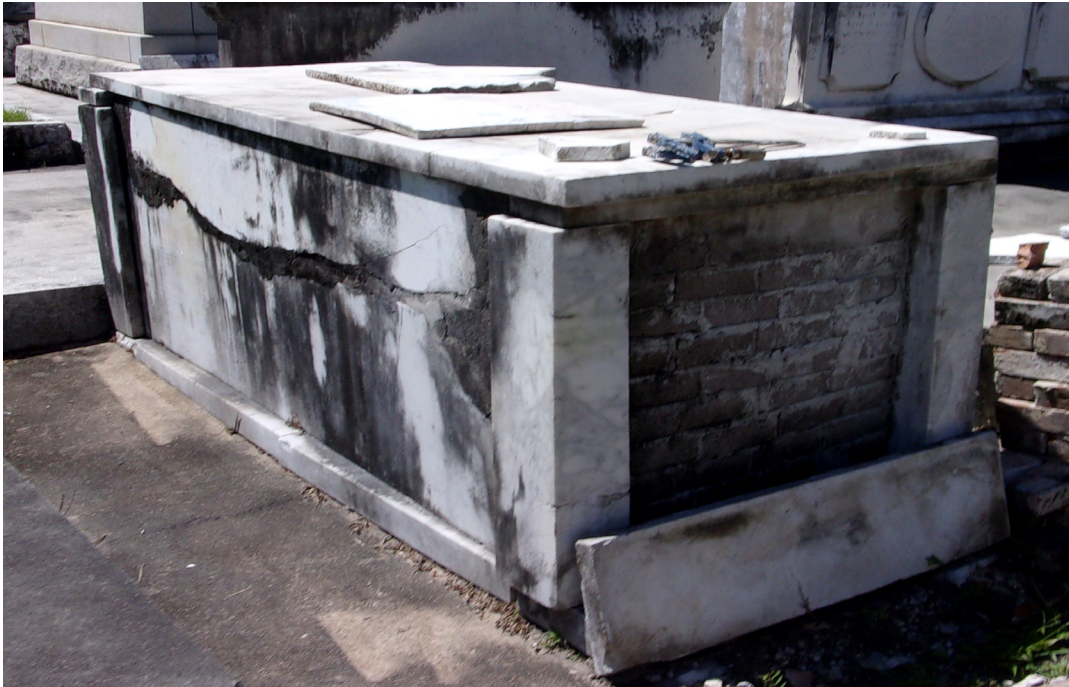
Figure 62. Platform tomb at OFR with a missing front tablet.

These platform tombs are similar to pediment tombs. While not as tall as a pediment tomb, a platform tomb, the roofline is the same or similar, as is the materials (most likely). The coffin within the tomb is elevated on a platform or pedestal above ground, which can be seen from the exterior of the tomb. Earlier versions of this tomb have sunk into the ground, which can be seen in examples at OFR today. Also similar to the pediment tomb, these types were constructed in the 1800s.

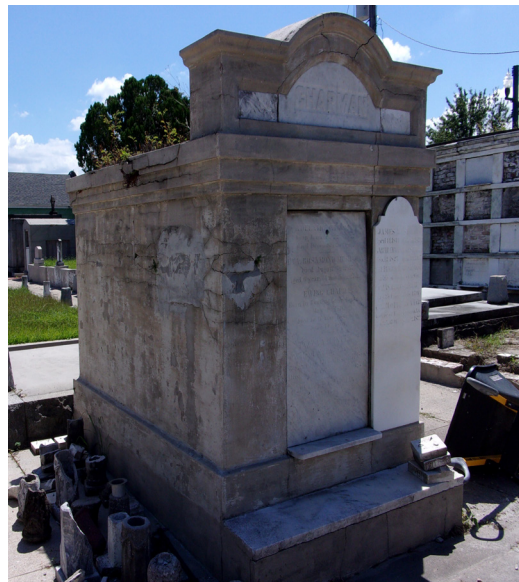
Parapet tombs can be single or multiple vault structures. There is a parapet wall on the façade, meaning that the façade is higher than the rest of the tomb behind. The roofline, behind the parapet wall, is varied (can be vaulted, gabled, stepped or flat). There is normally a pediment with a decorated cornice on the parapet wall. Made of brick and covered with stucco, these structures were mainly built in the 1800s.

Figure 63. Parapet tomb in OFR.

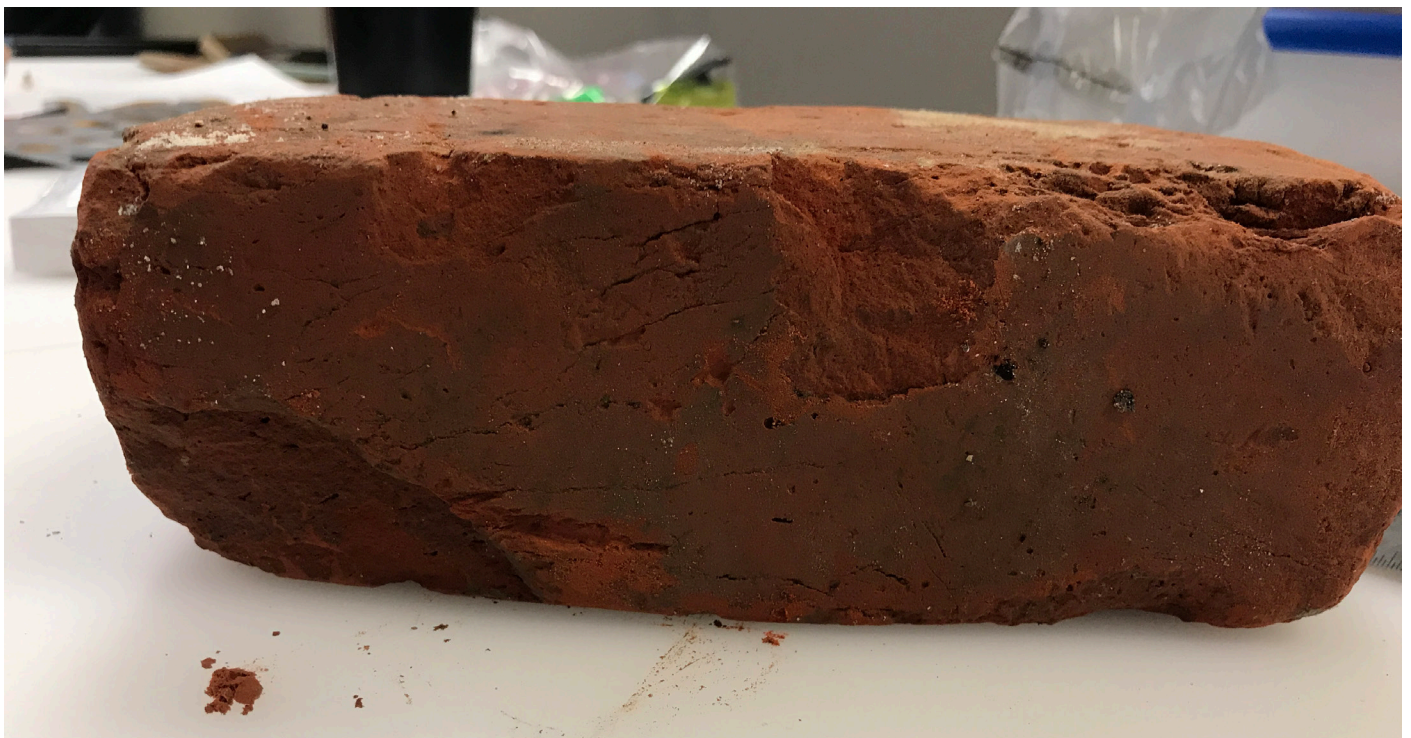
The majority of the extant tombs in OFR were built by the 1930s – meaning that the construction dates are circa 1850 – 1930s.<sup>1</sup> Up until the Civil War, the most common building materials in New Orleans were bricks – river or lake. River bricks (Figure 64), made from the clay of the Mississippi River, are classified as a “soft red,” and are the earliest bricks to be made and used in New Orleans. Due to their softness, these bricks deteriorate quicker than other bricks – especially when exposed to humidity and varying temperature cycles.

Figure 64. New Orleans river brick: soft, red brick made from clay from the banks of the Mississippi River.

To mitigate this deterioration, a lime-based stucco was used as a coating or protective covering for these bricks. River bricks were used in cemetery construction longer than they were used in commercial and city construction, partly because of their price (they were cheaper than other materials) and partly due to a city ordinance that required all tombs to be covered in a protective stucco.<sup>2</sup>

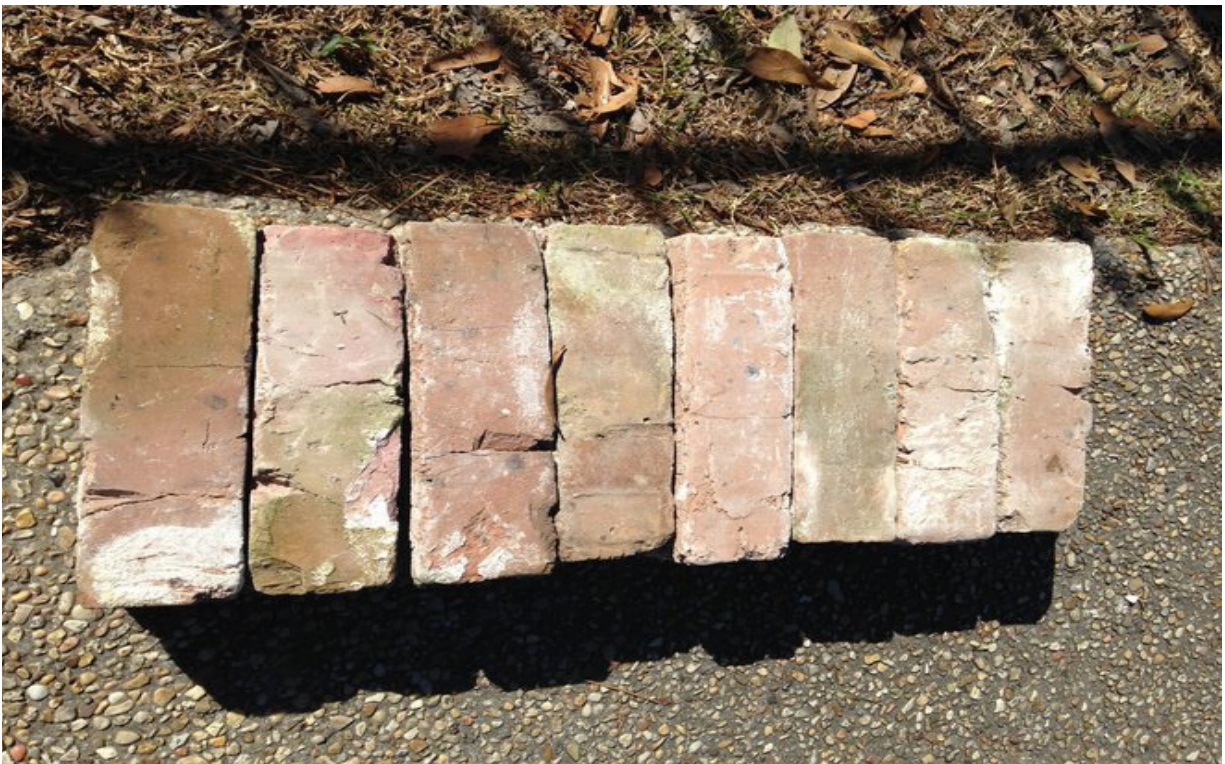
Lake bricks (Figure 65) are made from clay from two different places: Lake Pontchartrain and St. Tammany Parish. These bricks are “hard tans” and are more durable than their counterpart. While these bricks were used in tomb construction, they were more commonly used in commercial and city construction and eventually became the standard throughout New Orleans. While these two brick types were easy to manufacture and acquire, the majority of bricks coming in to New Orleans after the 1850s came from steam-powered brick-making operations in Biloxi, Mobile, and Thibodeaux. By the end of the Civil War, river bricks were no longer being used in cemeteries, meaning all brick tombs constructed after 1865 used hard tan bricks. This can also be assumed because of certain recognizable characteristics of these bricks, such as color and texture.<sup>3</sup>

Figure 65. New Orleans lake brick: hard, tan bricks made from clay from Lake Pontchartrain and St. Tammany Parish.

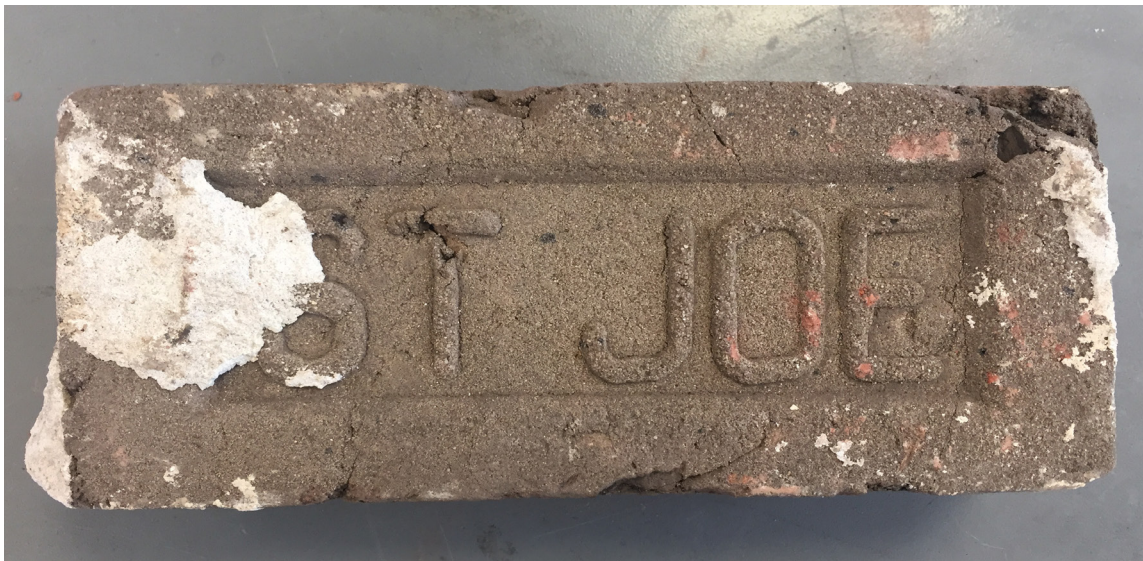
In 1891, St. Joe Brick Company was established (Figure 66).<sup>4</sup> This iconic brickyard produced, and still does, hard tan bricks that lend themselves to tomb construction – especially tombs covered in a lime stucco – due to the dimension, porousness, and permeability of the bricks.<sup>5</sup> St. Joe bricks are made using traditional, colonial methods with a wood mold.<sup>6</sup> In tomb construction, bricks were structural, making up the base, walls, and roof of the building.<sup>7</sup> Mortar is used to bind the bricks together and was historically made of lime, sand (aggregate), and water.<sup>8</sup> Lime is made when limestone is burned through the lime cycle. Mortars are supposed to deteriorate quicker than the bricks they surround, as they are not as durable as the bricks and subsequently serve as a protective layer for the bricks. Mortar should absorb water in the building system, therefore should be replaced more frequently than bricks.<sup>9</sup>

Figure 66. Historic St. Joe brick, with iconic and recognizable stamp. Taken by Amanda Coleman, October 2017.

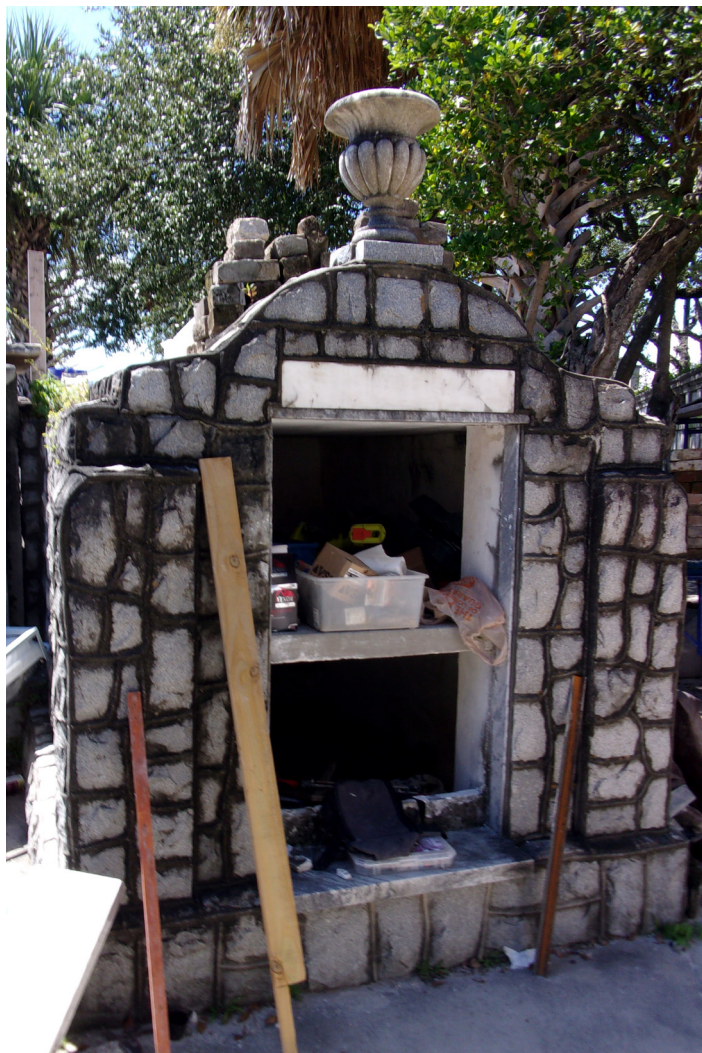
Figure 67. Tomb in Odd Fellows' Rest clad in granite rubble stone and thick Portland cement mortar joints. This granite rubble was most likely a twentieth century addition.

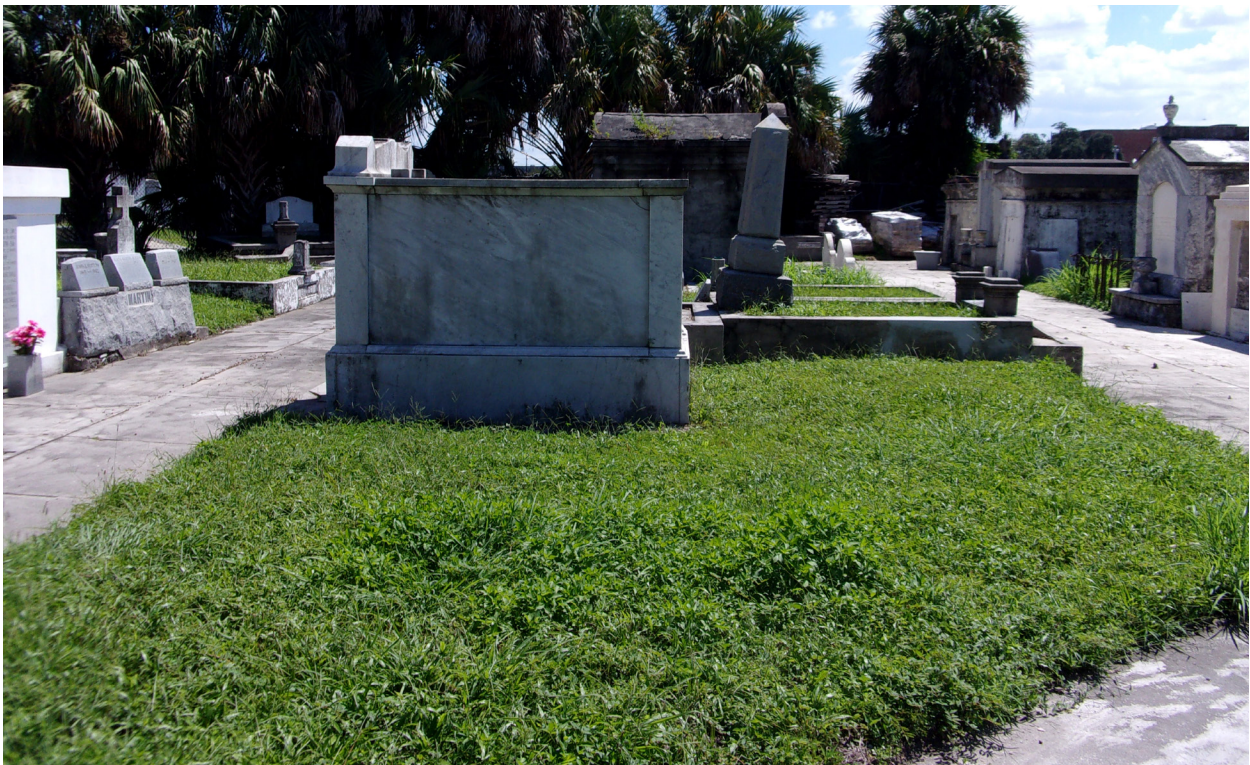
There are thirty-one empty lots and ten headstones in OFR, totaling forty-one lots. The empty lots are spaced out throughout the cemetery and are covered in grass, which is occasionally mowed (Figure 69). Plots where headstones are present are also covered in grass (also occasionally mowed), which is why they are grouped with the empty lots. As this is a survey of the conditions of structures within the cemetery, and a headstone does not constitute a structure, it was unnecessary to classify the headstones in the same categories as the built tombs. With that being said, the majority of the headstones are made of marble or granite and are

Figure 69. Multiple empty lots (in the foreground) in OFR.

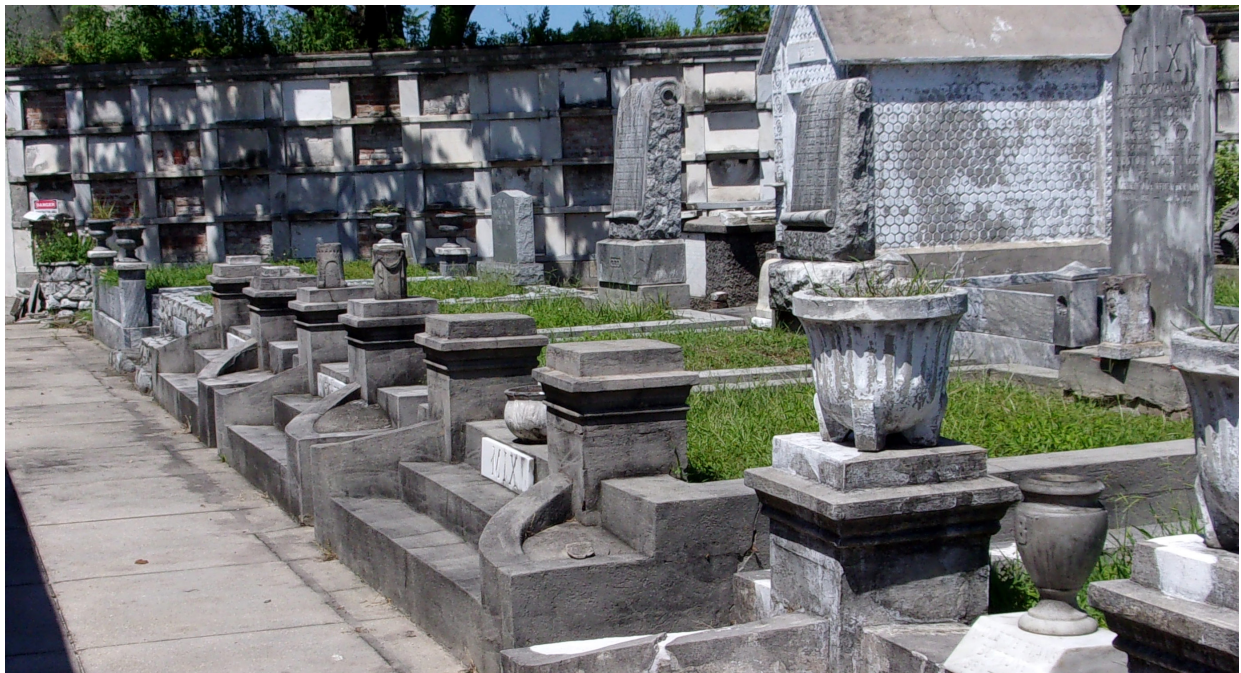
Many of the structures that are in good condition in OFR are coping graves (see page 50). While not all of the coping graves are in good condition, the majority of them are (Figure 70). This is due to a few factors: when they were built, which also can determine material used, how they were built, and if there have been any interventions. The majority of the coping graves are made out of cement, leading to the conclusion that these were built or rehabilitated, at least, after the mid-1930s (when Portland cement became the norm in the construction industry and replaced lime).

Figure 70. Row of coping graves in good condition.

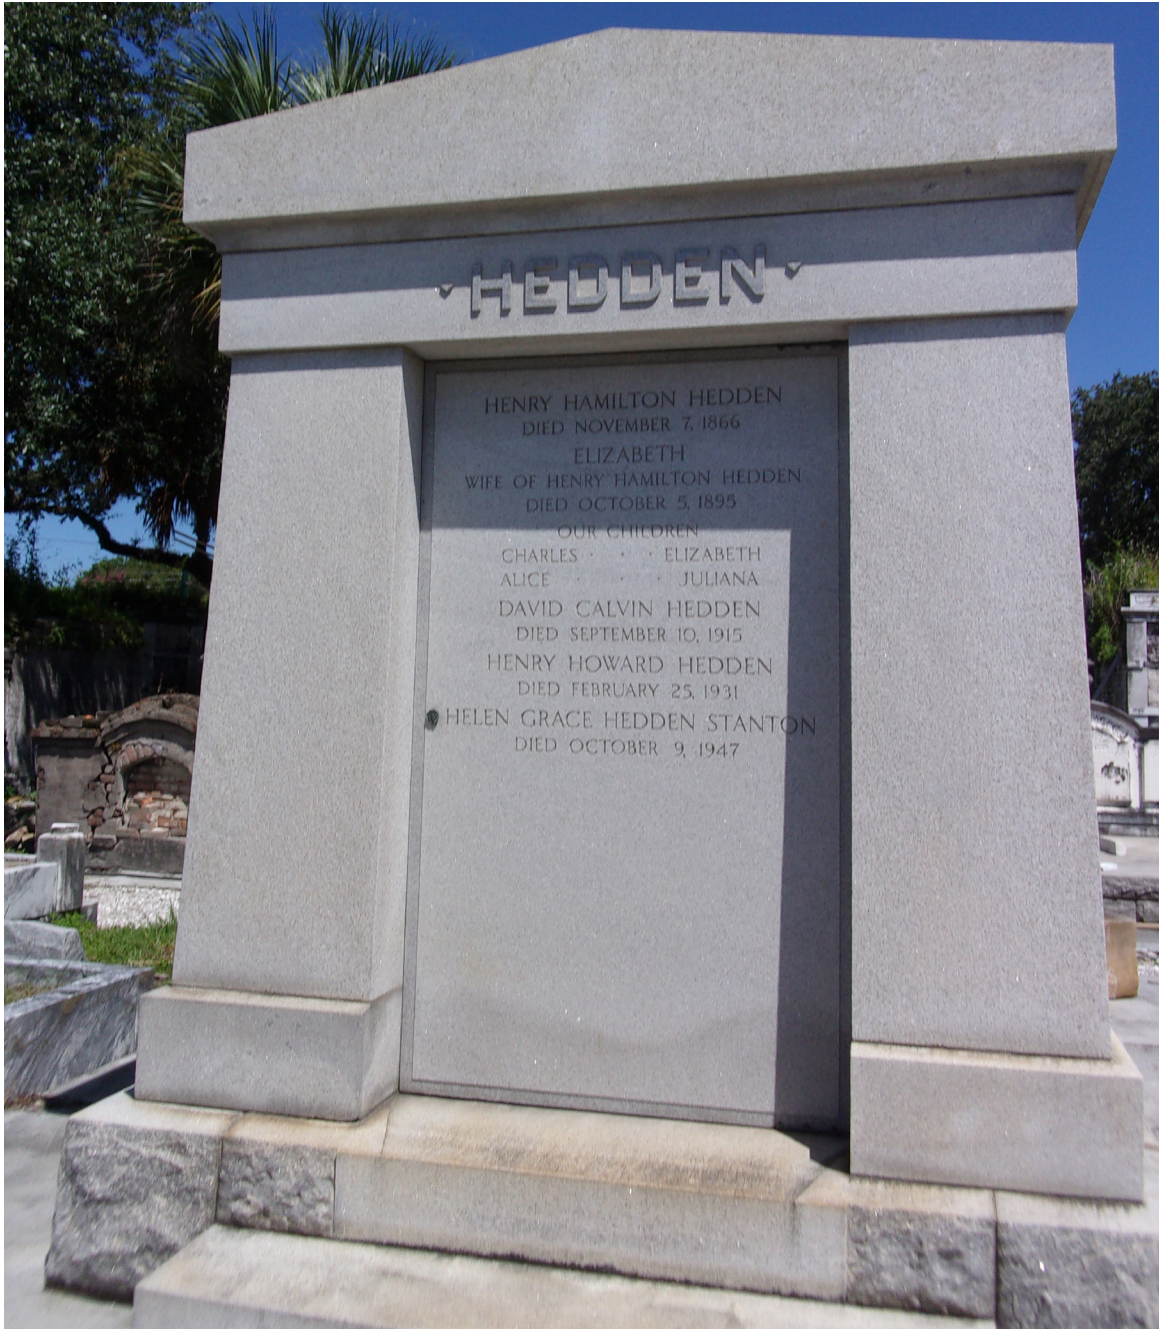
Figure 71. Large family tomb in good condition, but with some visible issues, such as the staining on the bottom steps.

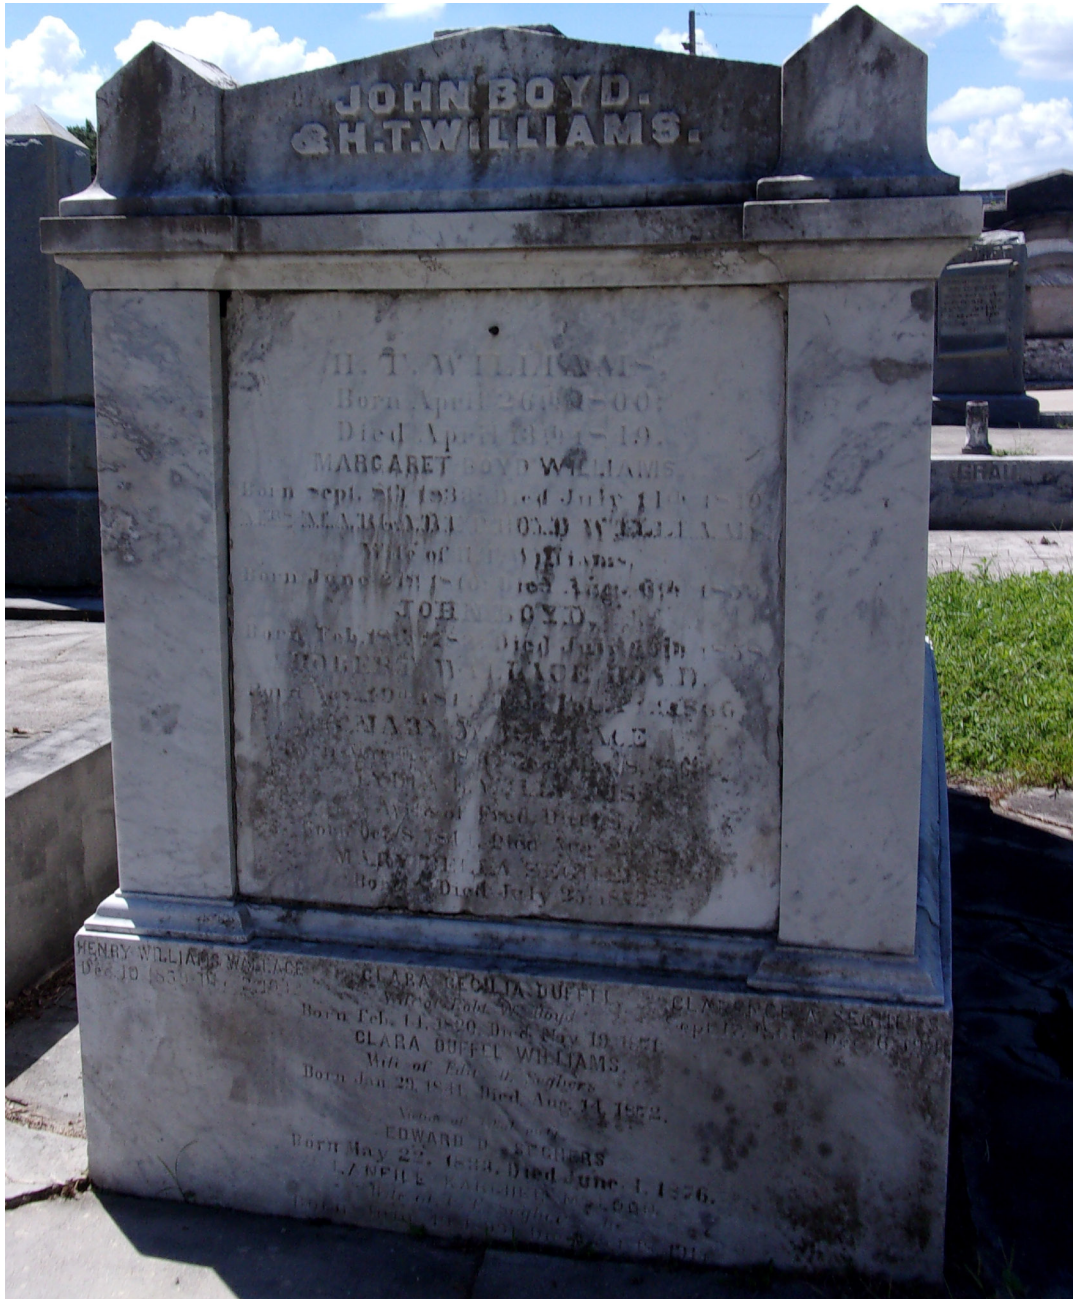
Figure 72. Structurally sound family tomb, showing mainly cosmetic issues (staining), which are relatively easy to repair. Marble is in good condition.

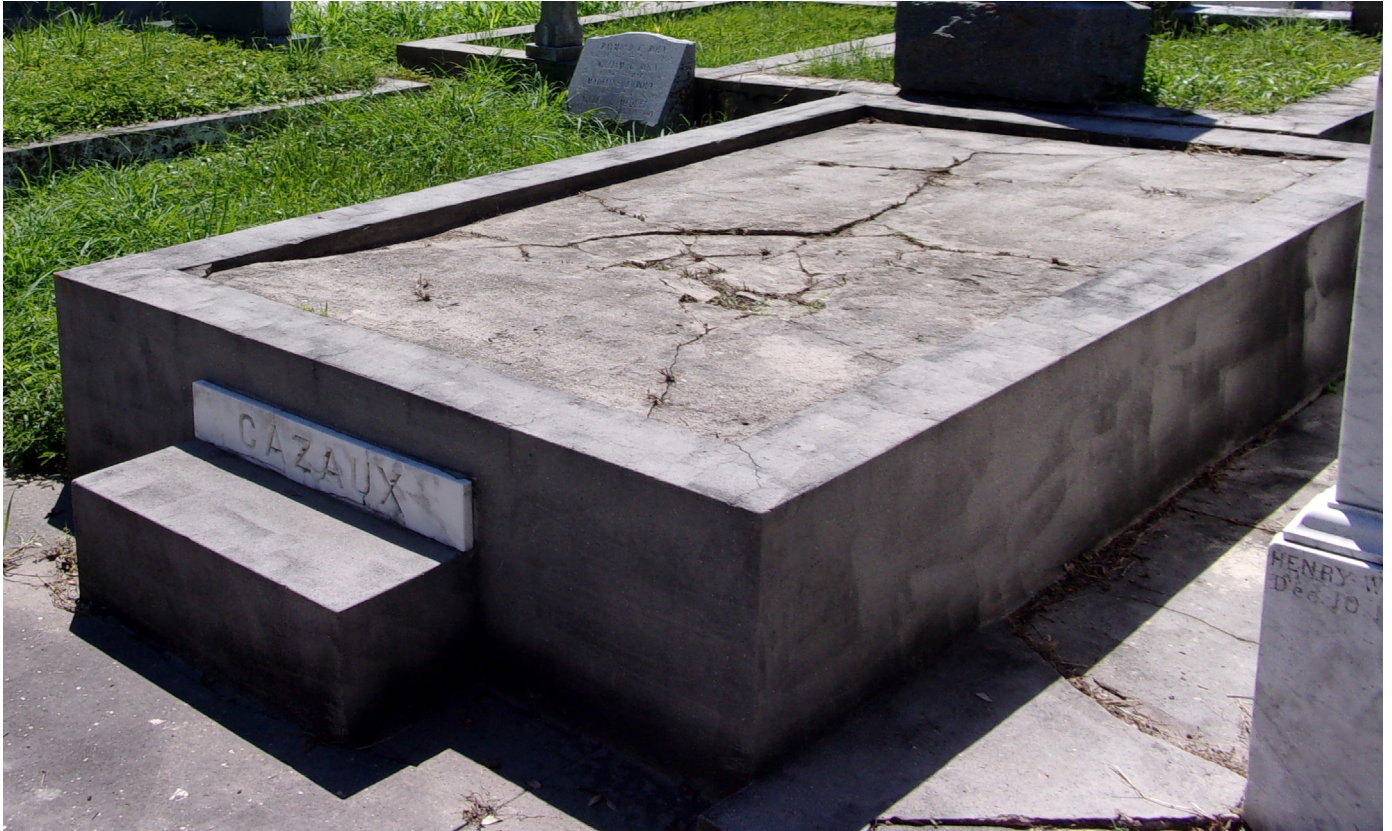
Figure 73. Coping grave, showing relatively good/fair conditions with cracking on the top of the grave.

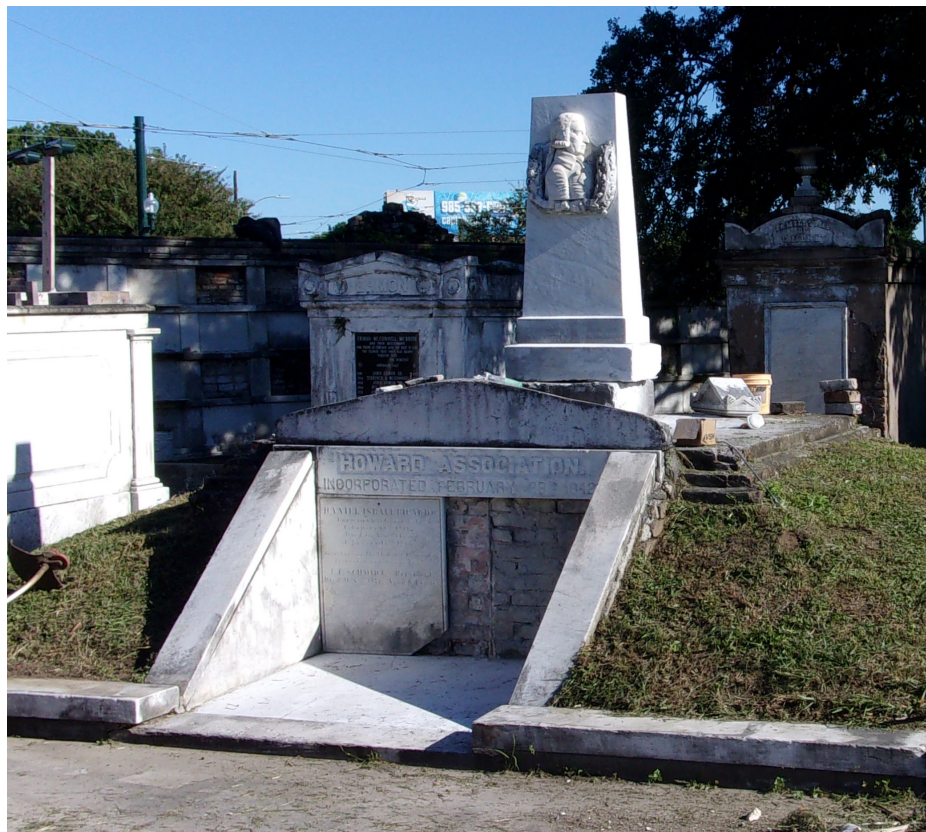
Figure 74. This tomb is not as exposed to the elements due to it being a tumulus, helping to contribute to its maintained condition. It has minor staining and has recently been cleaned.

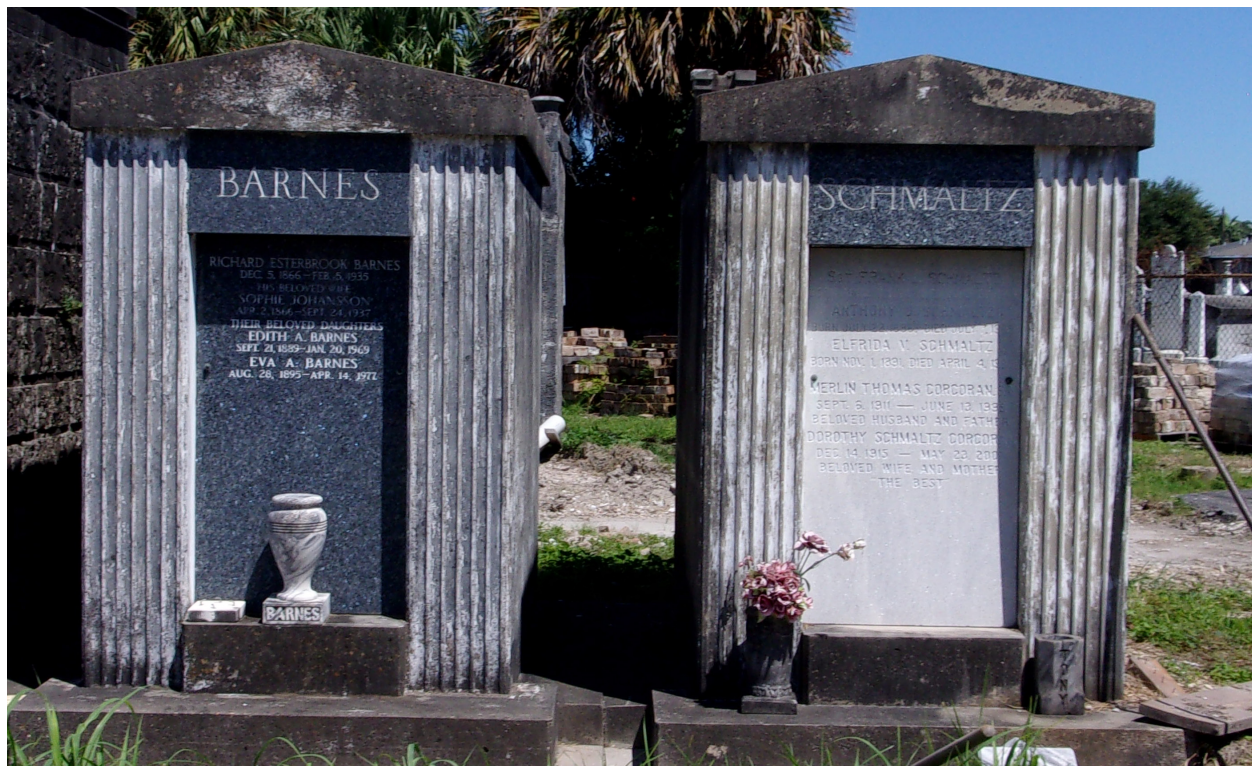
Figure 76. Two structurally sound tombs with some spalling. Cleaning is needed.

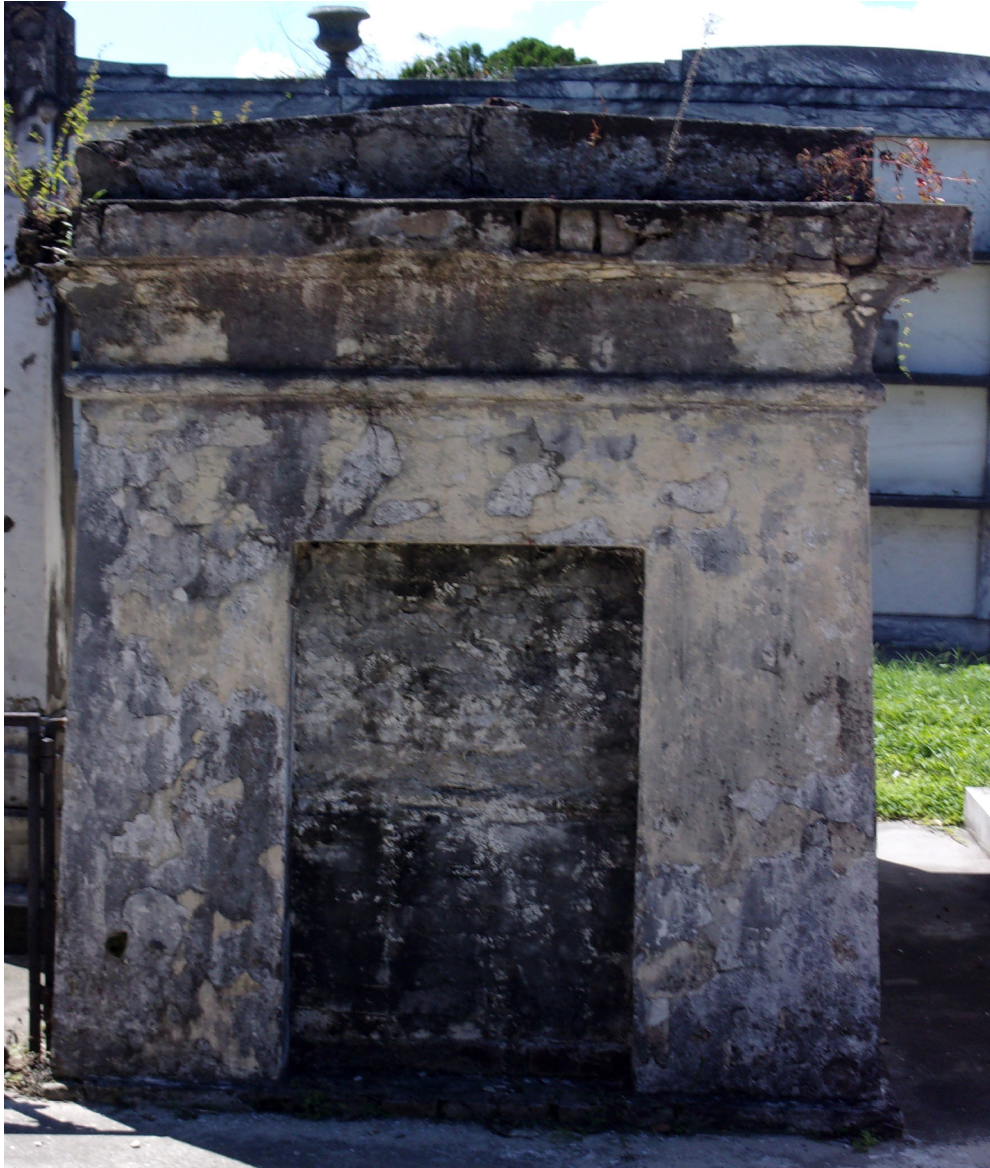
Figure 77. Mostly structurally sound tomb with noticeable biological growth, cracking, and spalling of the stuccoed exterior. Missing closure tablet.

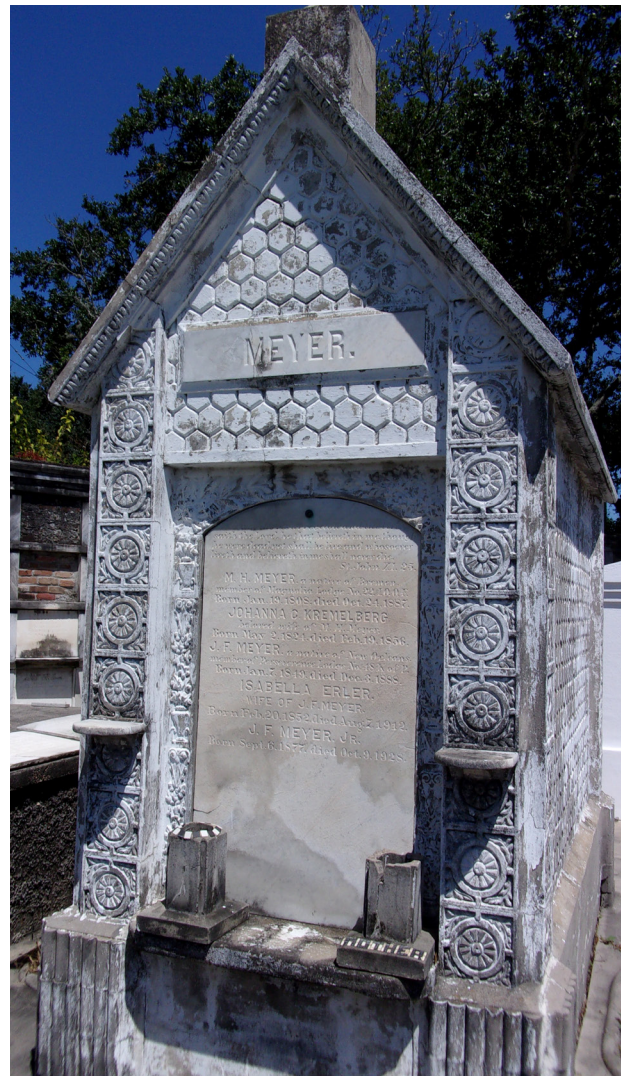
Figure 79 (to the right). Highly decorated, structurally sound tomb showing lots of staining.

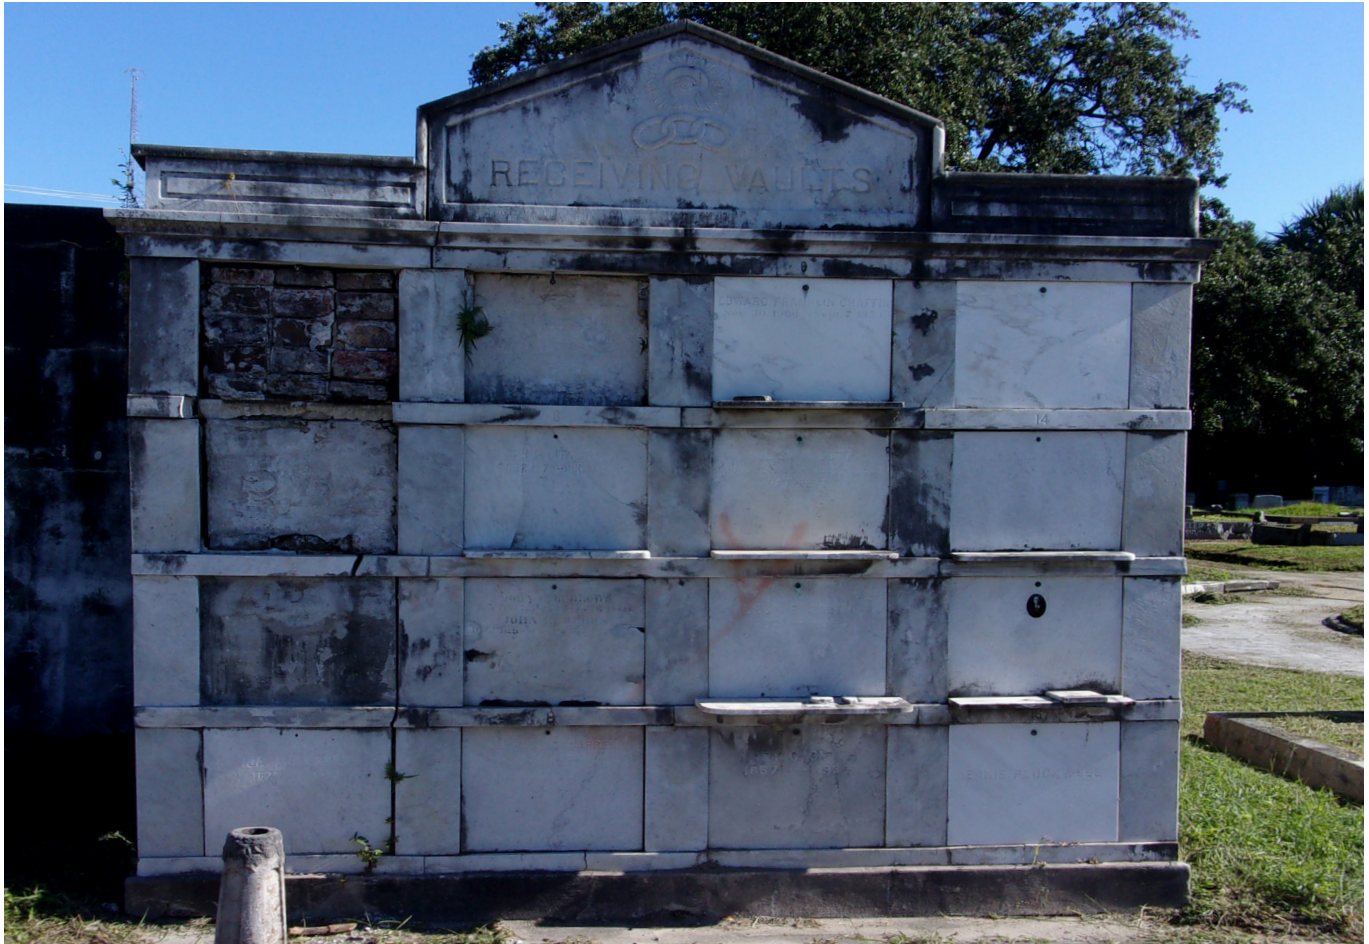
Figure 80 (top). Society tomb showing major crackining and staining and missing closure tablets.

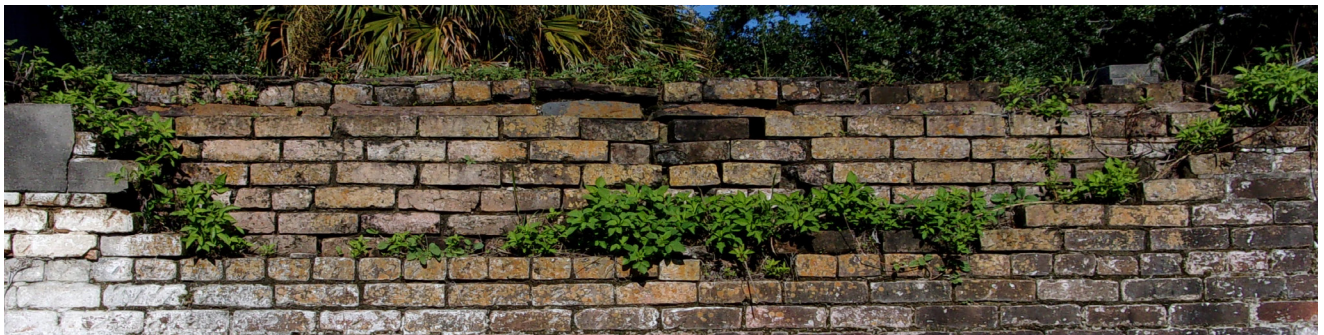
Figure 81 (bottom). Side view of top portion of roof on the same tomb pictured above. Lots of vegetation, missing brick cornice, and loss of stuccoed exterior (can see some remaining on bottom left corner of photograph).

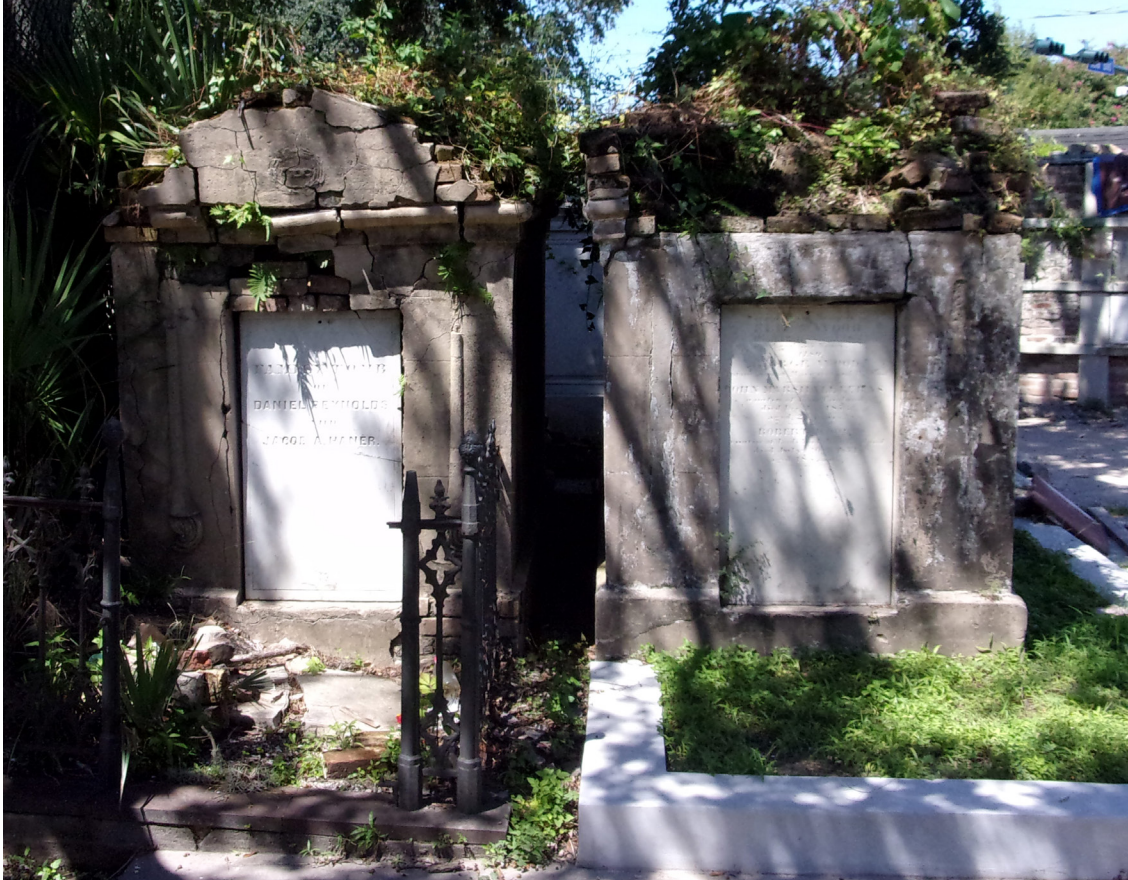
Figure 84. Two tombs in poor condition: significant vegetation growth and cracking. Missing bricks, stucco, and partially missing gate on the left.

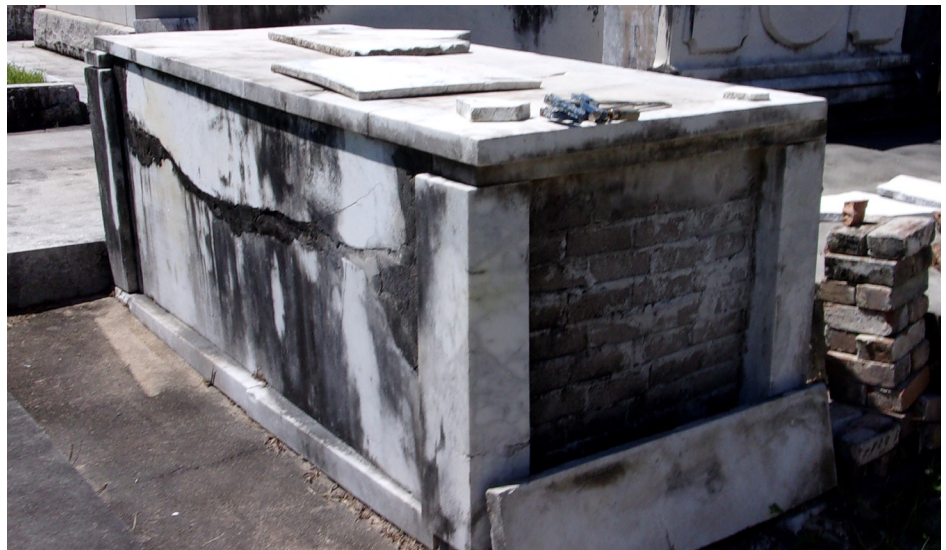
Figure 85 (to the right). Tomb with a large and severe crack on the side, as well as significant staining and a missing enclosure tablet.

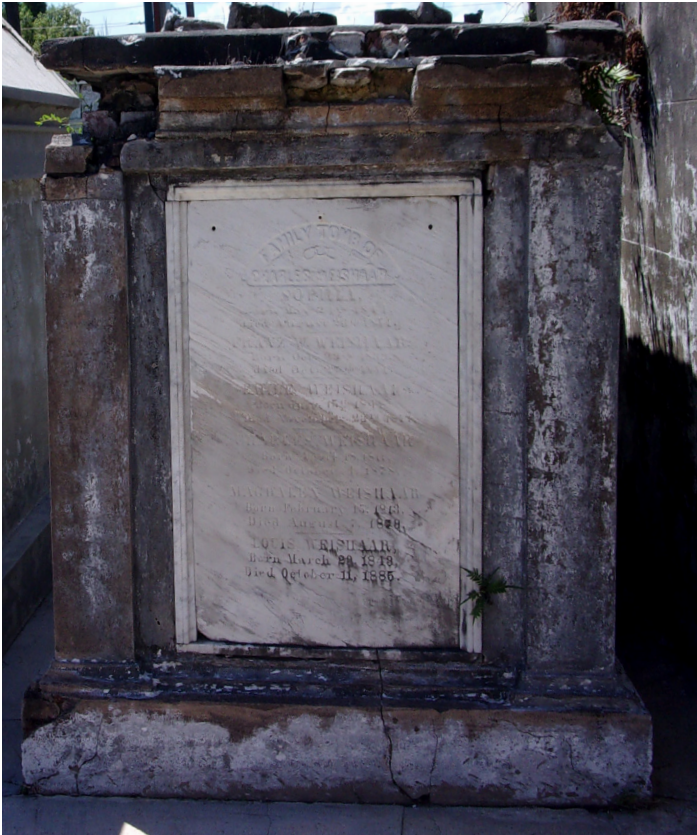
Figure 86. Significant missing material of the cornice and roof, cracking, spalling, and staining of front facade.

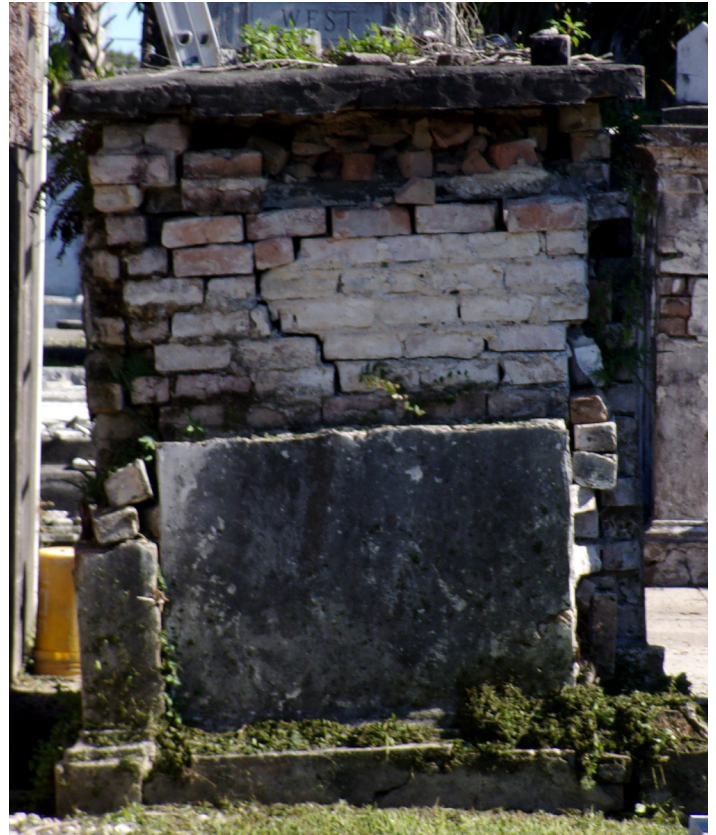
Figure 87. View of the rear of tomb shown to the left; partially missing stone veneer and bricks, vegetation.

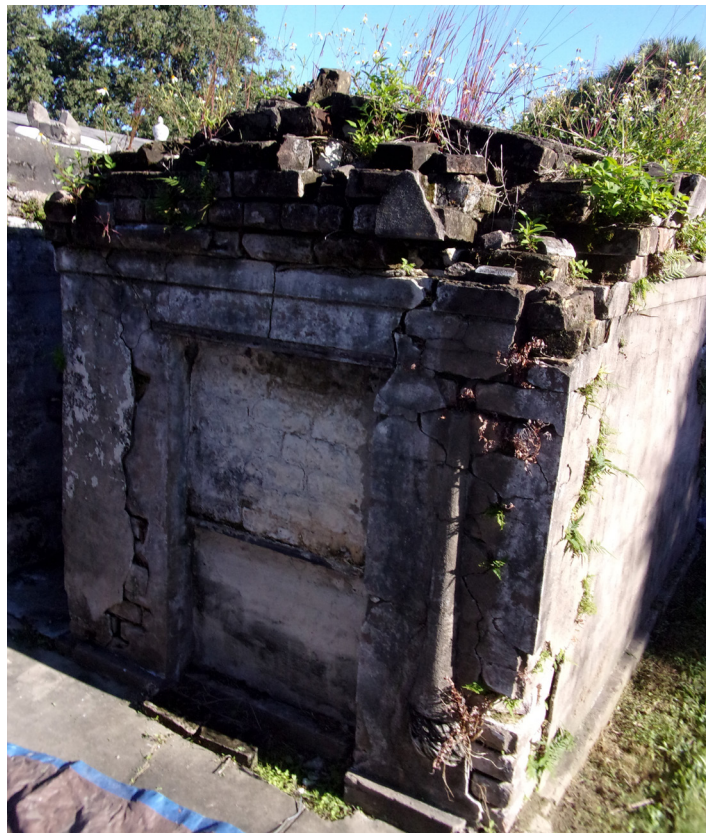
Figure 88. Severe vegetation and cracking, missing features (enclosure tablet and inverted torch), missing bricks and stucco.

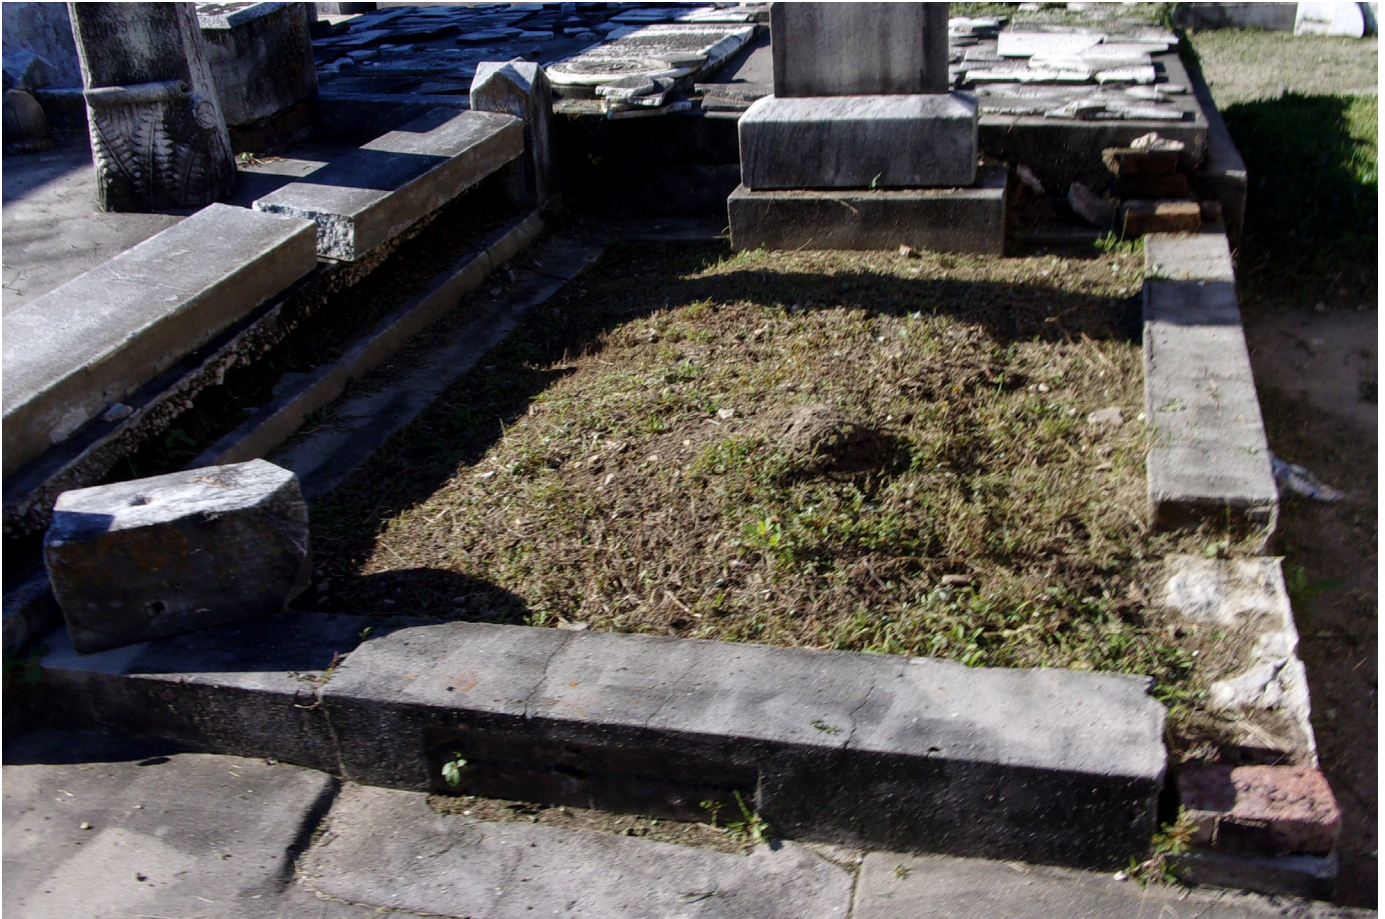
Figure 89. Coping grave in poor condition with cracking and some missing material.
