ODD FELLOWS' REST CEMETERY  
5055 Canal Street  
New Orleans, LA 70119

Final Practicum Report  
Teutonia Lodge Society Tomb HABS Report  
Existing Conditions Assessment

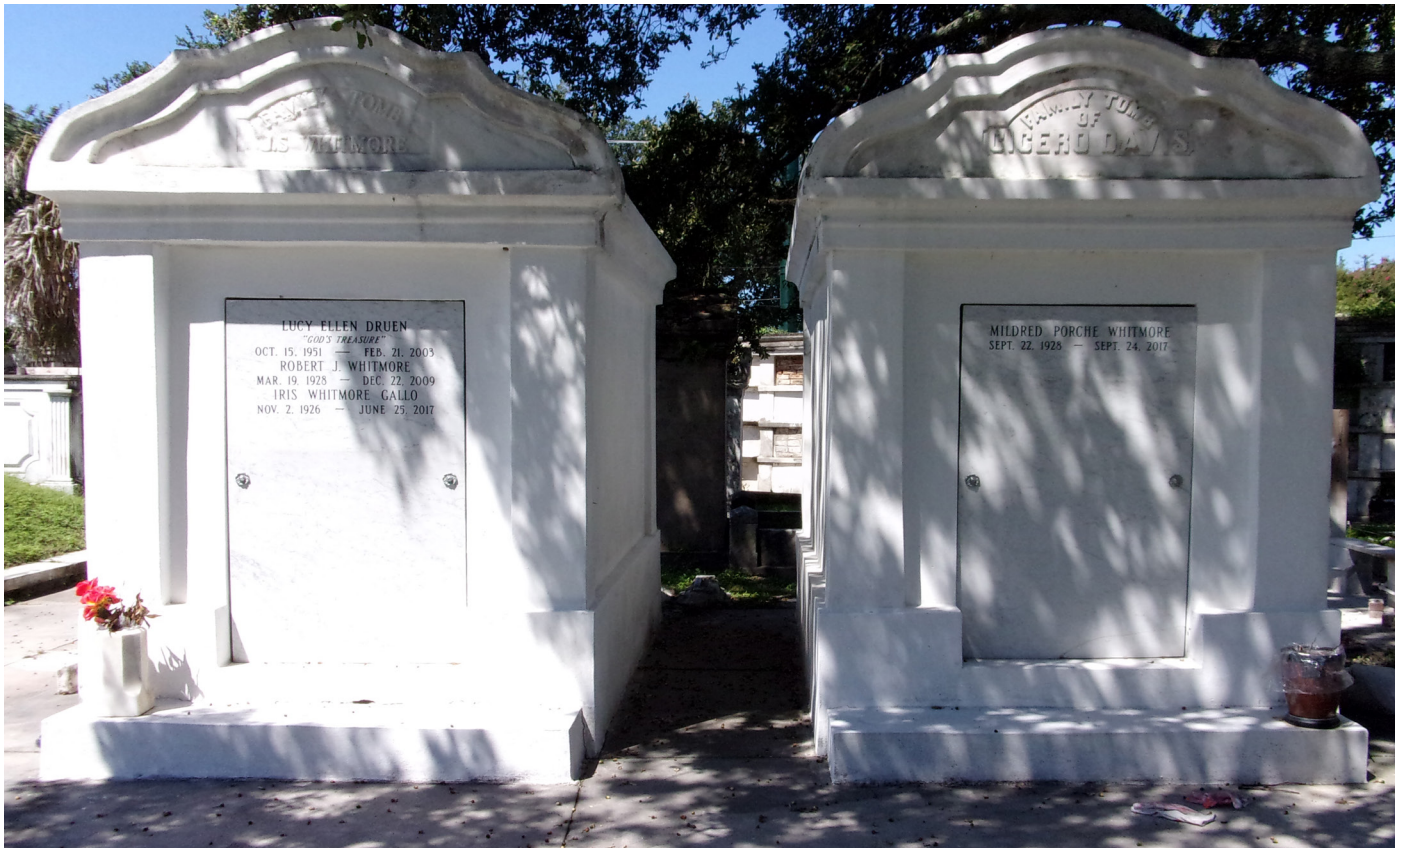
Figure 90. Two tombs being cared for in perpetuity.

trust is used to provide regular care and maintenance and to make repairs of whichever kind as required to keep the memorial in first class condition.”<sup>1</sup> Perpetual care maintenance, in general, includes cleaning and the yearly application of a layer of white paint over the surface of the tomb. This layer of paint is intended to be a protective layer for the tomb, as well as a cosmetic choice – it hides any irregularities or cracks on the surface.

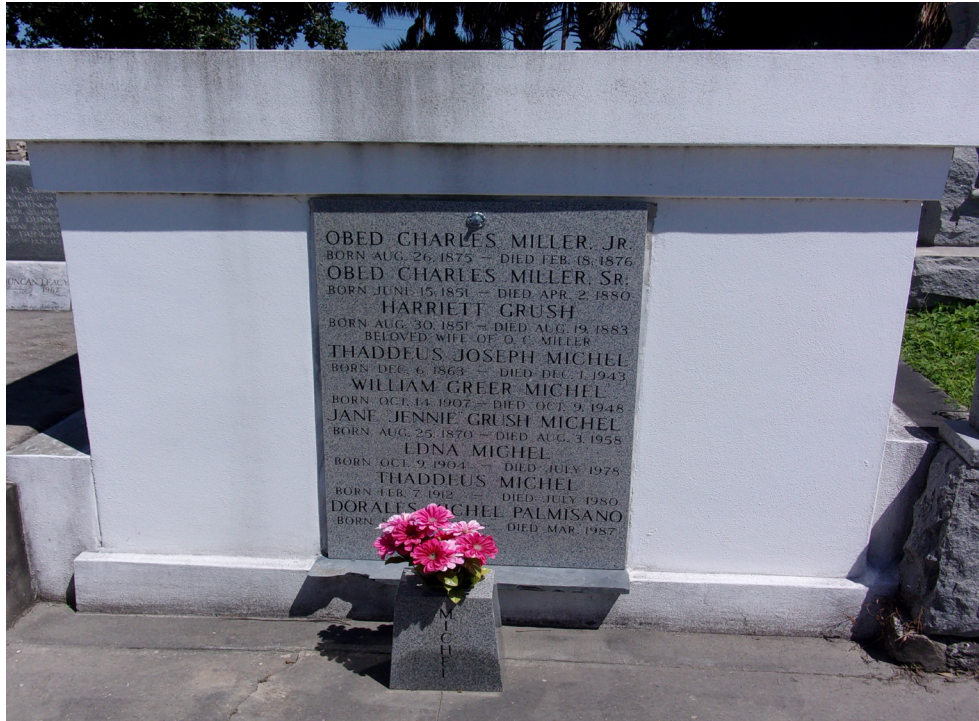
However, perpetual care is not necessarily the best form of maintenance for these small buildings. Instead of fixing any major problems, the perpetual care is covering them. They are not in as good of condition as they look to be because of the yearly paint layers. The paint layers trap moisture inside the building system which can cause system failures and severe material deterioration. Unfortunately, these failures and deterioration are never seen, so the damage cannot be recognized and therefore mitigated. It would be a much better system if the paint layer was instead a lime wash, a more compatible material that would allow moisture to enter and leave the building as needed – as would happen in a structural sound building.

Figure 91. Perpetual care tomb.
