# PORTFOLIO

Elisabeth Price  
Master of Preservation Studies  
Tulane University  
2018

# TABLE OF CONTENTS

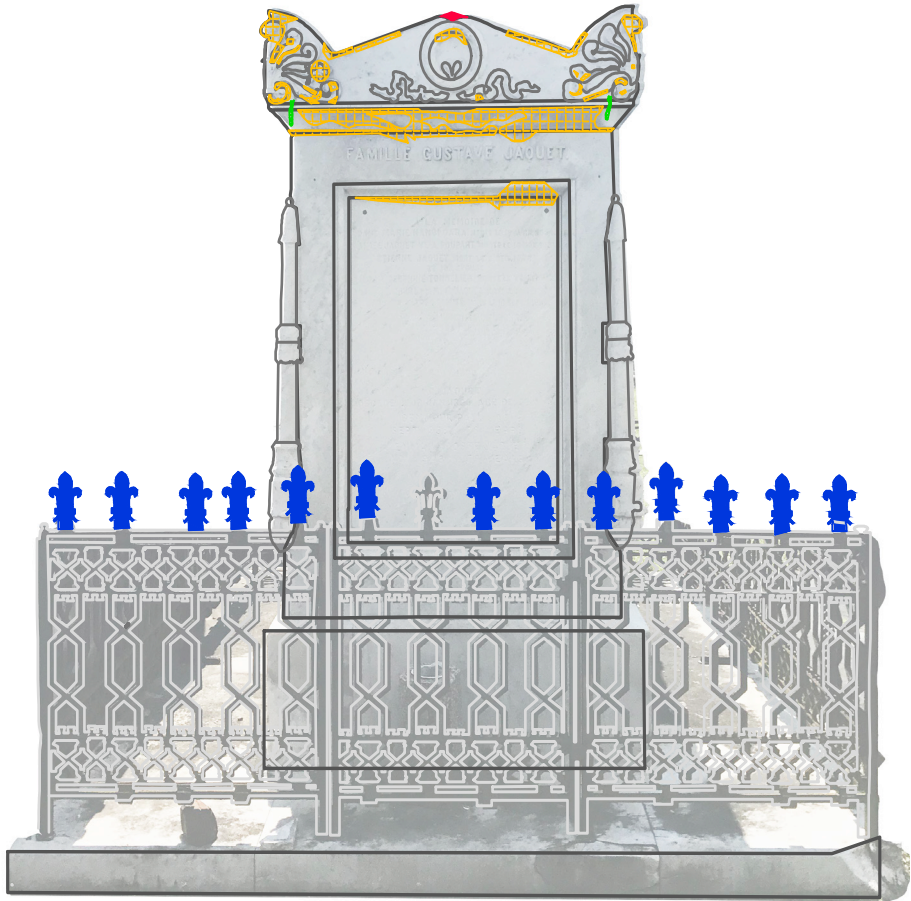
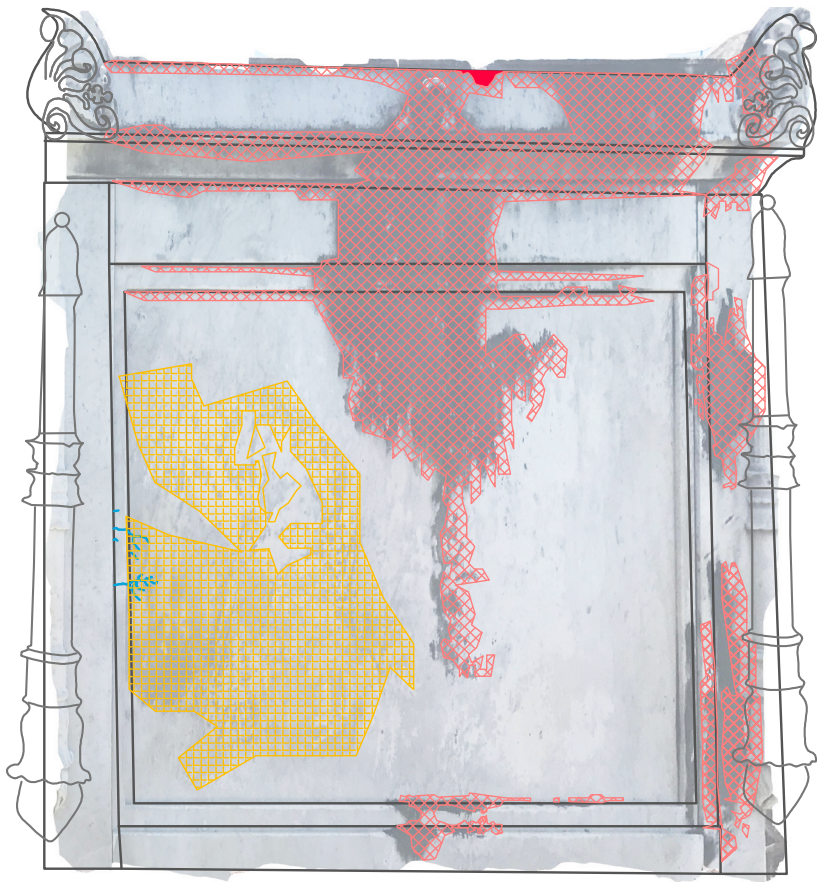
Top right: Northwest elevation, bottom right: Southeast elevation, Top left: Northeast elevation, Bottom left: Southwest elevation

General Note: The substrate has eroded over the entirety of the structure.

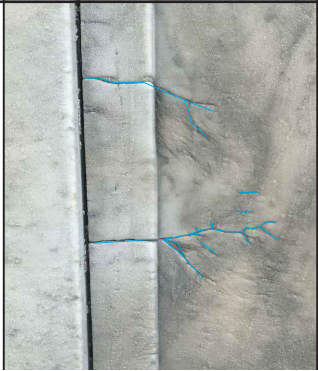
CRACKING - Narrow fissures in a block of masonry.

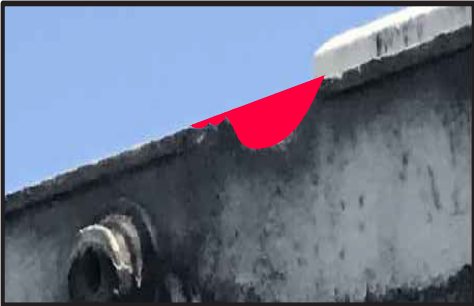
LOSS - loss of portions of marble due to general weathering and erosion

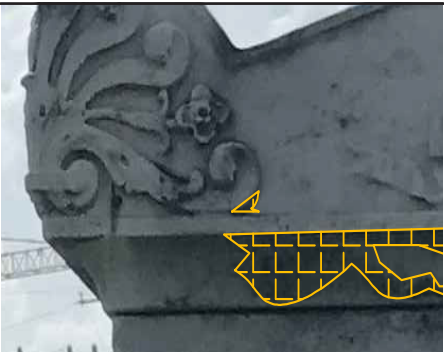
POLLUTION - staining due to airborne pollutants that leave a film over the surface of the substrate

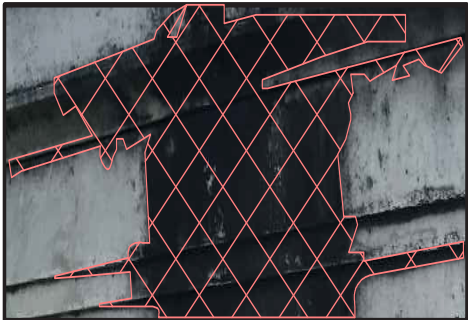
BIOLOGICAL GROWTH - grows when moisture is present and the substrate is not exposed to the sun

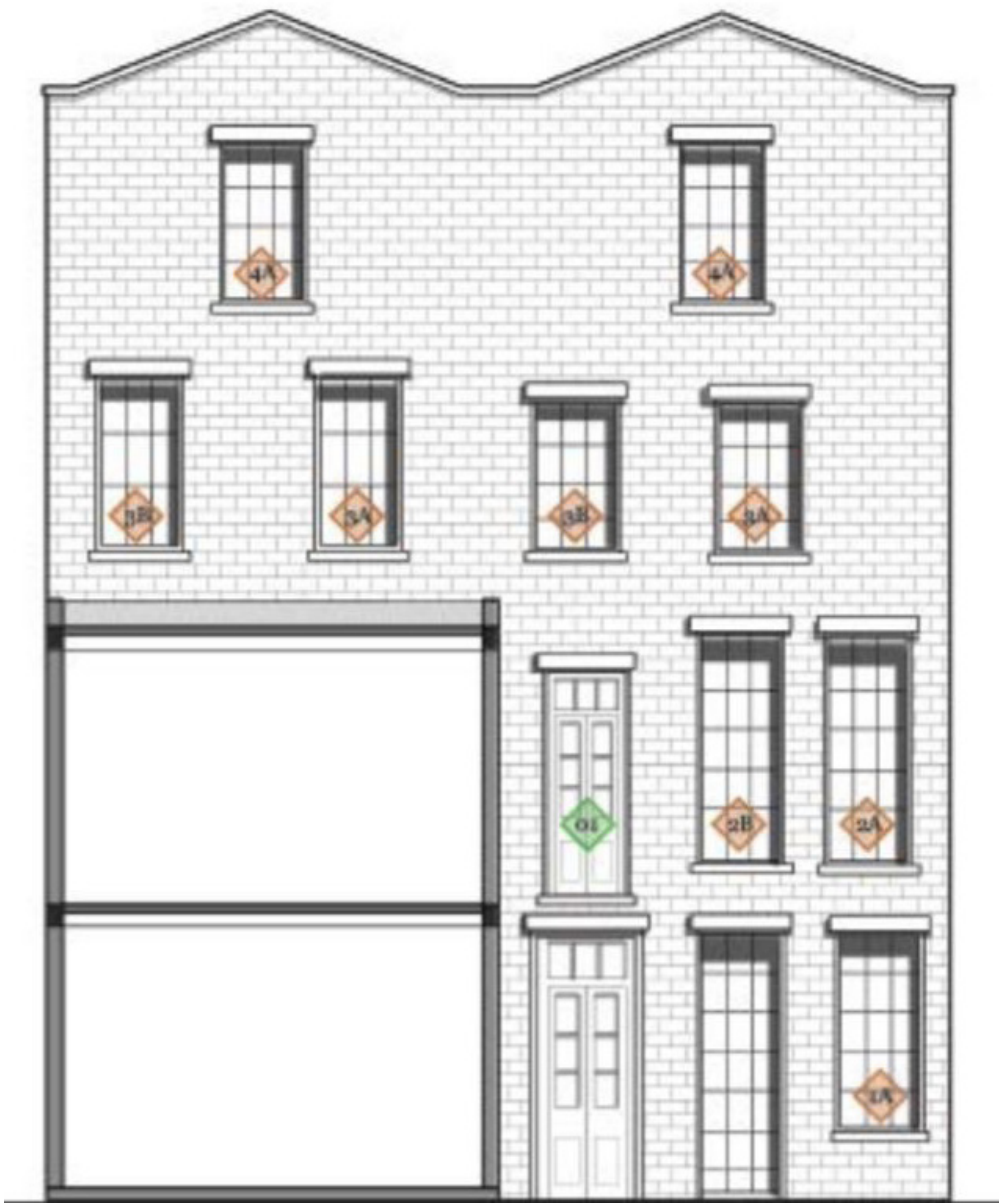
Rear elevation drawing of 614-618 Gravier Street

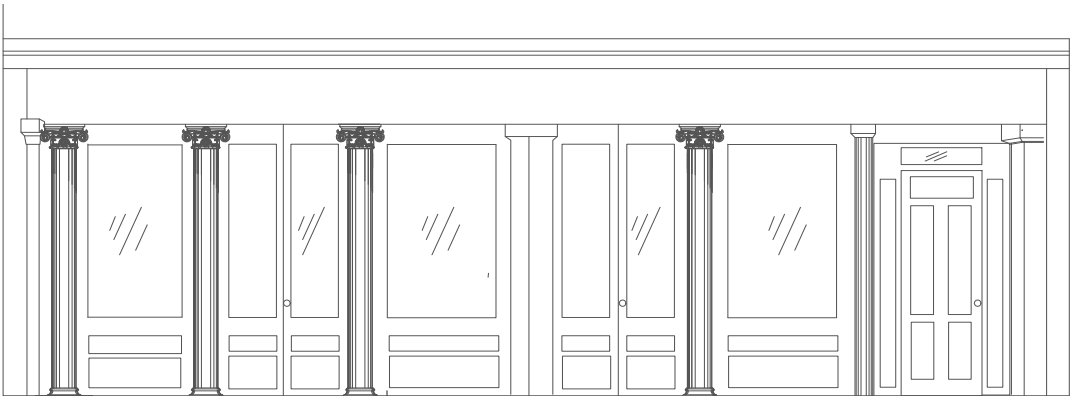
Above: CAD drawing of proposed inspired by the photo to the right.

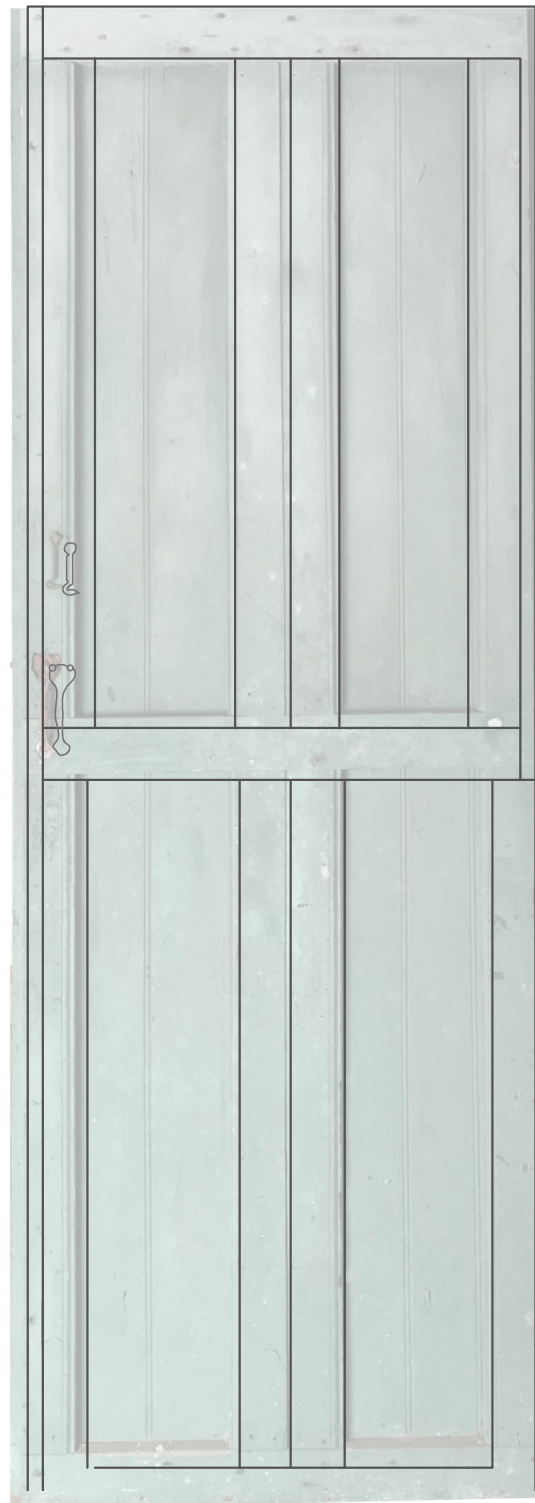
The Bright House, ca. 1790s  
A bousillage house in Slidell, LA.  
Original interior beadboard wood door (34"x90")

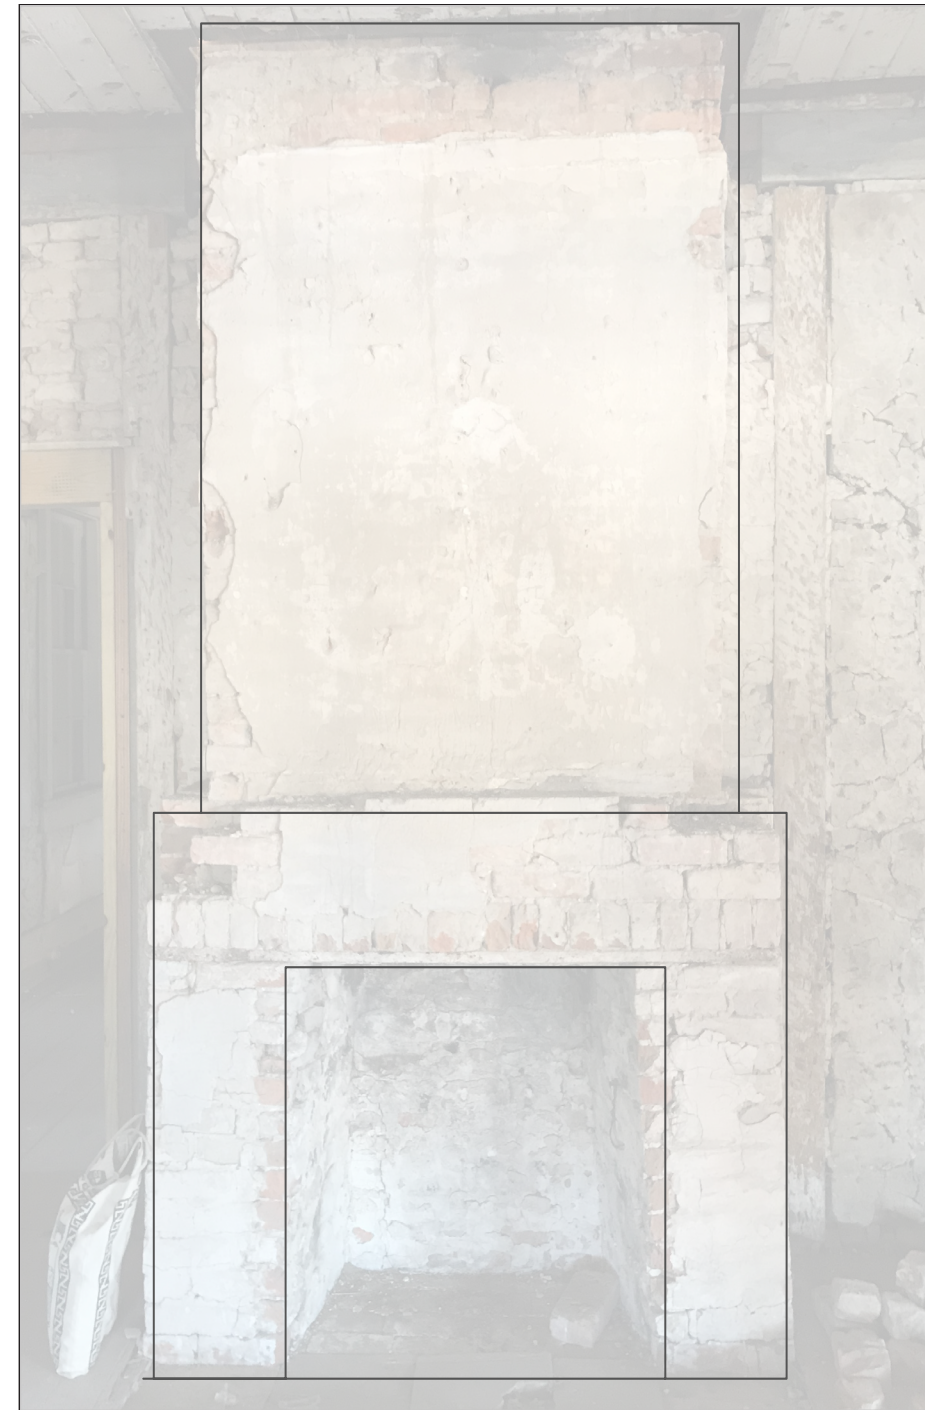
Godchaux Reserve, ca. 1790s  
A bousillage building in Reserve, LA.  
Original fireplace, original wood mantles are missing

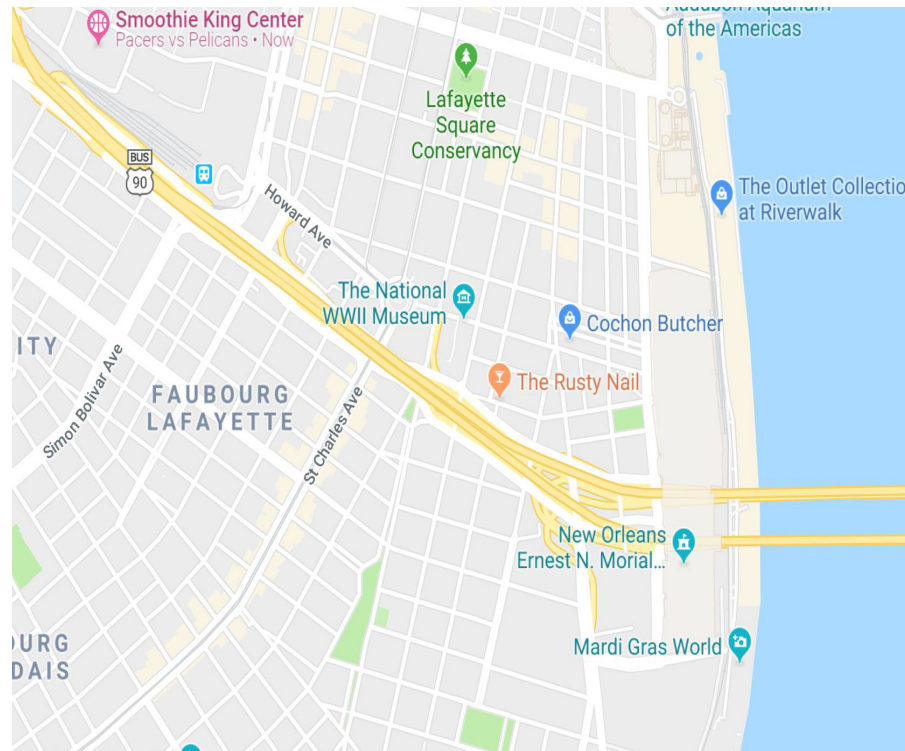
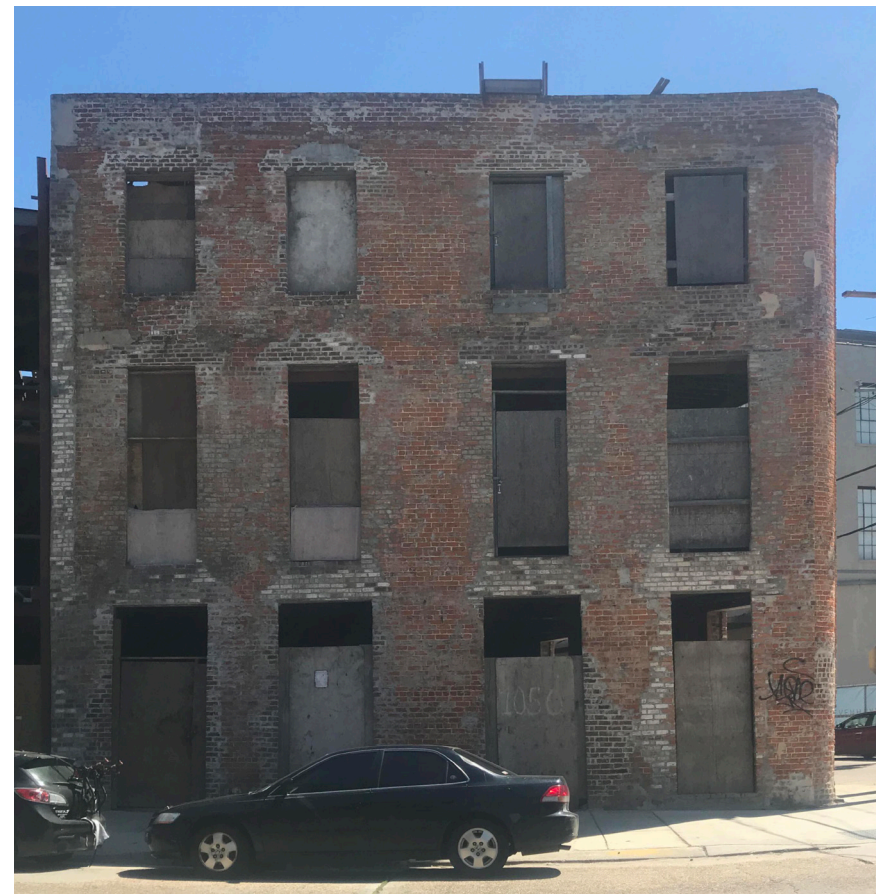
Front facade of 1050 Annunciation Street

Located in the warehouse district, 1050 Annunciation Street is a three story brick building built in 1852 as a residence. While currently the building is on the corner of Annunciation and John Churchill Chase Streets, originally, John Churchill Chase Street was a large alleyway with no street name. The building originally had numerous outbuildings associated with residential buildings, such as a cistern or a privy. Eventually, the building was enlarged and turned into a commercial space – at one point it was a machine shop. This was most likely due to meet the needs of the neighborhood because as people moved out of this part of town, the area turned more and more into the historic warehouse district that we know it as today. Many of these changes can be seen on the Sanborn Fire Insurance Maps. Physically, the building has been through quite a bit, with the removal of the granite lintels, application and removal of stucco, and the removal of windows and doors. The bricks used in construction are low-fired river bricks. This building has an interesting history as a residence turned commercial space for a building in its location. It is important to understand this history in order to properly address the needs of the building in its restoration.

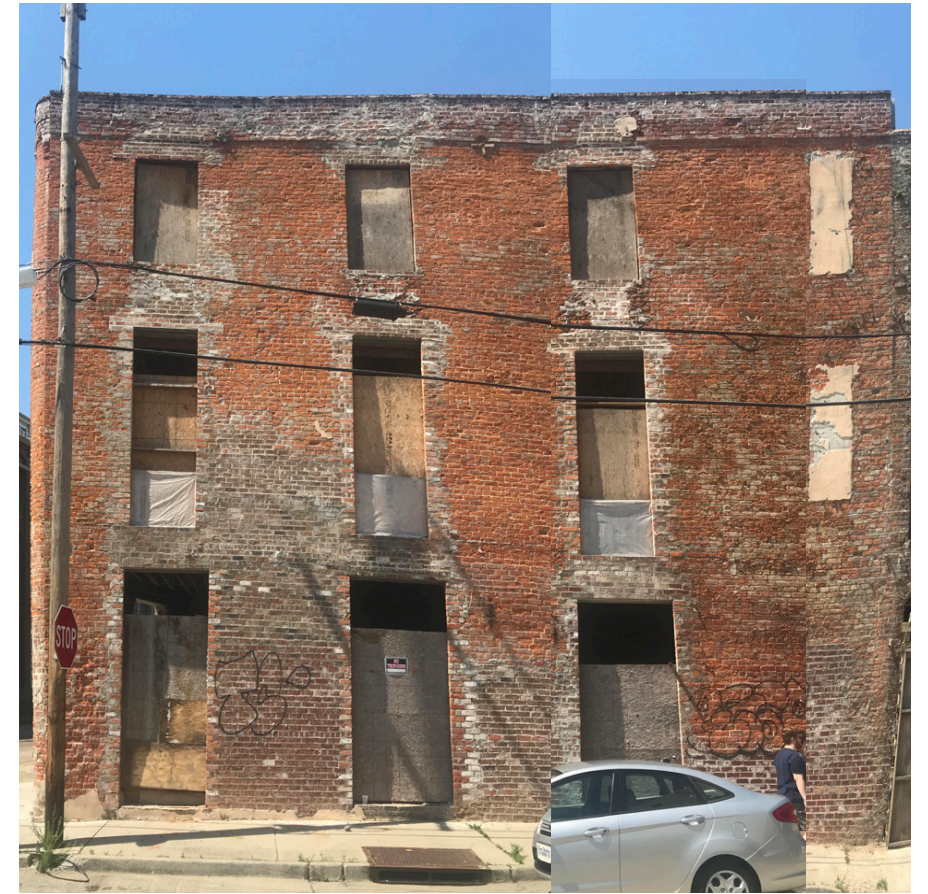
Side elevation (John Churchill Chase Street side) of 1050 Annunciation Street

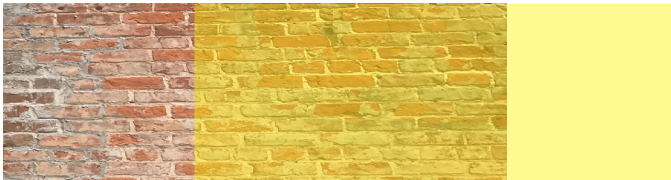
DAMAGED BRICK FROM STUCCO REMOVAL

At some point in the history of the building, the brick facades were covered in stucco. The current owners removed this stucco, resulting in the damaging of the original brick. This damage was most likely across the entire surface of the building, but there are other, more severe spaces of deterioration on the building.

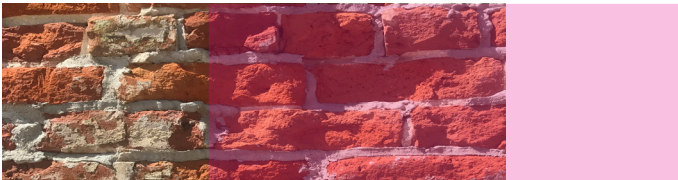
HEAVILY DETERIORATED BRICK

The low-fired river brick, once the stucco was removed, was cleaned improperly. This brick is heavily deteriorated due to this too aggressive cleaning. This has resulted in the loss of the brick's fire skin, or its protective coating from the kiln, leaving the bricks vulnerable to even more damage and deterioration. This can also be called spalling.

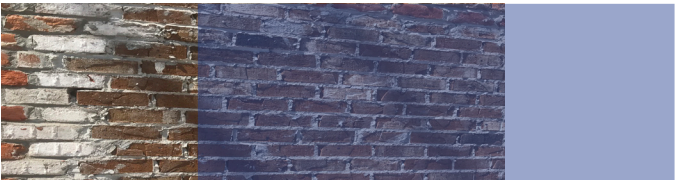
NEW / REPLACEMENT BRICK

A previous project had repointed and replaced various sections of deteriorated brick with a variety of new replacement bricks. This new mortar and brick system is not compatible with the existing original bricks because the new system is too hard. This causing even further failure within the bricks in the building system.

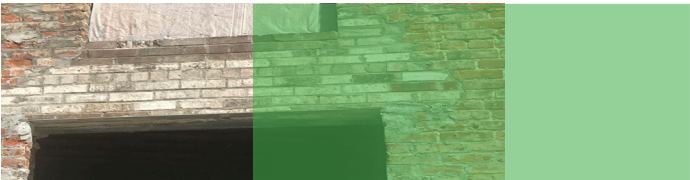
NEW BRICK THAT REPLACED LINTELS AND SURROUNDS

Originally, the building had granite lintels around the window openings. A previous project removed these lintels and replaced them with various types of new brick and a new mortar system. This new system is not compatible with the existing historic bricks. This causes even further failure within the building system.

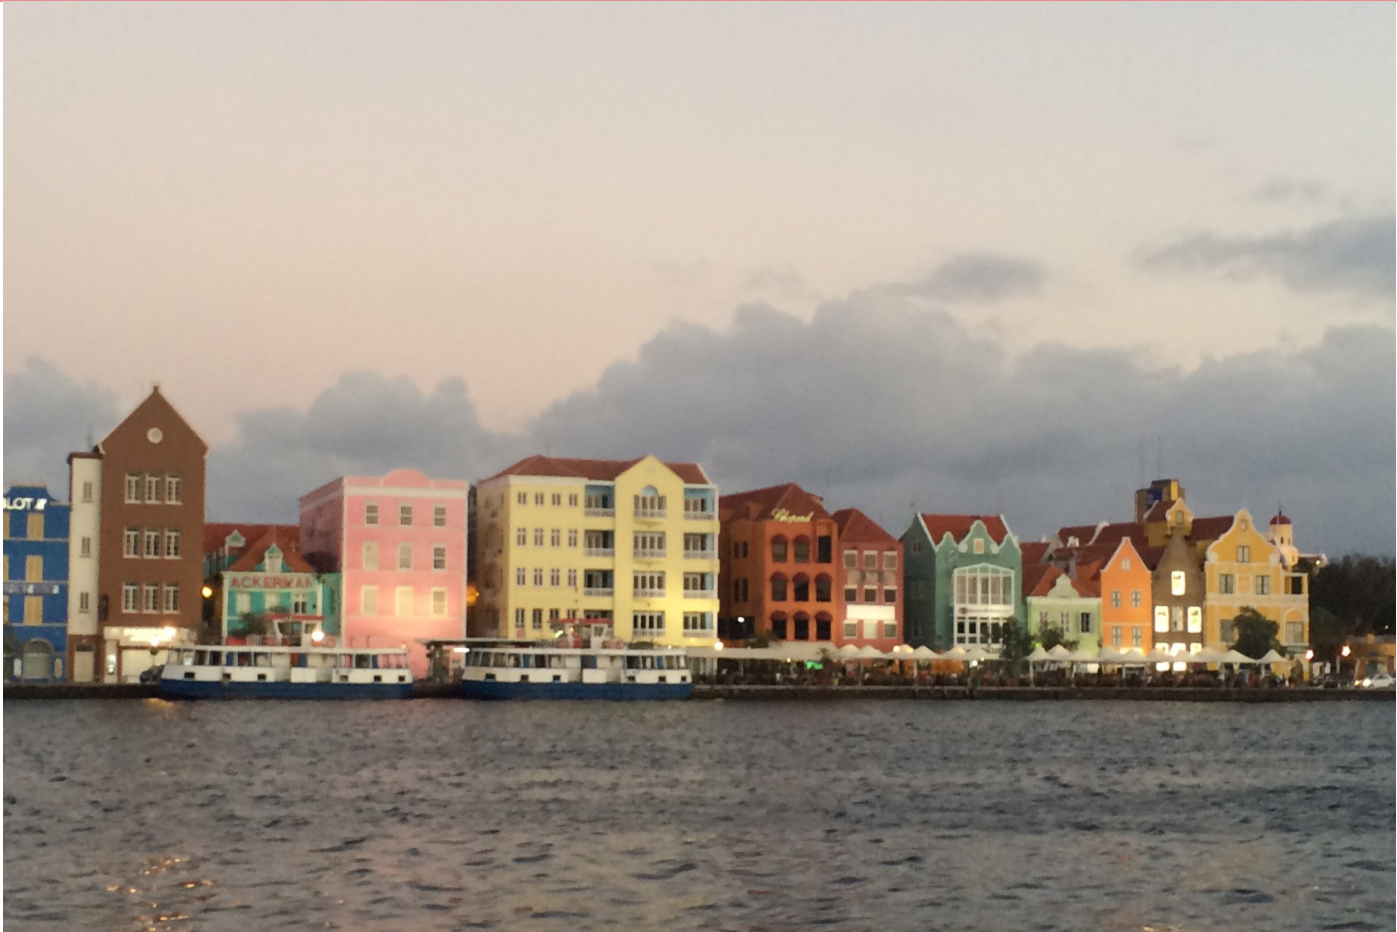
Above: Willemstad buildings; Below: Sketch of partial roofline
